## LEAD BASED PAINT INVESTIGATION REPORT

S-36-277 (PAUL LONG RD.) OVER BIG BEAVER DAM CREEK  
BRIDGE # 367027700100  
(SCOPE BRIDGE # 3670027700100)  
NEWBERRY COUNTY, SOUTH CAROLINA

May 8, 2019

F&ME Project No.: G6100.050

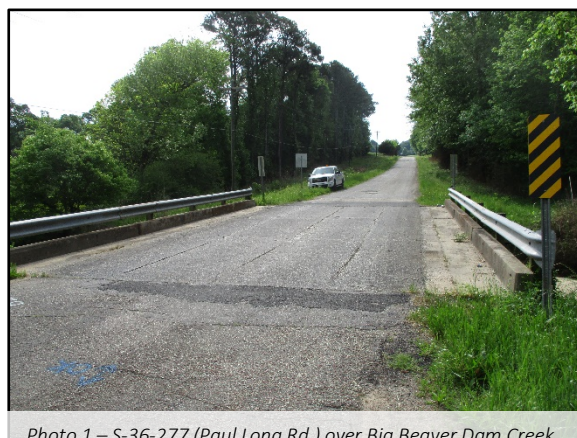
Photo 1 – S-36-277 (Paul Long Rd.) over Big Beaver Dam Creek, Newberry County, South Carolina.

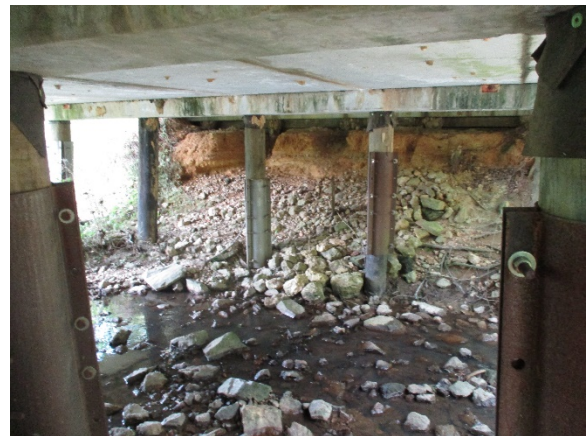
**Photo 4.** Underside View of Bridge.

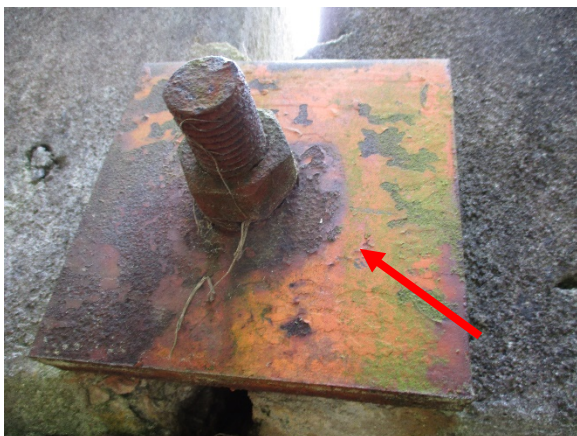
The XRF results indicate that LBP is present on the tie-rod washers located at the north and south ends of the bridge on each corner and the horizontal I-beam on the underside of bent #2. For more information regarding the specific descriptions and locations of the items that were scanned, refer to the Appendix C – XRF Data. Also, Appendix E – Site Photographs, shows top and underside views of the bridge. Appendix D - Personnel Certification provides the LBP certifications for FME.

**Photo 5.** Tie-rod Washer is Positive for Lead.

The results of this LBP investigation determined that there are lead-based paints or coatings on the tie-rod washers located at the north and south ends of the bridge on each corner and the horizontal I-beam on the underside of bent #2. These components can either be thrown away with the general construction and demolition debris, or they can be segregated and taken to a metal recycling facility that accepts lead coated materials. No other coated or painted bridge components containing lead were found. During the bridge demolition activities, some painted surfaces may be exposed. If paint is exposed and it is determined to contain levels of lead  $\geq 0.7$  mg/cm<sup>2</sup>, the coated/painted components will need to be handled and disposed of properly. Proper handling includes the avoidance of creating lead dust, as

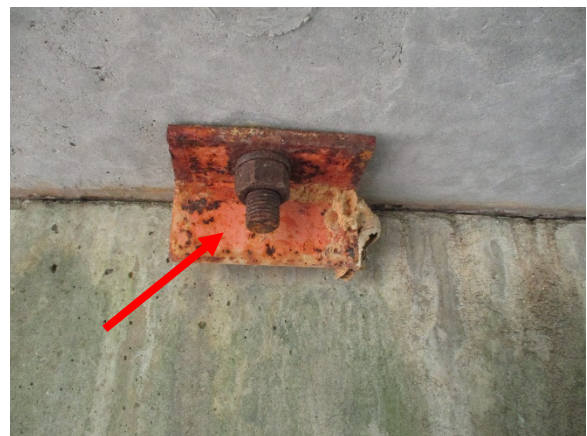
**Photo 6.** L-Bracket is Positive for Lead.
