ASBESTOS CONTAINING MATERIAL INVESTIGATION REPORT

S-41-281 (MATTHEWS RD.) BRIDGE OVER TRIBUTARY TO LAKE
MURRAY

BRIDGE #417028100100 (SCOPE BRIDGE ID# 4170028100100)
SALUDA COUNTY, SOUTH CAROLINA

May 22, 2019

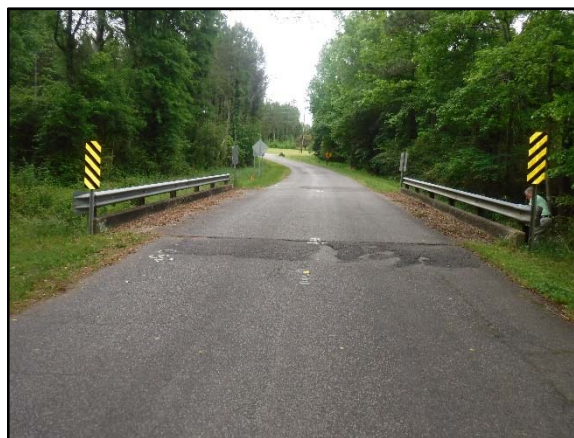
Photo 1 – S-41-218 (Mathews Road) Bridge over Tributary to Lake Murray, in Saluda County, South Carolina

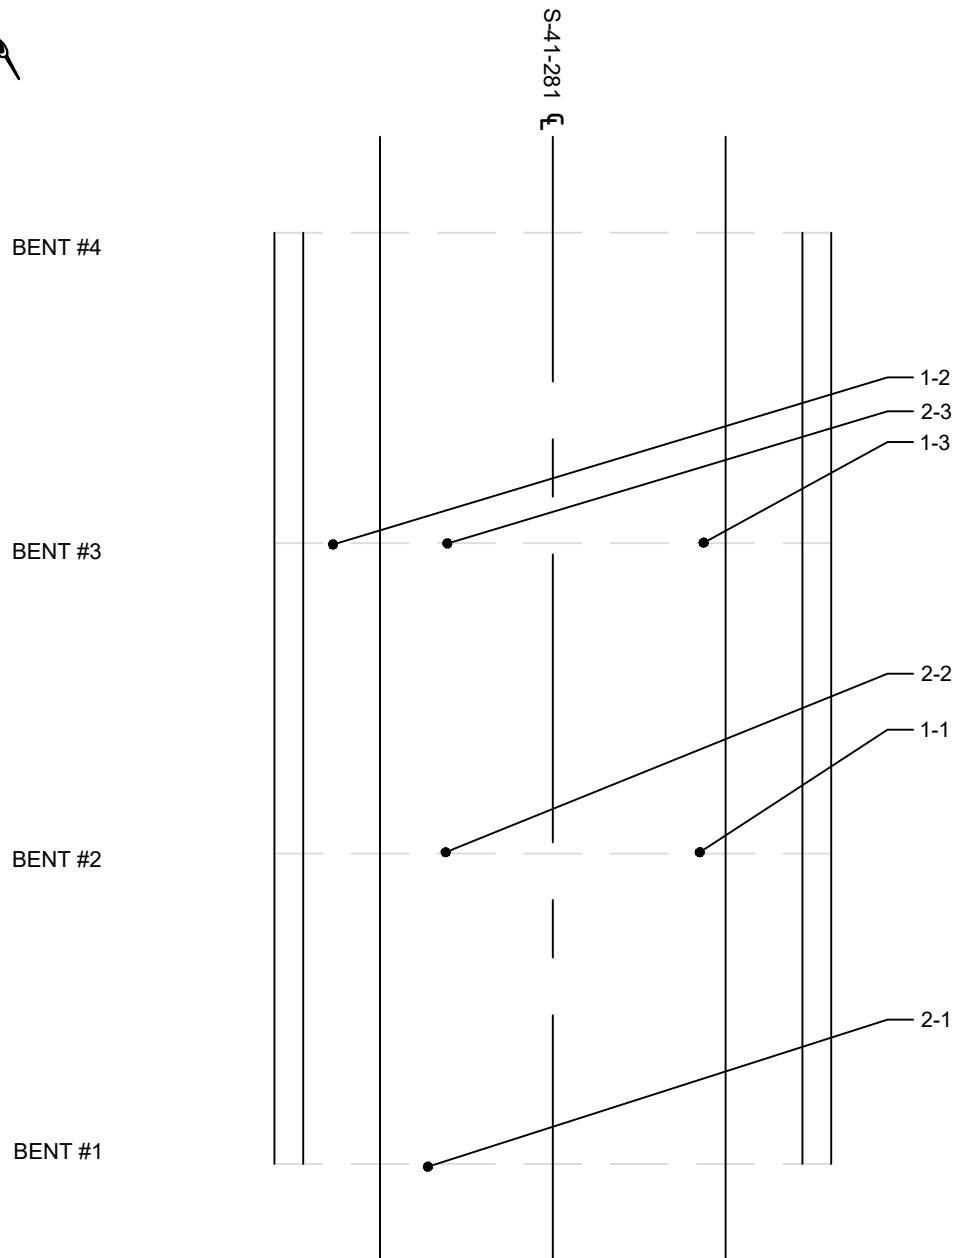
2

**ASBESTOS CONTAINING MATERIALS
INVESTIGATION**
**S-41-281 (Mathews Rd.) over Tributary to Lake
Murray**
Saluda County, SC
Sample Location Plan
Prepared for: S.C. Department of Transportation
955 Park Street
Columbia, SC 29201

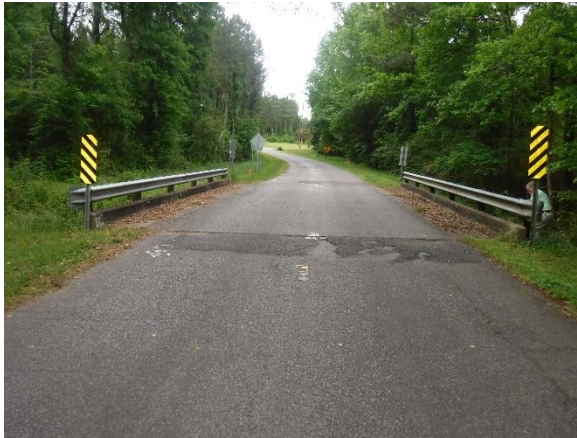
Photo 1. Top View of Bridge.

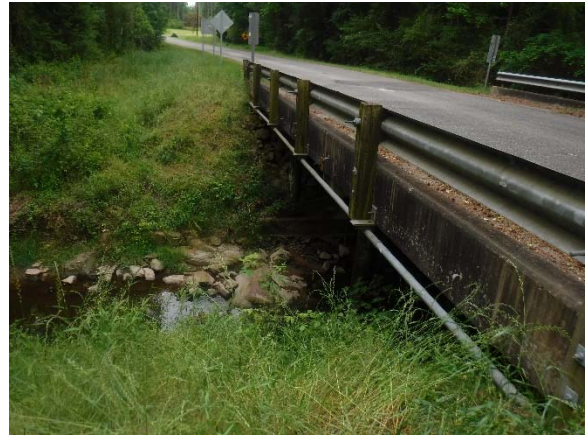
Photo 2. East Side View of Bridge.

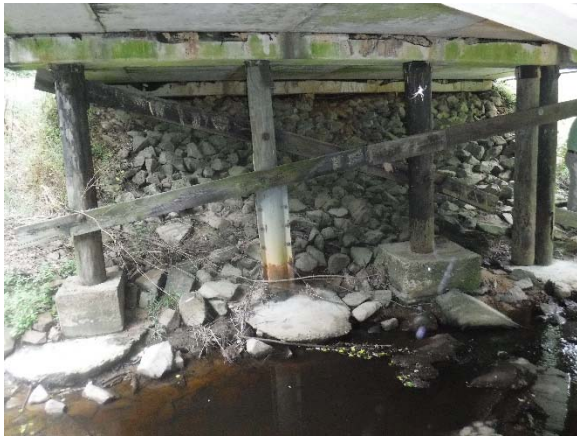
Photo 3. Underside of Bridge View

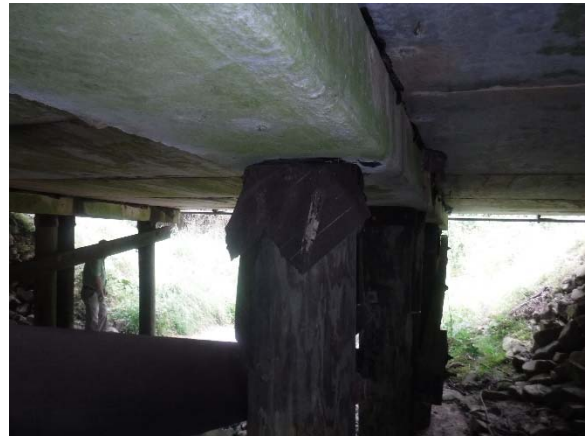
| Sample | Description | Appearance | Non-Asbestos | | Asbestos |
|---|---|---|---|---|---|
| 1-1 021903213-0001 | Timber Pile Cap Felt | Gray/Black Fibrous Homogeneous | 75% Cellulose | 25% Non-fibrous (Other) | None Detected |
| 1-2 021903213-0002 | Timber Pile Cap Felt | Black Fibrous Heterogeneous | 60% Cellulose | 40% Non-fibrous (Other) | None Detected |

| Sample ID | Description | Appearance | % Matrix Material | % Non-Asbestos Fibers | Asbestos Types |
|---|---|---|---|---|---|
| 1-3 021903213-0005 | Timber Pile Cap Felt | Black Fibrous Homogeneous | 100.0 Other | None | No Asbestos Detected |

Photo 4. Timber Pile Cap Felt

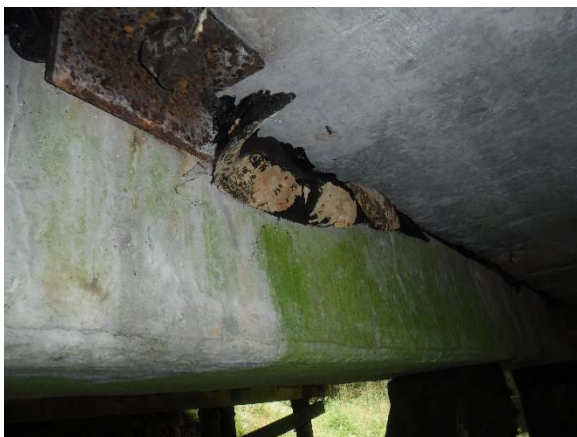
| Sample | Description | Appearance | Non-Asbestos | | Asbestos |
|---|---|---|---|---|---|
| 2-1 021903213-0003 | Bond Break Pad | Brown/Various/Black Non-Fibrous Homogeneous | 3% Cellulose | 97% Non-fibrous (Other) | None Detected |
| 2-2 021903213-0004 | Bond Break Pad | Brown/Black Non-Fibrous Heterogeneous | 1% Cellulose | 99% Non-fibrous (Other) | None Detected |

| Sample ID | Description | Appearance | % Matrix Material | % Non-Asbestos Fibers | Asbestos Types |
|---|---|---|---|---|---|
| 2-3 021903213-0006 | Bond Break Pad | Black Fibrous Heterogeneous | 100.0 Other | None | No Asbestos Detected |

Photo 5. Bond Break Pads

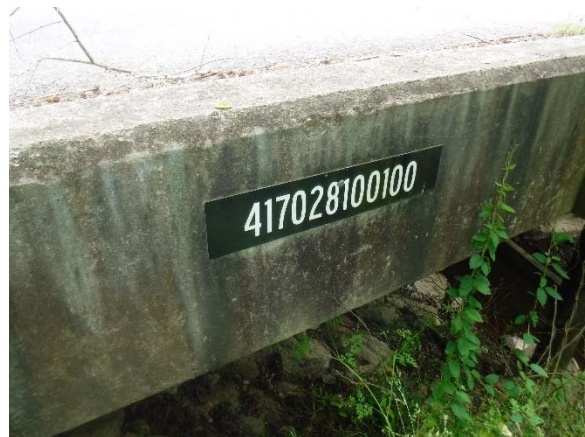
Photo 6. Bridge Identification Placard
