ASBESTOS CONTAINING MATERIAL INVESTIGATION REPORT

S-36-272 (GRAHAM RD.) BRIDGE OVER SECOND CREEK BRIDGE
#367027200100 (SCOPE BRIDGE ID # 3670027200100)
NEWBERRY COUNTY, SOUTH CAROLINA

May 10, 2019

FME Project No.: G6100.050

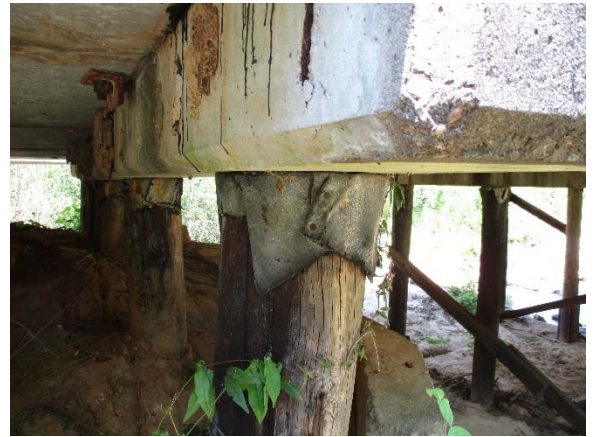
During the investigation, the black timber pile cap felt, and black bond break pads were the only suspect materials observed associated with the subject bridge. Six (6) random samples of these materials were collected for laboratory analysis, and their physical characteristics were recorded. The remaining bridge materials (i.e. concrete, steel, etc.) were not considered suspect and were not sampled.

Photo 4. Timber Pile Cap Felt

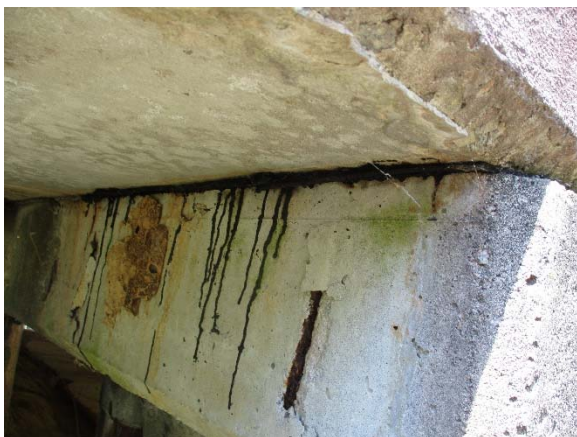
Photo 5. Bond Break Pad
