LEAD BASED PAINT INVESTIGATION REPORT

S-41-78 (SHILOH RD.) OVER PERSIMMON CREEK
BRIDGE # 417007800200
(SCOPE BRIDGE # 4170007800200)
SALUDA COUNTY, SOUTH CAROLINA

May 23, 2019

F&ME Project No.: G6100.050

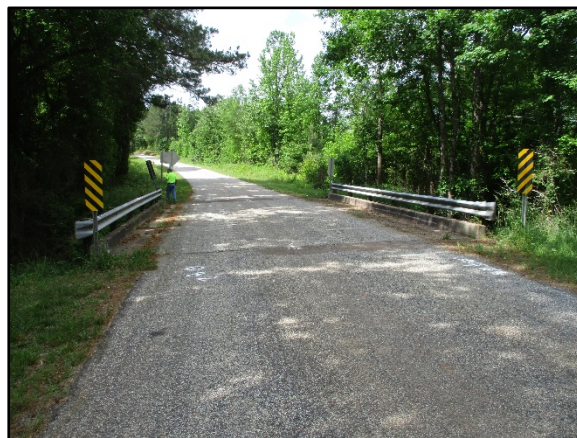
Photo 1 – S-41-78 (Shiloh Rd.) over Persimmon Creek, Saluda County, South Carolina.

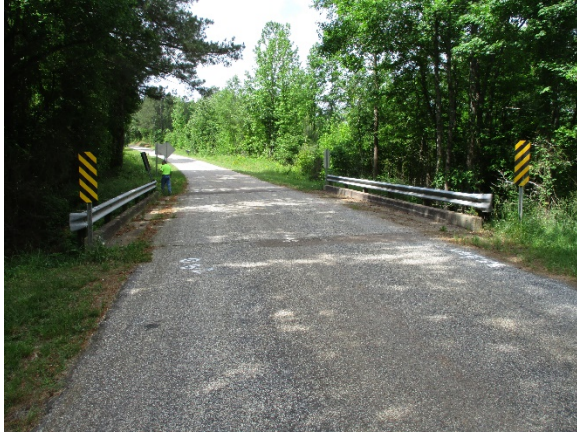
Photo 1. Top View of Bridge Deck.

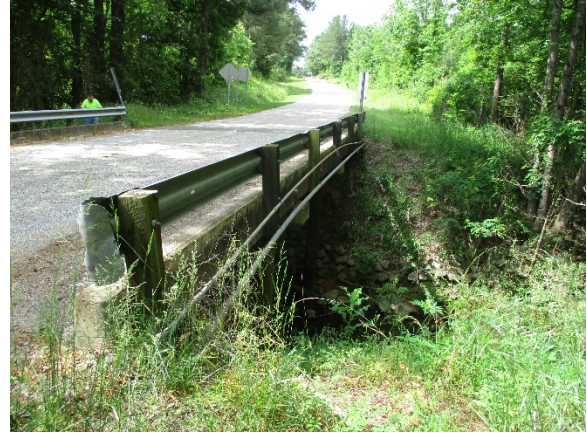
Photo 2. Side View of Bridge.

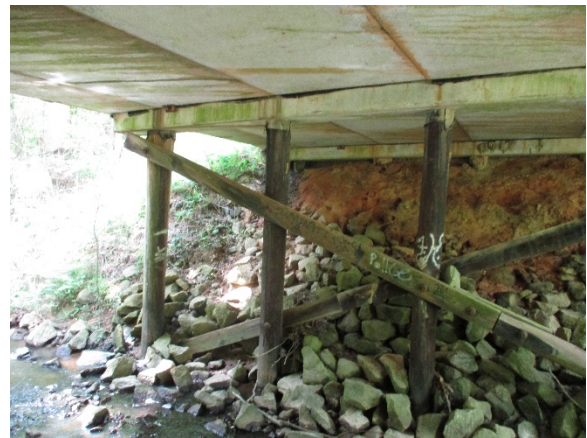
Photo 4. Underside of Bridge View.

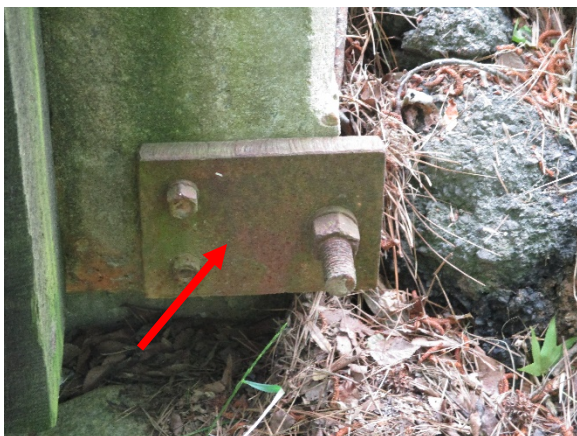
The XRF results indicate that LBP is present on the tie-rod washers located on the sides of the bridge and the L-brackets located on the underside of the bridge deck. For more information regarding the specific descriptions and locations of the items that were scanned, refer to the Appendix C – XRF Data. Also, Appendix E – Site Photographs, shows top and underside views of the bridge. Appendix D - Personnel Certification provides the LBP certifications for FME personnel.

Photo 5. Tie-rod Washer is Positive for Lead.

The results of this LBP investigation determined that there are lead-based paints or coatings on the tie-rod washers located on the sides of the bridge and the L-brackets located on the underside of the bridge deck. These components can either be thrown away with the general construction and demolition debris, or they can be segregated and taken to a metal recycling facility that accepts lead coated materials. No other coated or painted bridge components containing lead were found. During the bridge demolition activities, some painted surfaces may be exposed. If paint is exposed and it is determined to contain levels of lead ≥ 0.7 mg/cm², the coated/painted components will need to be handled and disposed of properly. Proper handling includes the avoidance of creating lead dust, as well as the creation of lead-contaminated soil hazards. Activities that would generate lead dust include

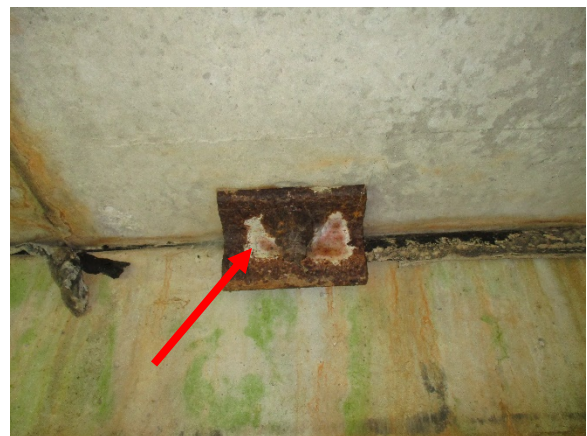
Photo 6. L-Bracket is Positive for Lead.
