LEAD BASED PAINT INVESTIGATION REPORT

S-36-342 (BIG BEAVER DAM CREEK RD.) OVER BIG BEAVER
DAM CREEK
BRIDGE # 367034200200 (SCOPE BRIDGE # 3670034200200)
NEWBERRY COUNTY, SOUTH CAROLINA

May 8, 2019

F&ME Project No.: G6100.050

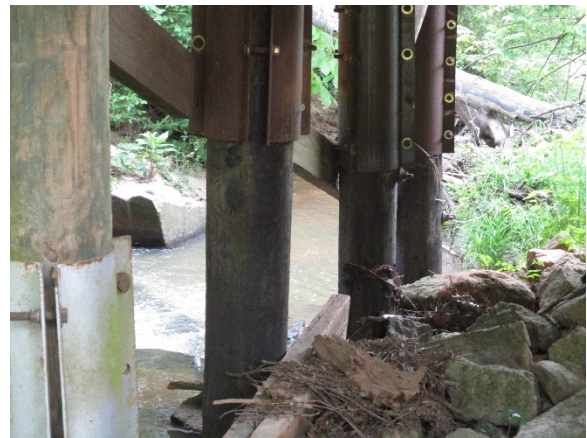
Photo 4. Metal Sleeve on Timber Pile.

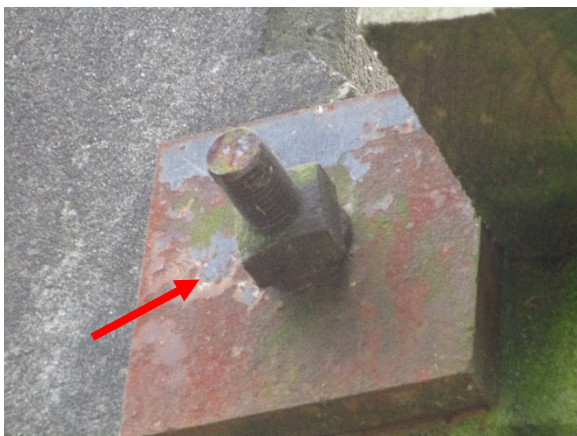
The XRF results indicate that LBP is present on the tie-rod washers located on the sides of the bridge and the L-brackets located on the underside of the bridge deck. For more information regarding the specific descriptions and locations of the items that were scanned, refer to the Appendix C – XRF Data. Also, Appendix E – Site Photographs, shows top and underside views of the bridge. Appendix D - Personnel Certification provides the LBP certifications for FME personnel.

Photo 5. Orange Tie-rod Washer is Positive for LBP.

The results of this LBP investigation determined that there are lead-based paints or coatings on the tie-rod washers located along the sides of the bridge and the L-brackets located on the underside of the bridge. These components can either be thrown away with the general construction and demolition debris, or they can be segregated and taken to a metal recycling facility that accepts lead coated materials. No other coated or painted bridge components containing lead were found. During the bridge demolition activities, some painted surfaces may be exposed. If paint is exposed and it is determined to contain levels of lead ≥ 0.7 mg/cm², the coated/painted components will need to be handled and disposed of properly. Proper handling includes the avoidance of creating lead dust, as well as the creation of lead-contaminated soil hazards. Activities that would generate lead dust include abrasion, scraping,

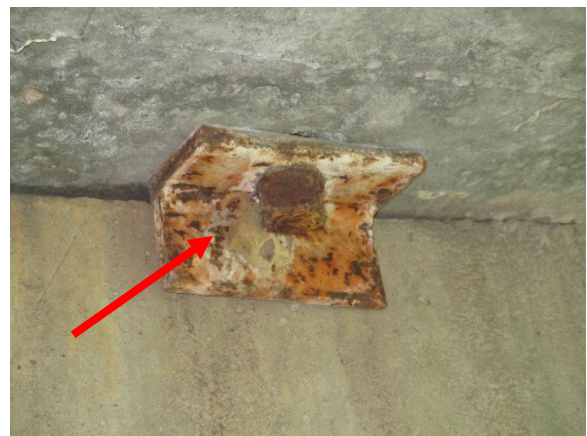
Photo 6. Orange L-Bracket is Positive for LBP.
