LEAD BASED PAINT INVESTIGATION REPORT

S-1-96 (BULLS HORNE RD.) OVER SHANKLIN CREEK
(SCOPE BRIDGE # 0170009600100)
ABBEVILLE COUNTY, SOUTH CAROLINA

May 22, 2019

F&ME Project No.: G6100.050

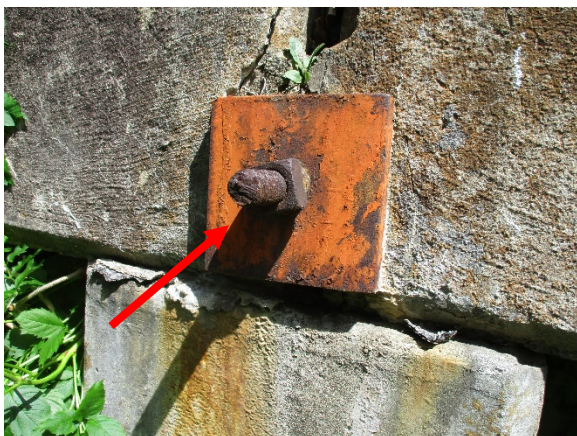
The XRF results indicate that LBP is present on the tie-rod washers located on the sides of the bridge and the L-brackets located on the underside of the bridge deck. For more information regarding the specific descriptions and locations of the items that were scanned, refer to the Appendix C – XRF Data. Also, Appendix E – Site Photographs, shows top and underside views of the bridge. Appendix D - Personnel Certification provides the LBP certifications for FME personnel.

Photo 5. Orange Tie-rod Washer is Positive for Lead.

The results of this LBP investigation determined that there are lead-based paints or coatings on the tie-rod washers located on the sides of the bridge and the L-brackets located on the underside of the bridge deck. These components can either be thrown away with the general construction and demolition debris, or they can be segregated and taken to a metal recycling facility that accepts lead coated materials. No other coated or painted bridge components containing lead were found. During the bridge demolition activities, some painted surfaces may be exposed. If paint is exposed and it is determined to contain levels of lead ≥ 0.7 mg/cm², the coated/painted components will need to be handled and disposed of properly. Proper handling includes the avoidance of creating lead dust, as well

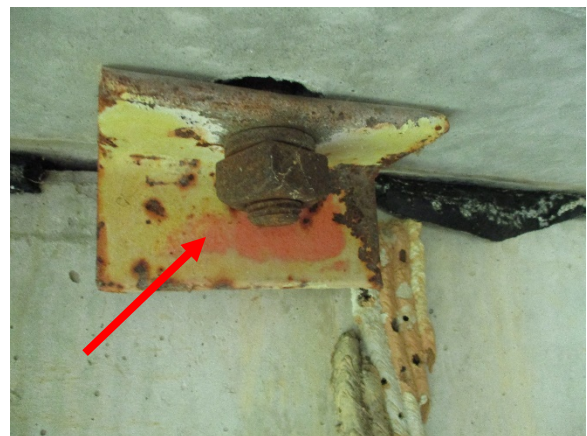
Photo 6. Orange L-Bracket is Positive for Lead.
