## LEAD BASED PAINT INVESTIGATION REPORT

S-36-272 (GRAHAM RD.) OVER SECOND CREEK  
BRIDGE # 367027200100  
(SCOPE BRIDGE # 3670027200100)  
NEWBERRY COUNTY, SOUTH CAROLINA

May 22, 2019

F&ME Project No.: G6100.050

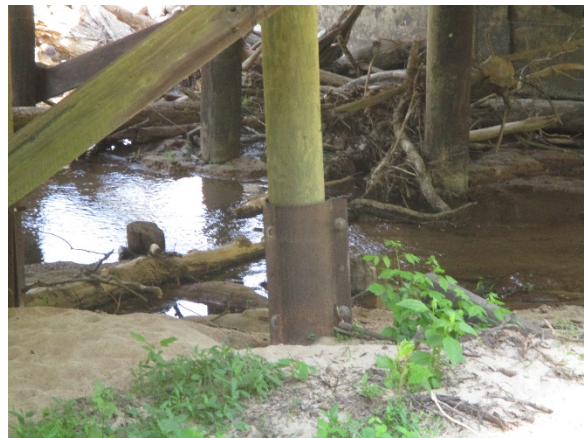
**Photo 4.** Metal Sleeve on Timber Pile.

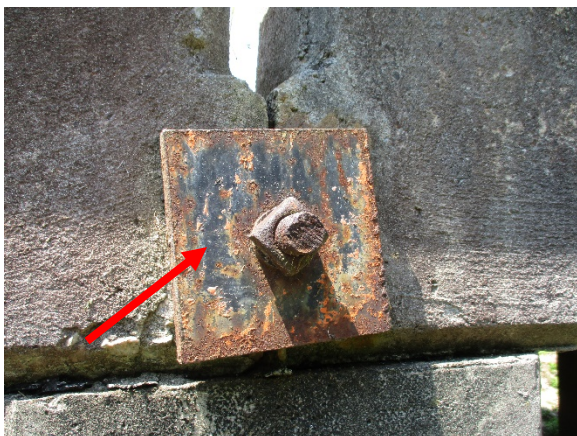
The XRF results indicate that LBP is present on the tie-rod washers located on the sides of the bridge and the L-brackets located on the underside of the bridge deck. For more information regarding the specific descriptions and locations of the items that were scanned, refer to the Appendix C – XRF Data. Also, Appendix E – Site Photographs, shows top and underside views of the bridge. Appendix D - Personnel Certification provides the LBP certifications for FME personnel.

**Photo 5.** Tie-rod Washer is positive for Lead.

The results of this LBP investigation determined that there are lead-based paints or coatings on the tie-rod washers located along the sides of the bridge and the L-brackets located on the underside of the bridge. These components can either be thrown away with the general construction and demolition debris, or they can be segregated and taken to a metal recycling facility that accepts lead coated materials. No other coated or painted bridge components containing lead were found. During the bridge demolition activities, some painted surfaces may be exposed. If paint is exposed and it is determined to contain levels of lead  $\geq 0.7$  mg/cm<sup>2</sup>, the coated/painted components will need to be handled and disposed of properly. Proper handling includes the avoidance of creating lead dust, as well as the creation of lead-contaminated soil hazards. Activities that would generate lead dust include abrasion, scraping, or

SCDHEC regulates the proper disposal of LBP and associated debris. SCDHEC defines two types of LBP debris. The first is LBP *waste*, which is defined as material such as wood, brick and metal that is painted with LBP. The other is LBP *residue* which is defined as residue that is generated from the removal (e.g., scraped, chipped, sandblasted, or chemical) of LBP from a structure. LBP *waste* that comes from a commercial or residential facility may be disposed of in either a class 2 or 3 landfill, while LBP *residue* from a commercial facility must have a toxicity characteristic leaching procedure (TCLP) analysis to determine the lead content. TCLP analysis is used to determine whether or not a waste is a characteristic hazardous waste due to leachability under the South Carolina Hazardous Waste Management Regulations. LBP *residue* with a TCLP analysis result greater than or equal to five milligrams per liter ( $\geq 5$  mg/l) lead must be disposed of in a Subtitle C landfill (Hazardous Waste). However, LBP *residue* from a commercial facility with a TCLP analysis result less than five milligrams per liter ( $< 5$  mg/l) lead is required to be disposed of in a Class 3 landfill.

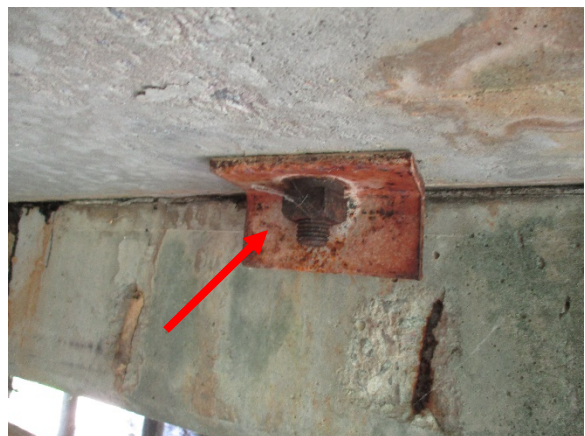
**Photo 6.** L-Bracket is Positive for Lead.
