ASBESTOS CONTAINING MATERIAL INVESTIGATION REPORT

S-41-211 (RICHLAND CREEK RD.) BRIDGE OVER RICHLAND CREEK
BRIDGE #417021100100 (BRIDGE SCOPE ID # 4170021100100)
SALUDA COUNTY, SOUTH CAROLINA

May 22, 2019

FME Project No.: G6100.050

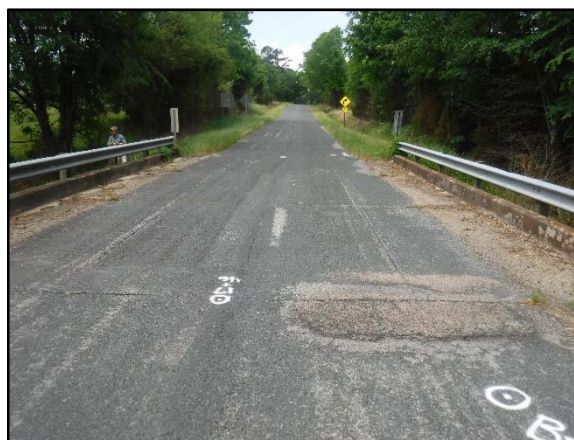
Photo 1 – S-41-211 (Richland Creek Road) Bridge over Richland Creek, in Saluda County, South Carolina.

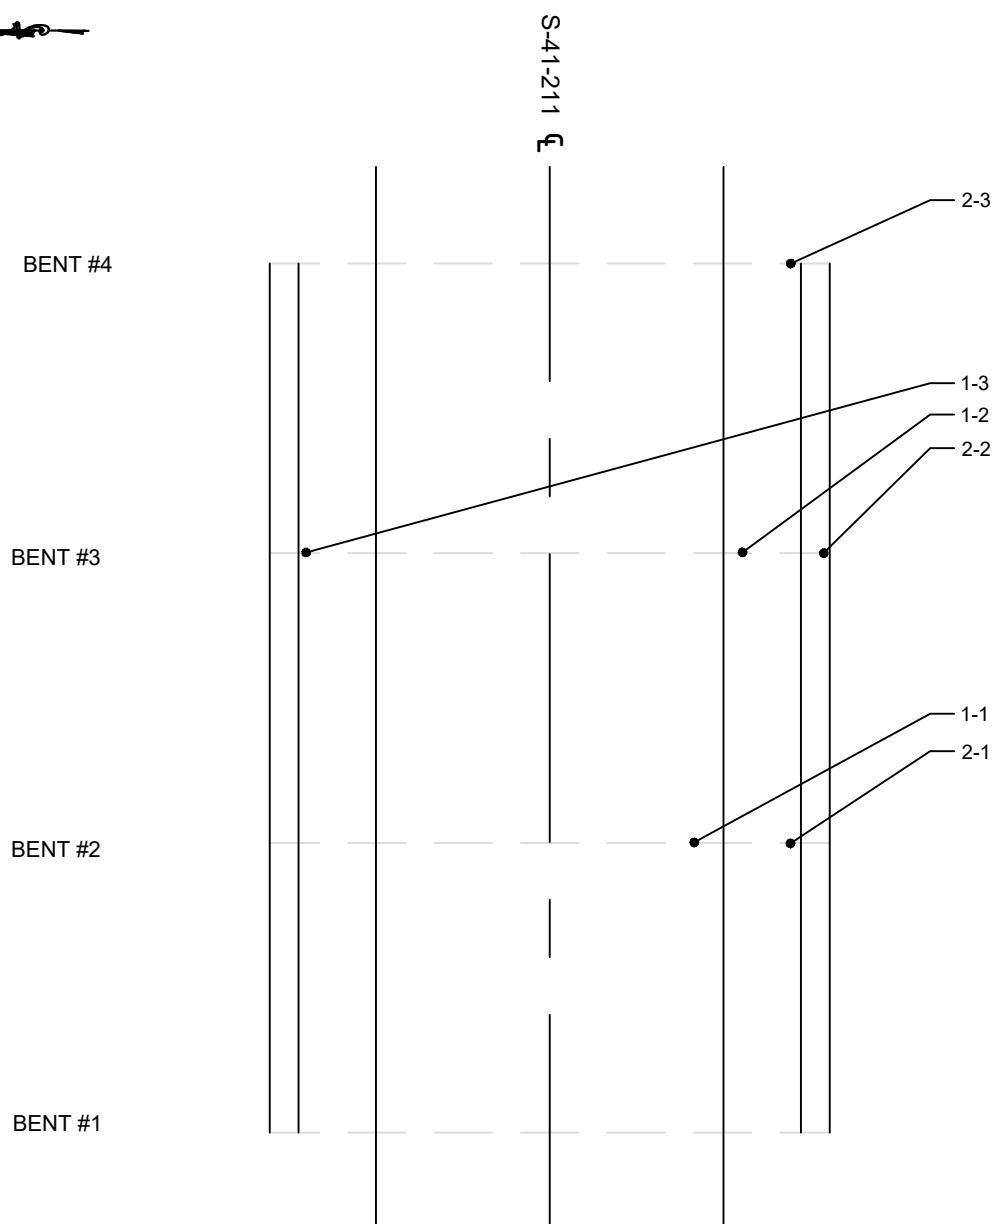
2

Saluda County, SC
Sample Location Plan
Prepared for: S.C. Department of Transportation
955 Park Street
Columbia, SC 29201

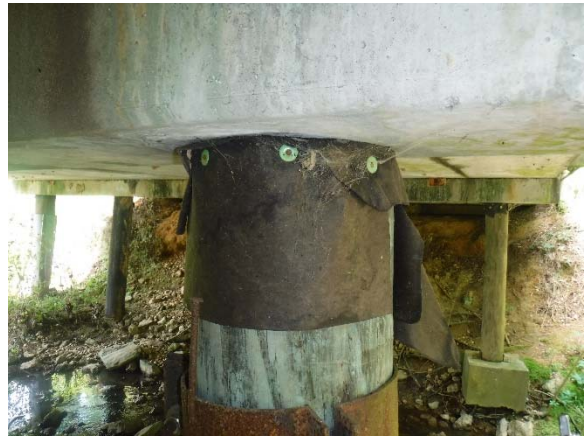
During the investigation, timber pile cap felt, and bond break pads were the only suspect materials observed associated with the subject bridge. Three (3) random samples of each of the suspect materials were collected for laboratory analysis, and their physical characteristics were recorded. The remaining bridge materials (i.e. concrete, steel, etc.) were not considered suspect and were not sampled.

Photo 4. Timber Pile Cap felt.

It is our understanding that the existing bridge structure will be demolished. All accessible suspect materials have been sampled and analyzed by an accredited laboratory and found to contain no ACM. Therefore, there are no foreseen special handling or disposal requirements, regarding asbestos, that will be required for the demolition of this bridge.

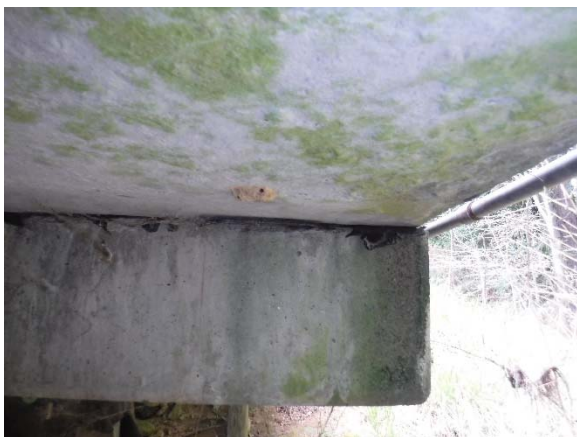
Photo 5. Bond Break Pads
