LEAD BASED PAINT INVESTIGATION REPORT

S-41-211 (RICHLAND CREEK RD.) OVER RICHLAND CREEK
BRIDGE # 417021100100
(SCOPE BRIDGE # 4170021100100)
SALUDA COUNTY, SOUTH CAROLINA

May 22, 2019

F&ME Project No.: G6100.050

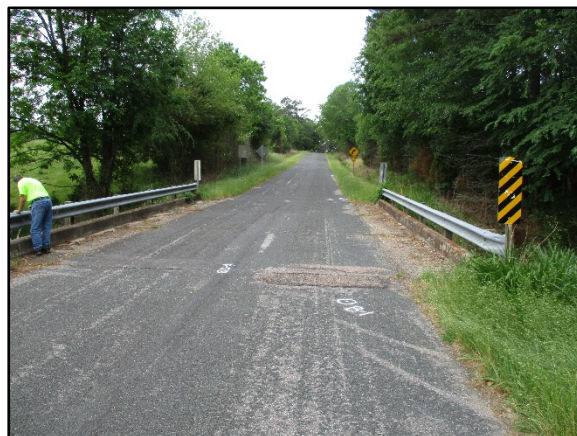
Photo 1 – S-41-211 (Richland Creek Rd.) over Richland Creek, Saluda County, South Carolina.

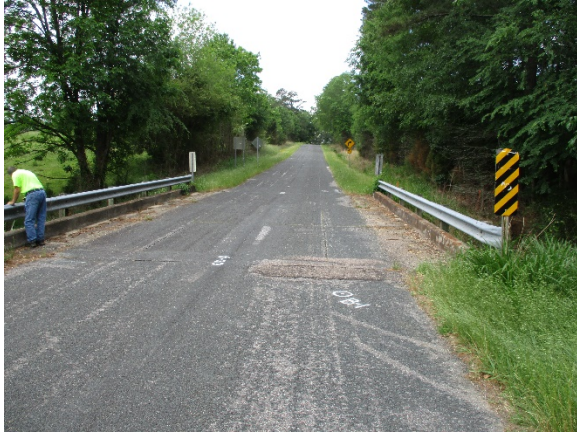
Photo 1. Top View of Bridge Deck.

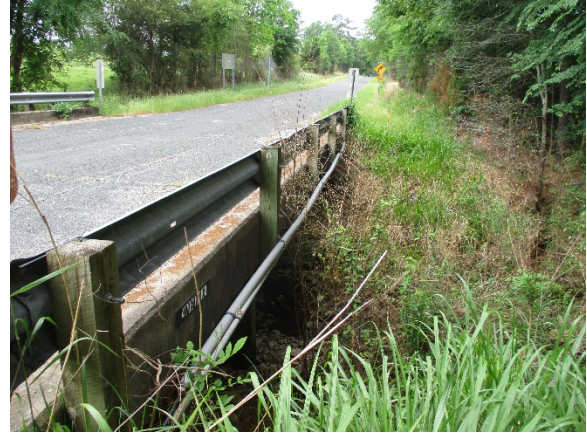
Photo 2. Side View of Bridge.

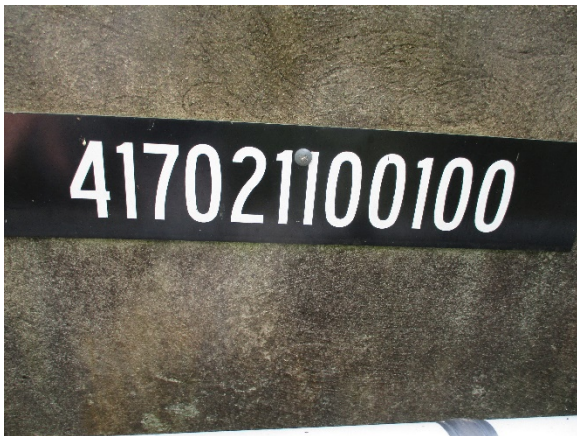
Photo 3. SCDOT Bridge Number.
