ASBESTOS CONTAINING MATERIAL INVESTIGATION REPORT

S-33-52 (BALL FIELD RD.) BRIDGE OVER ROCKY CREEK
BRIDGE #337005200100 (SCOPE BRIDGE ID# 3370005200100)
MCCORMICK COUNTY, SOUTH CAROLINA

May 22, 2019

FME Project No.: G6100.050

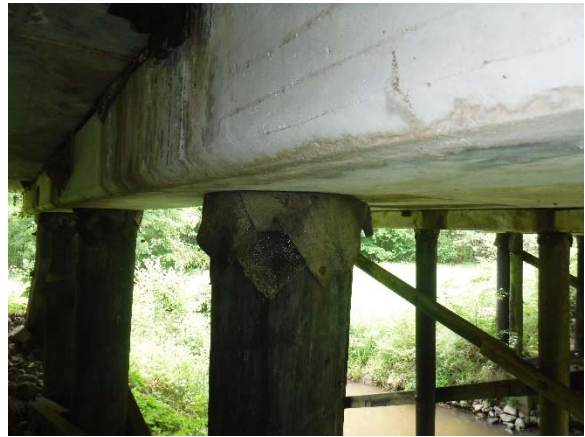
During the investigation, timber pile cap felt, and bond break pads were the only suspect materials observed associated with the subject bridge. Three (3) random samples of each of suspect materials were collected for laboratory analysis, and their physical characteristics were recorded. The remaining bridge materials (i.e. concrete, steel, etc.) were not considered suspect and were not sampled.

It is our understanding that the existing bridge structure will be demolished. All accessible suspect materials have been sampled and analyzed by an accredited laboratory and found to contain no ACM. Therefore, there are no foreseen special handling or disposal requirements, regarding asbestos, that will be required for the demolition of this bridge.

Photo 4. Timber Pile Cap Felt.

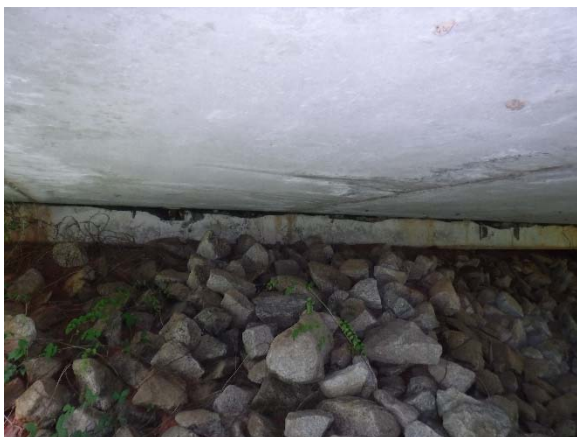
Photo 5. Bond Break Pad
