## LEAD BASED PAINT INVESTIGATION REPORT

S-41-281 (MATTHEWS RD.) OVER TRIBUTARY TO LAKE MURRAY  
BRIDGE # 417028100100 (SCOPE BRIDGE # 4170028100100)  
SALUDA COUNTY, SOUTH CAROLINA

May 23, 2019

F&ME Project No.: G6100.050

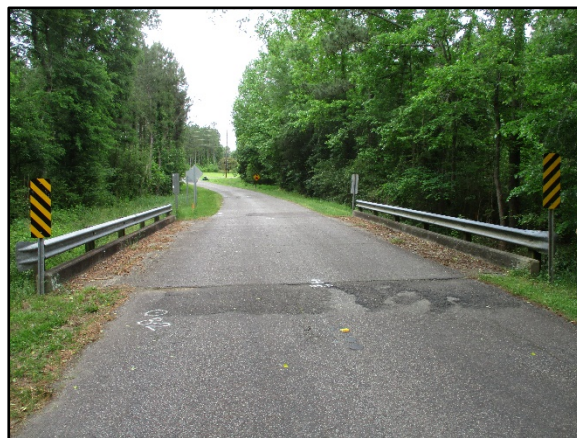
*Photo 1 – S-41-281 (Matthews Rd.) over Tributary to Lake Murray, Saluda County, South Carolina.*

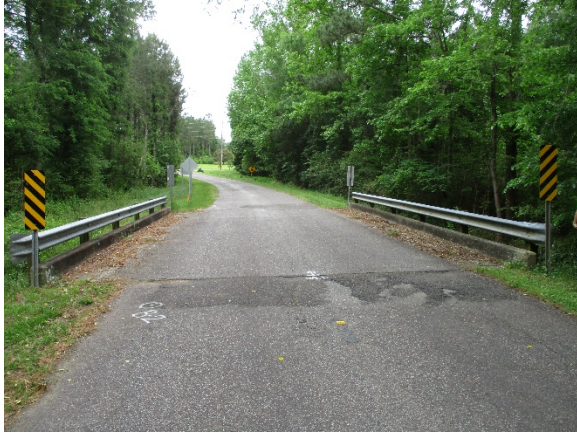
**Photo 1.** Top View of Bridge Deck.

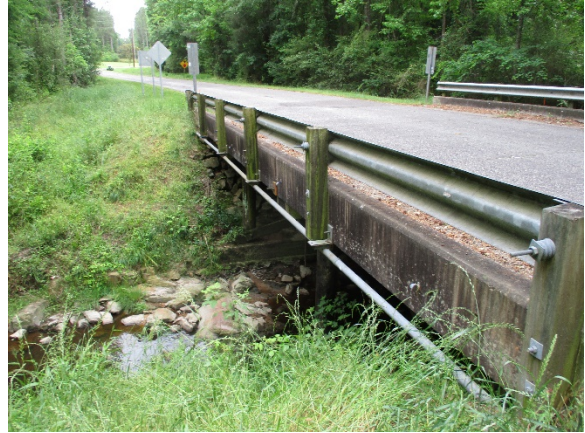
**Photo 2.** Side View of Bridge

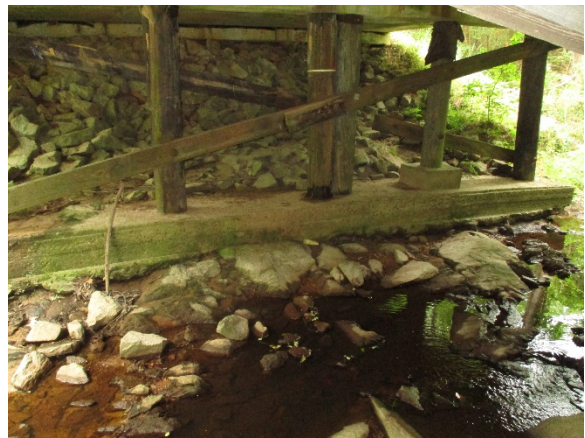
**Photo 4.** Underside of Bridge View.

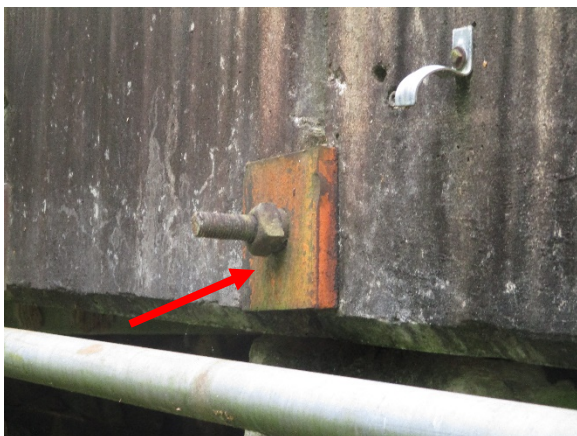
The XRF results indicate that LBP is present on the tie-rod washers located on the sides of the bridge and the L-brackets located on the underside of the bridge deck. For more information regarding the specific descriptions and locations of the items that were scanned, refer to the Appendix C – XRF Data. Also, Appendix E – Site Photographs, shows top and underside views of the bridge. Appendix D - Personnel Certification provides the LBP certifications for FME personnel.

Reading No.	PbC (mg/cm <sup>2</sup> )	Component	Substrate	Side	Condition	Color
1	1.00	Calibrate				
2	1.00	Calibrate				
3	1.04	Calibrate				
4	1.54	Tie-rod Washer	Metal	B	Poor	Orange
5	1.67	Tie-rod Washer	Metal	D	Poor	Orange
6	0.77	L-Bracket	Metal	D	Poor	Orange
7	0.80	L-Bracket	Metal	B	Poor	Orange
8	LOD	Sleeve	Metal	B	Poor	Gray
9	LOD	Sleeve	Metal	B	Poor	Gray
10	LOD	Sleeve	Metal	B	Poor	Gray
11	0.94	Calibrate				
12	0.91	Calibrate				
13	1.01	Calibrate

**Photo 5.** Tie-rod Washer is Positive for Lead.

The results of this LBP investigation determined that there are lead-based paints or coatings on the tie-rod washers located on the sides of the bridge and the L-brackets located on the underside of the bridge deck. These components can either be thrown away with the general construction and demolition debris, or they can be segregated and taken to a metal recycling facility that accepts lead coated materials. No other coated or painted bridge components containing lead were found. During the bridge demolition activities, some painted surfaces may be exposed. If paint is exposed and it is determined to contain levels of lead  $\geq 0.7$  mg/cm<sup>2</sup>, the coated/painted components will need to be handled and disposed of properly. Proper handling includes the avoidance of creating lead dust, as well as the creation of lead-contaminated soil hazards. Activities that would generate lead dust include

SCDHEC regulates the proper disposal of LBP and associated debris. SCDHEC defines two types of LBP debris. The first is LBP *waste*, which is defined as material such as wood, brick and metal that is painted with LBP. The other is LBP *residue* which is defined as residue that is generated from the removal (e.g., scraped, chipped, sandblasted, or chemical) of LBP from a structure. LBP *waste* that comes from a commercial or residential facility may be disposed of in either a class 2 or 3 landfill, while LBP *residue* from a commercial facility must have a toxicity characteristic leaching procedure (TCLP) analysis to determine the lead content. TCLP analysis is used to determine whether or not a waste is a characteristic hazardous waste due to leachability under the South Carolina Hazardous Waste Management Regulations. LBP *residue* with a TCLP analysis result greater than or equal to five milligrams per liter ( $\geq 5$  mg/l) lead must be disposed of in a Subtitle C landfill (Hazardous Waste). However, LBP *residue* from a commercial facility with a TCLP analysis result less than five milligrams per liter ( $< 5$  mg/l) lead is required to be disposed of in a Class 3 landfill.

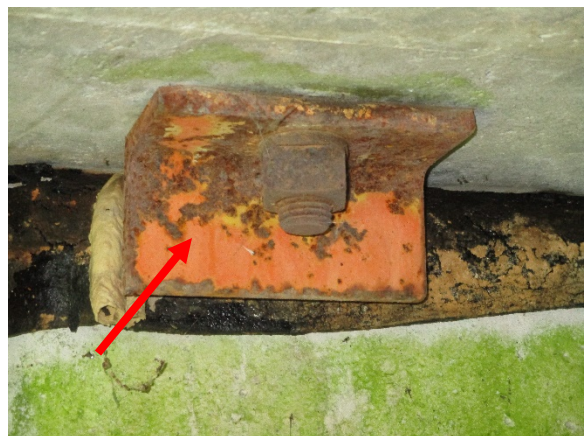
**Photo 6.** L-Bracket is Positive for Lead.
