## ASBESTOS CONTAINING MATERIAL INVESTIGATION REPORT

S-41-37 (ROCKY CREEK RD.) BRIDGE OVER ROCKY CREEK  
BRIDGE #417003700100 (SCOPE BRIDGE # (4170003700100)  
SALUDA COUNTY, SOUTH CAROLINA

**May 22, 2019**

FME Project No.: G6100.050

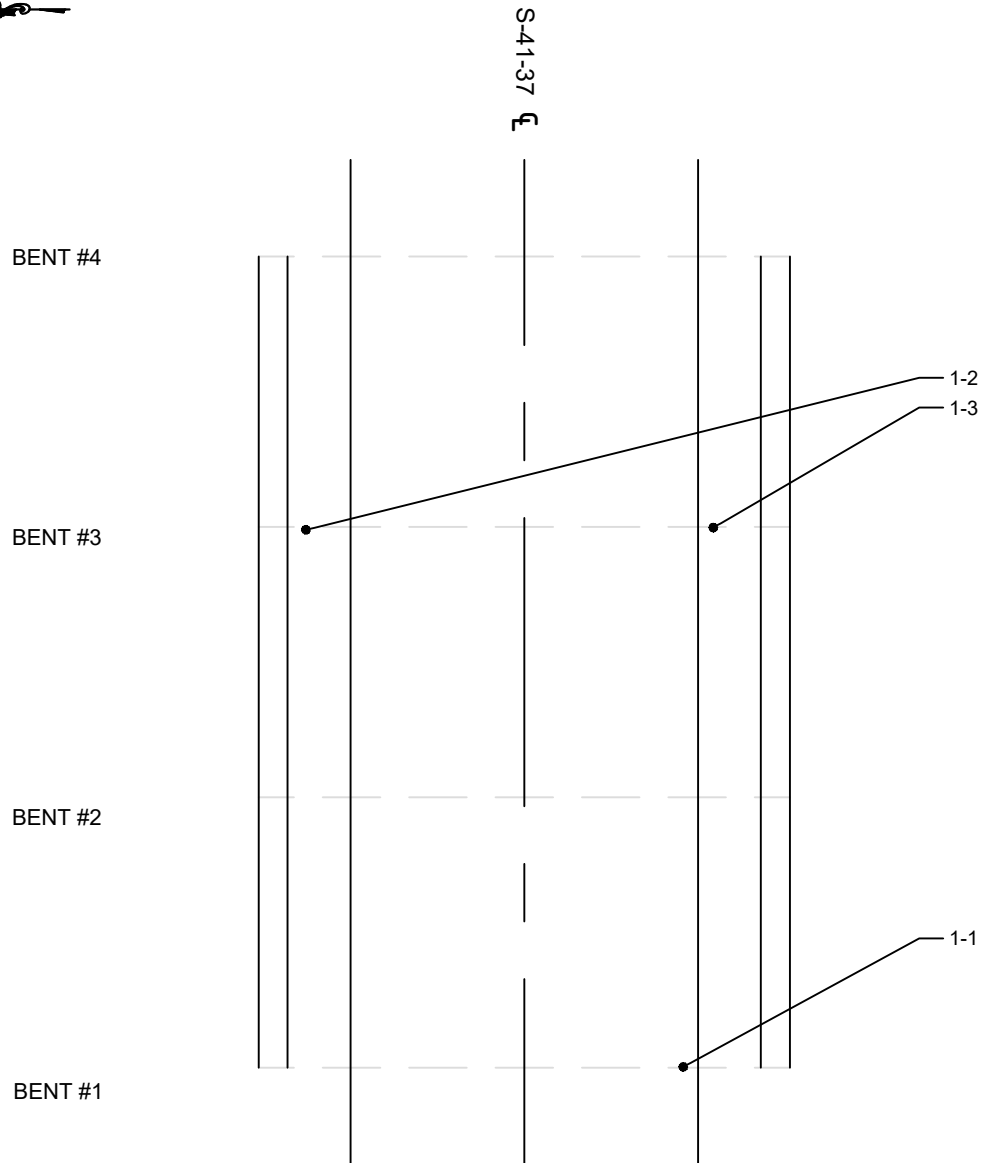
2

**ASBESTOS CONTAINING MATERIALS  
INVESTIGATION**  
**S-41-37 (Rocky Creek Rd.) over Rocky Creek**  
Saluda County, SC  
**Sample Location Plan**

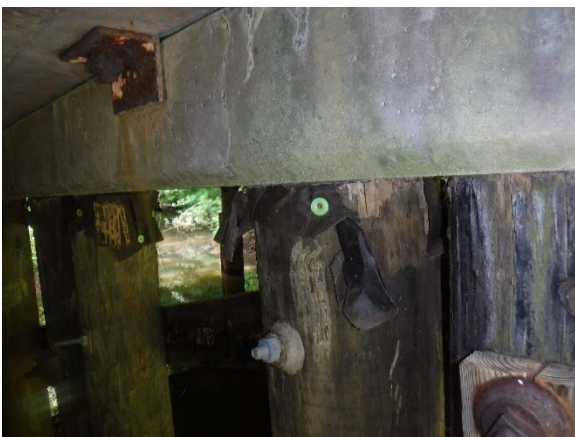
During the investigation, timber pile cap felt was the only suspect material observed associated with the subject bridge. Three (3) random samples of this suspect material were collected for laboratory analysis, and their physical characteristics were recorded. The remaining bridge materials (i.e. concrete, steel, etc.) were not considered suspect and were not sampled.

The samples of the suspect material were analyzed by polarized light microscopy (PLM) in accordance with EPA 600/R-93/116. A *“first positive stop”* protocol was utilized for this investigation. This protocol establishes that if the first sample of a material tested positive for asbestos content, subsequent samples were not to be analyzed, and would be considered positive as well. **The results of the analysis indicated the suspect timber pile cap felt contained no asbestos.** Results of laboratory analysis are summarized in Appendix C – Summary of Sample Results.

**Photo 5.** Timber Pile Cap Felt

It is our understanding that the existing bridge structure will be demolished. All accessible suspect materials have been sampled and analyzed by an accredited laboratory and found to contain no ACM. Therefore, there are no foreseen special handling or disposal requirements, regarding asbestos, that will be required for the demolition of this bridge.
