**Asbestos & Lead-Based Paint
Assessment
SC 4 Bridge over South Edisto River
Route SC 4/302
Structure No. 02000400200
Aiken County, South Carolina
S&ME Project No. 207163**

**Travis Knight & Bobby McAllister
SCDHEC Lic. BI-00885 & BI-01429
Inspection Date: January 18, 2021**

Reference: **Asbestos & Lead-Based Paint Assessment**
SC 4 Bridge over South Edisto River
Route SC 4/302
Structure No. 02000400200
Aiken County, South Carolina
S&ME Project No. 207163

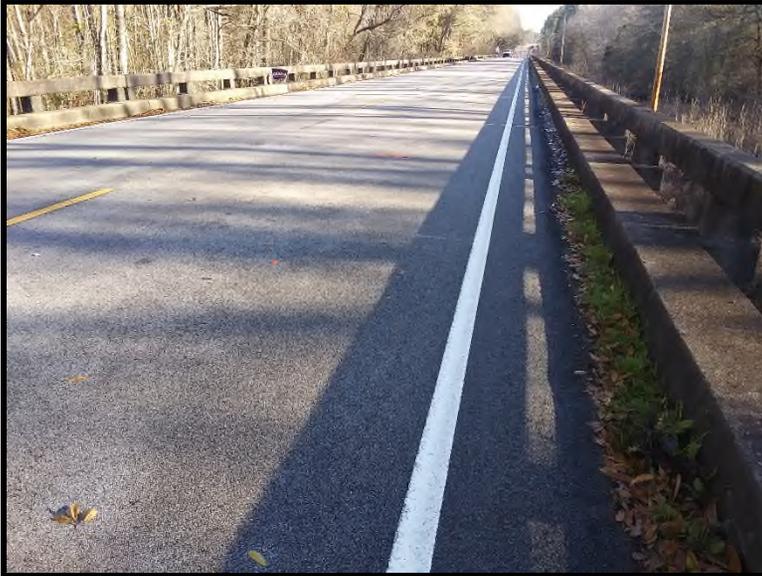
1 View of the subject bridge.

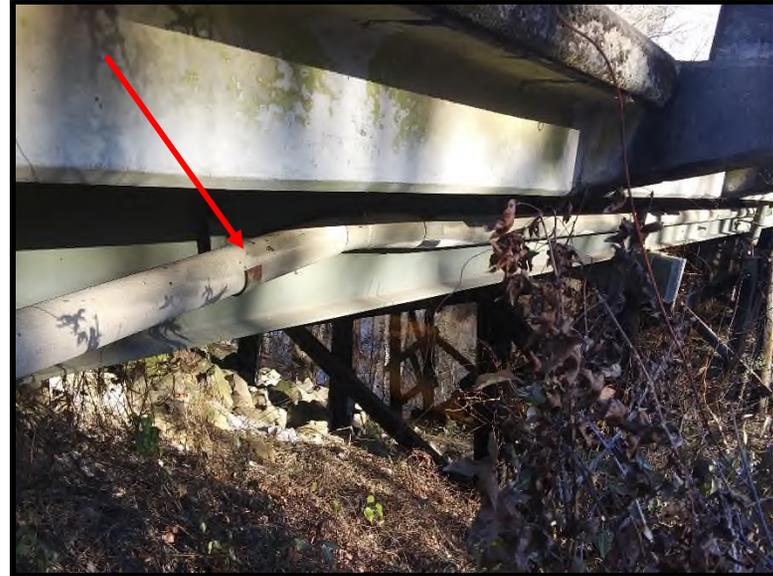
Material	¹ Material Location	² Type	Asbestos Type & Percent	³ Condition	⁴ Approx. Quantity
Cementitious pipe	Beneath west side of bridge	Misc.	Chrysotile 20% Crocidolite >1%	Good, NF	610 LF

2 Cementitious pipe tested positive for asbestos (20% chrysotile and >1% crocidolite).

S&ME recommends proper removal and disposal of the ACMs by a licensed asbestos abatement contractor, prior to activities that may disturb an ACM. State and Federal regulations should be carefully considered in order to verify compliance before any actions are initiated that may disturb an ACM. If additional suspect ACMs not included in this report are discovered and will be disturbed by the renovation/demolition activities, bulk samples must be collected by a licensed asbestos inspector and analyzed for asbestos content, prior to disturbance of the suspect material(s).

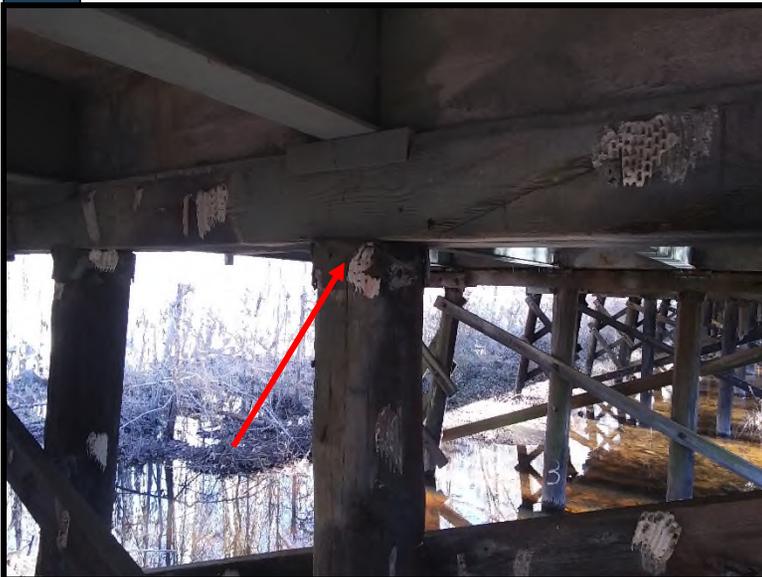
3 Vibration dampener tested negative for asbestos via PLM and TEM analysis.

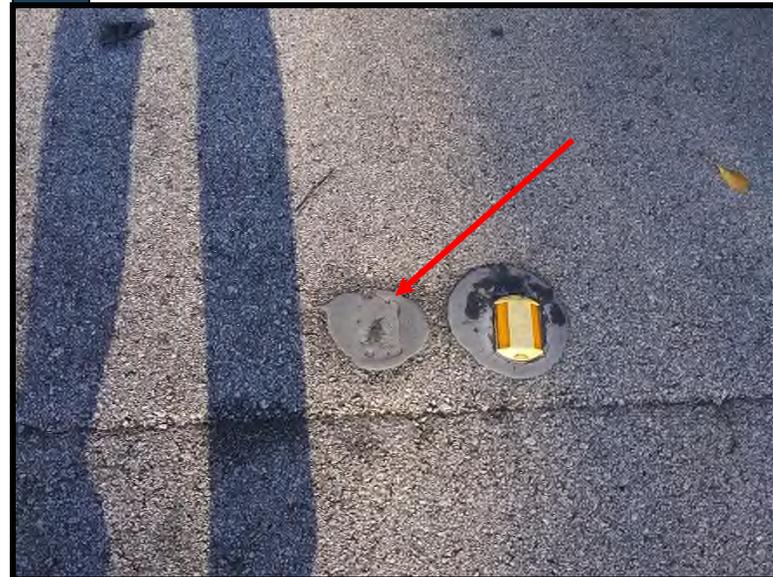
4 Black reflector mastic tested negative for asbestos via PLM and TEM analysis.

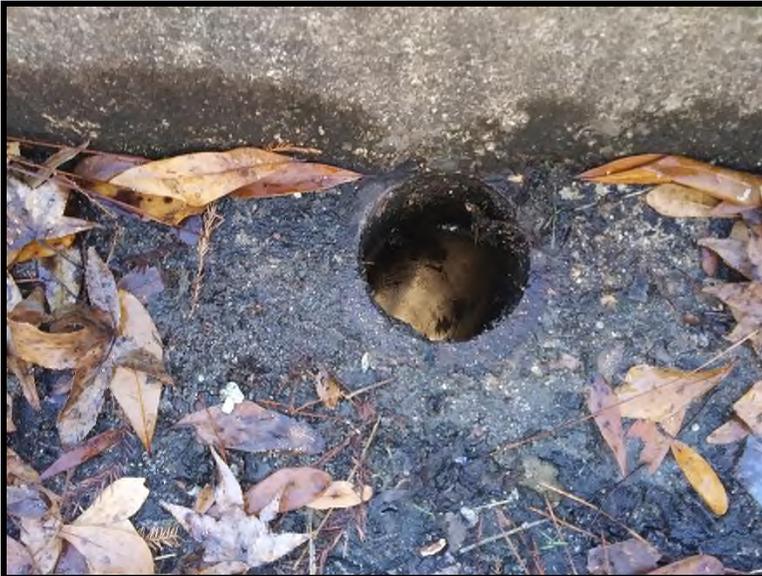
5 Bridge scuppers are metal.

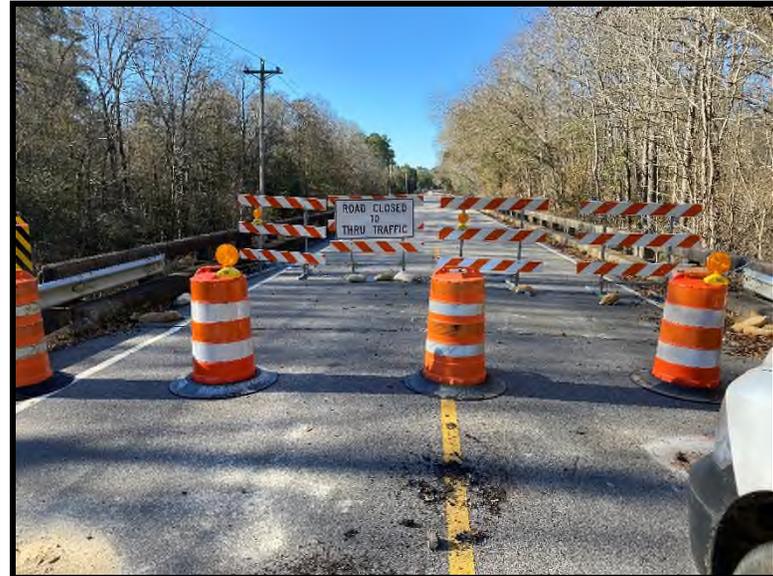
6 Yellow and white stripes tested negative for lead-based paint.

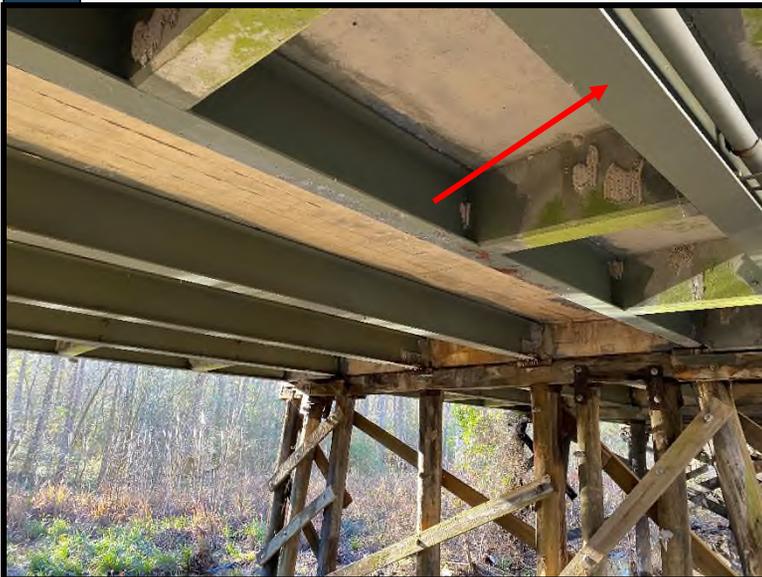
7 Green on metal beams tested negative for lead-based paint.

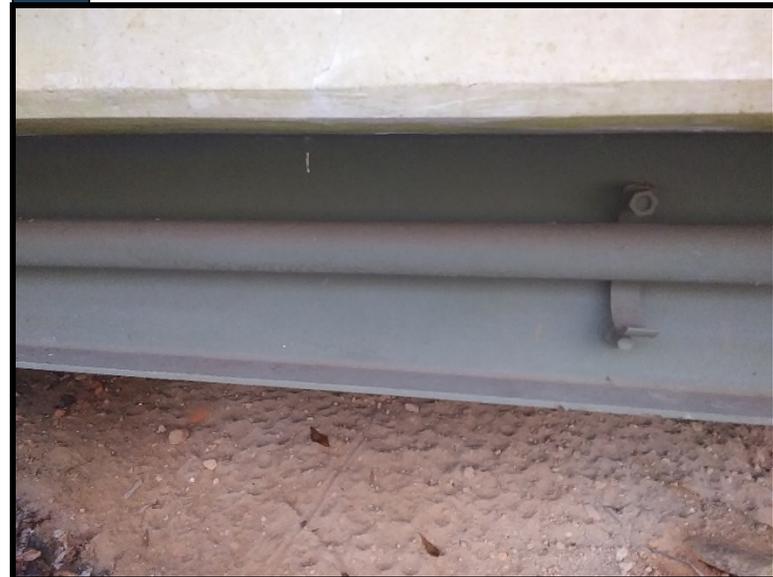
8 Green on metal pipe east side of bridge tested negative for lead-based paint.
