South Carolina
Department of Transportation

Preliminary Investigation Report

RE: I-77 Blythewood Exit 26 New Interchange Pavement Design Summary

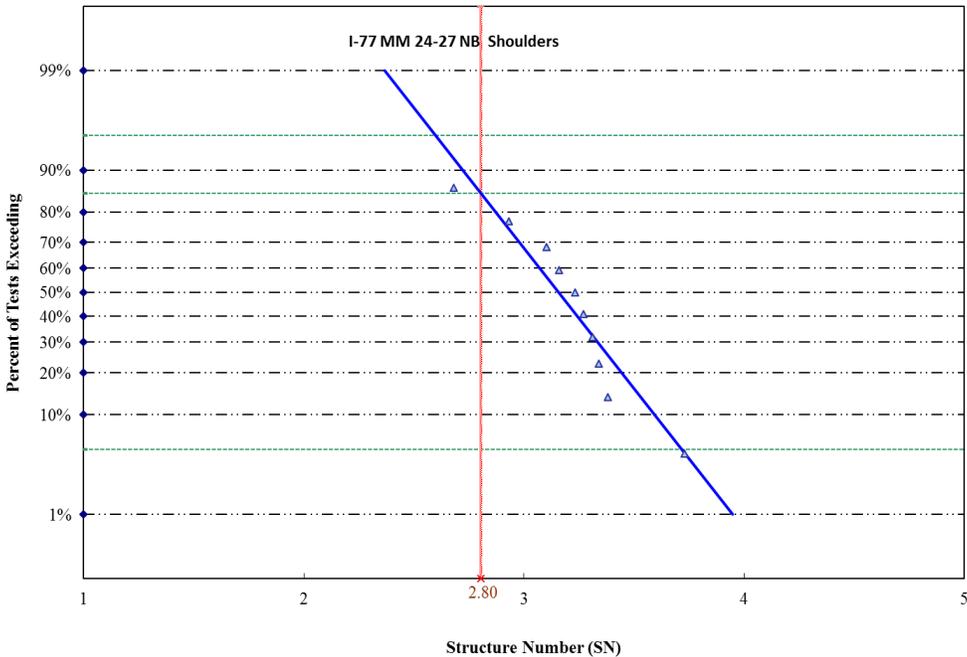
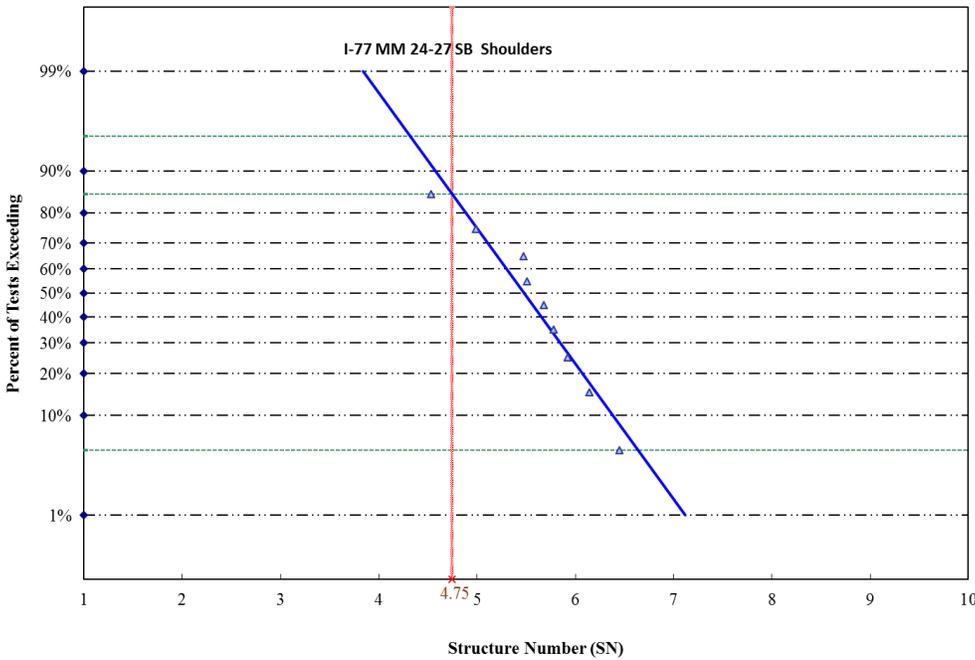
Structural Number Existing

The shoulder is a full-depth asphalt pavement and an average depth of 8.0 inches, ranging from 7.0 and 9.5 inches. The existing structural number, determined from the FWD test results, is 2.8. Both the inside and outside shoulders in this area have an existing structure number as low as 2.68.

The shoulder is a full-depth asphalt pavement with an average depth of 13.8 inches, ranging from 11.5 to 15.3 inches based on the cores, which includes the existing OGFC thicknesses of approximately 1.2 inches. The existing structure number of the both inside and outside southbound shoulders in this area is 4.75, as determined from FWD test results.

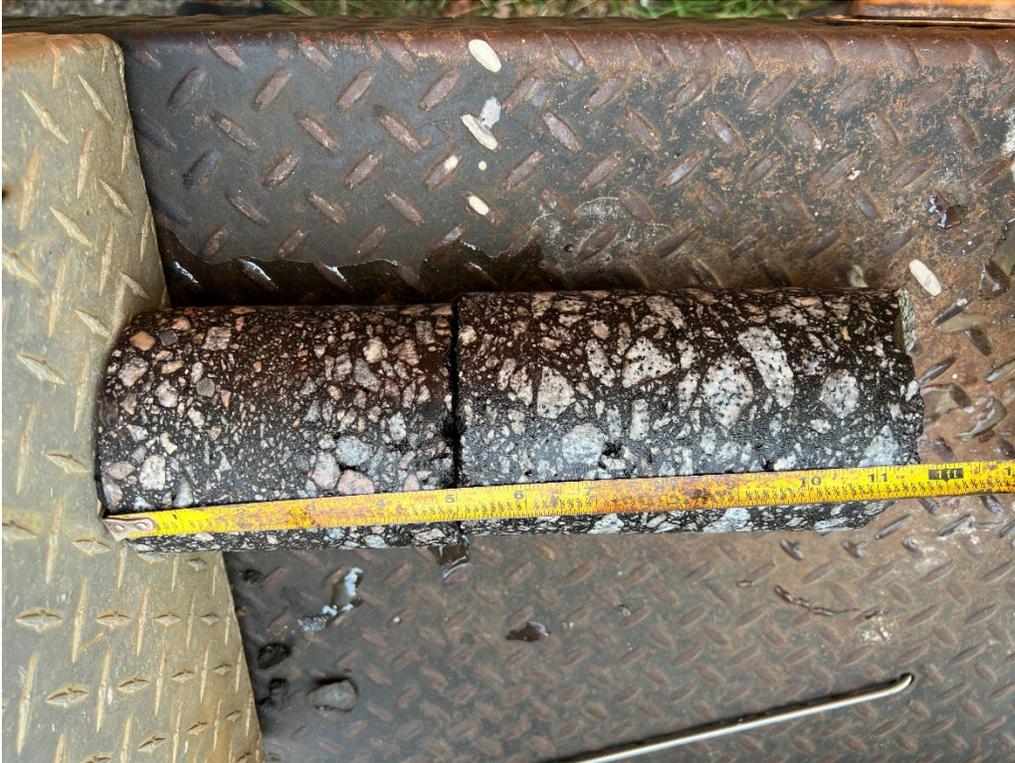
Core #3 – SB Outside Shoulder

The surface condition is relatively good with no noticeable deterioration. Please refer to the pictures of location # 3 and #4.

The shoulder may not be sufficient to accommodate temporary traffic for MOT depending on the construction period and potential weak areas. Please consult with OMR to finalize temporary pavement designs.

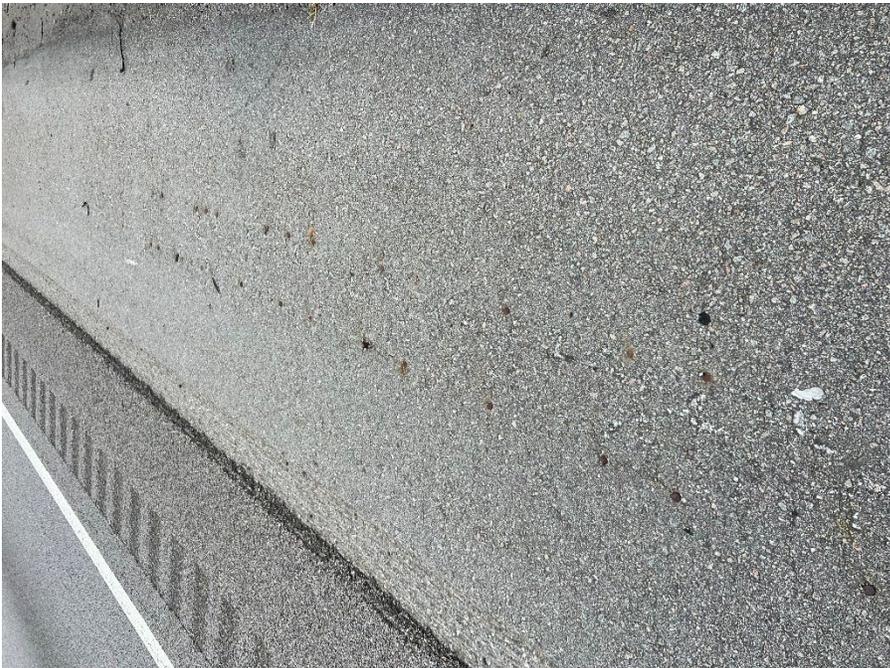
Core #4 – SB Outside Shoulder (relatively good condition)

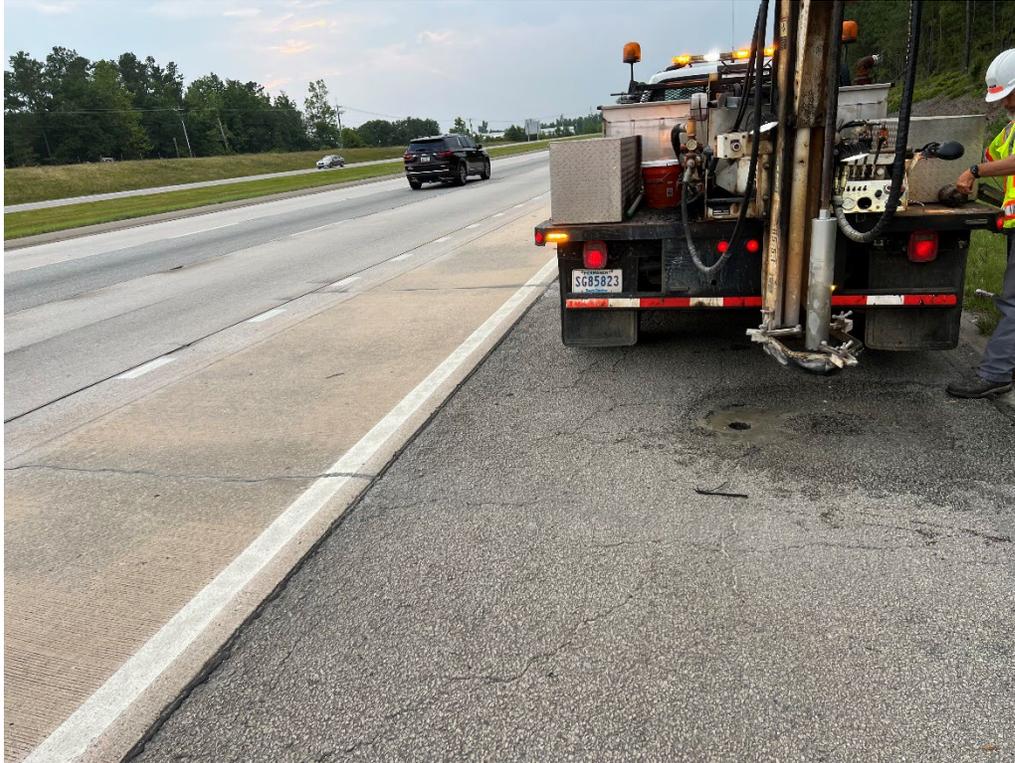
The surface condition is generally good, with the exception of low severity transverse cracking occurring approximately every 20 feet. Please refer to the pictures of locations #6, #9, and #19 for typical cores.

Core Location #6 – NB: Transversers Joints on Extra Lane

The shoulder does not appear to be adequate to carry temporary traffic for MOT due to the amount of distress present and potential weak areas. Caution should be exercised before utilizing the existing structure.

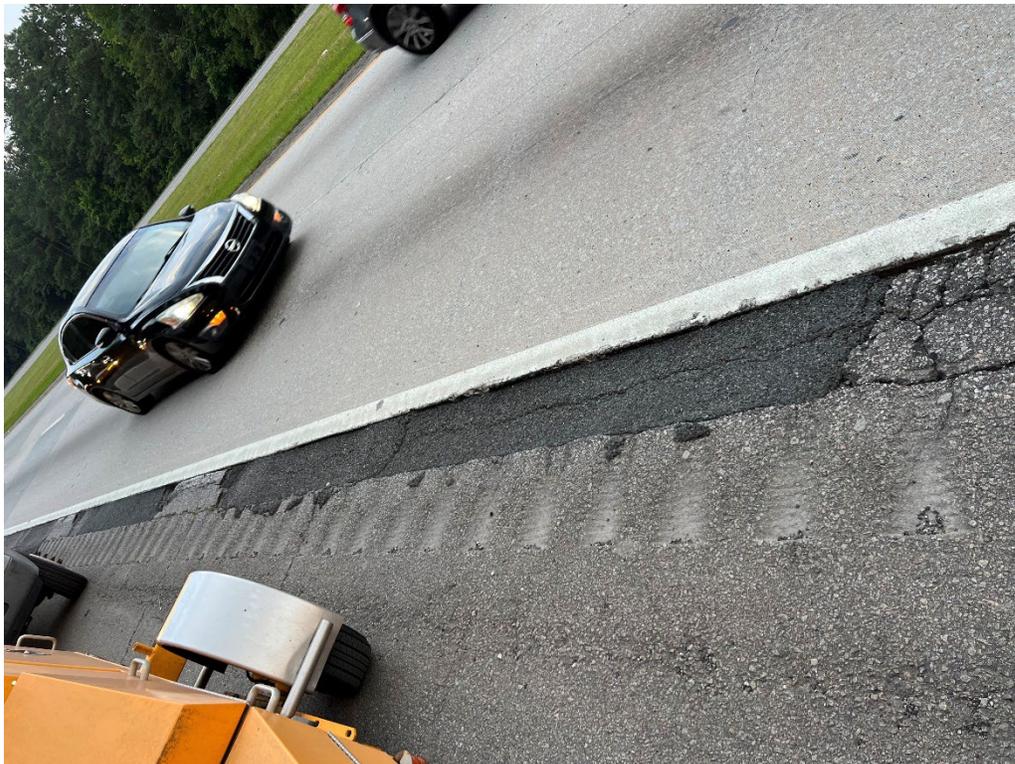
I-77 northbound is an old continuously reinforced concrete pavement (CRC). The surface condition of the CRC pavement is fair except for areas with joint issues (as shown in picture #9). The section between approximate mile market 24 and 25 is 3 lanes and the pavement appears to be CRC including the extra lane because there are no transverse joints. Cores were not obtained from the mainline, but based on plans and cores from the southbound, the depth of the concrete should be close to 9 inches for CRC, and 6 inches for the lean concrete base over 5 inches of Macadam.

Core Location #9 – NB Joint Failure

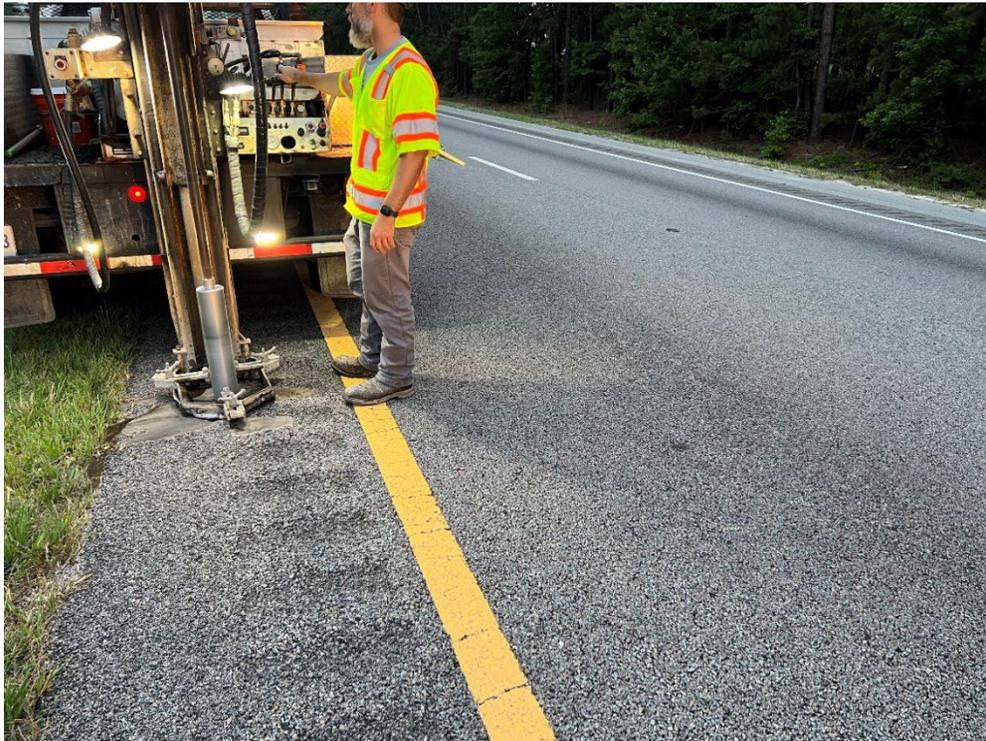
Core Location #14 – SB: AC on Shoulders, AC over CRC on Mainline

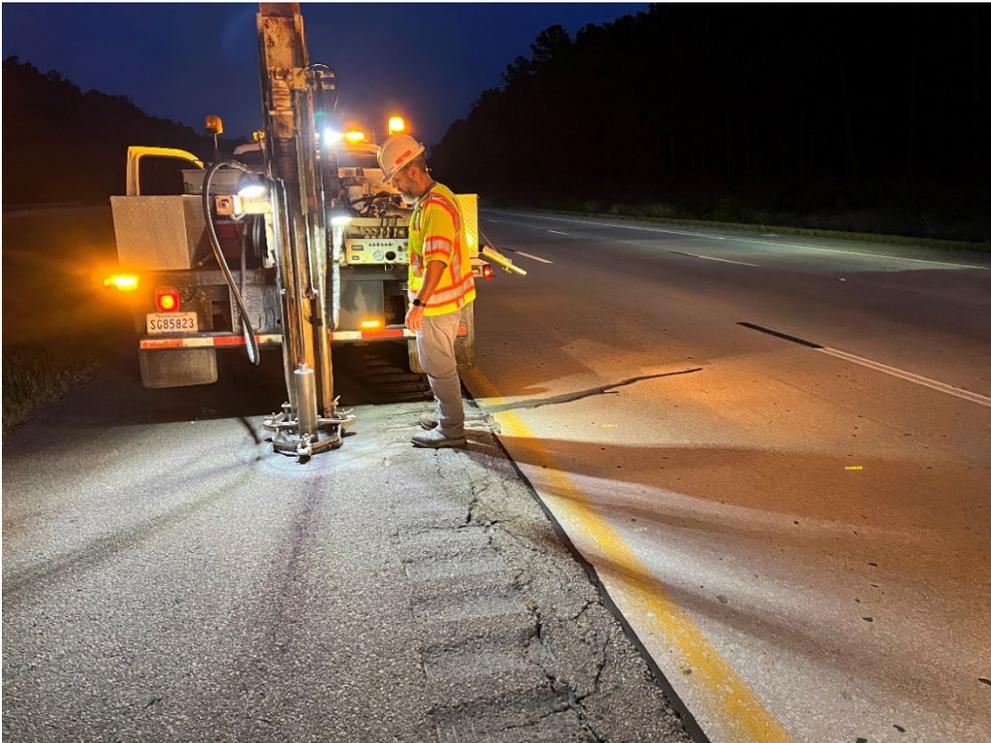
Core Location #19 – NB: AC on Shoulders, PCC on Mainline
