S-11-83 (Blacksburg Hwy) Bridge over I-85 (Exit 100)  
Cherokee County, South Carolina

Asbestos and Lead-Based Paint  
Survey Report - Revised

ARM Project # 16-314-15

April 17, 2017

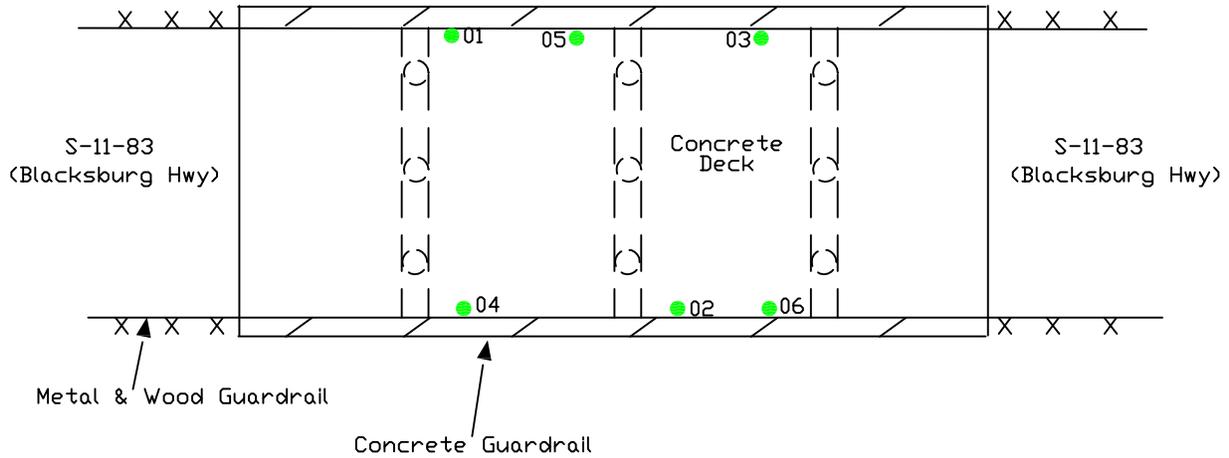
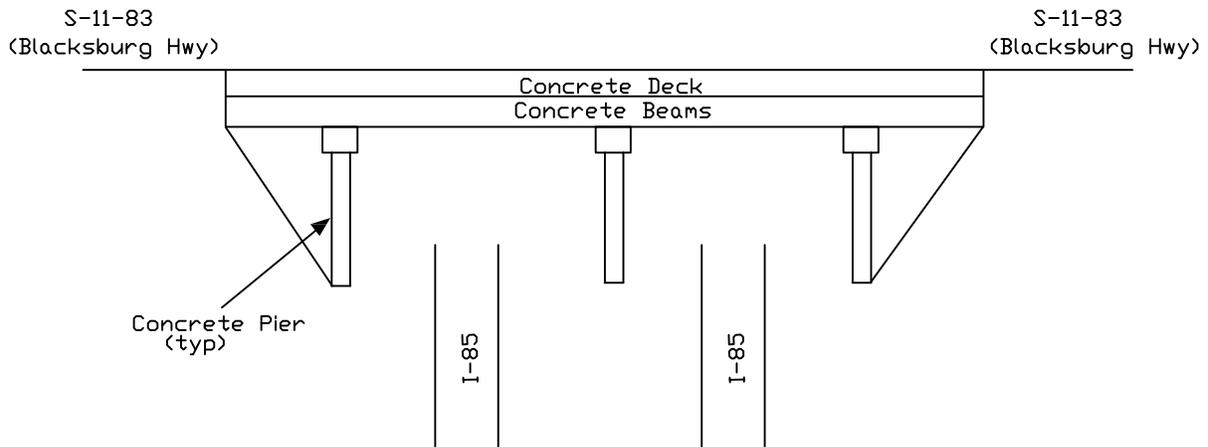
**FIGURE 2**

Site Plan Showing  
 Sample Locations

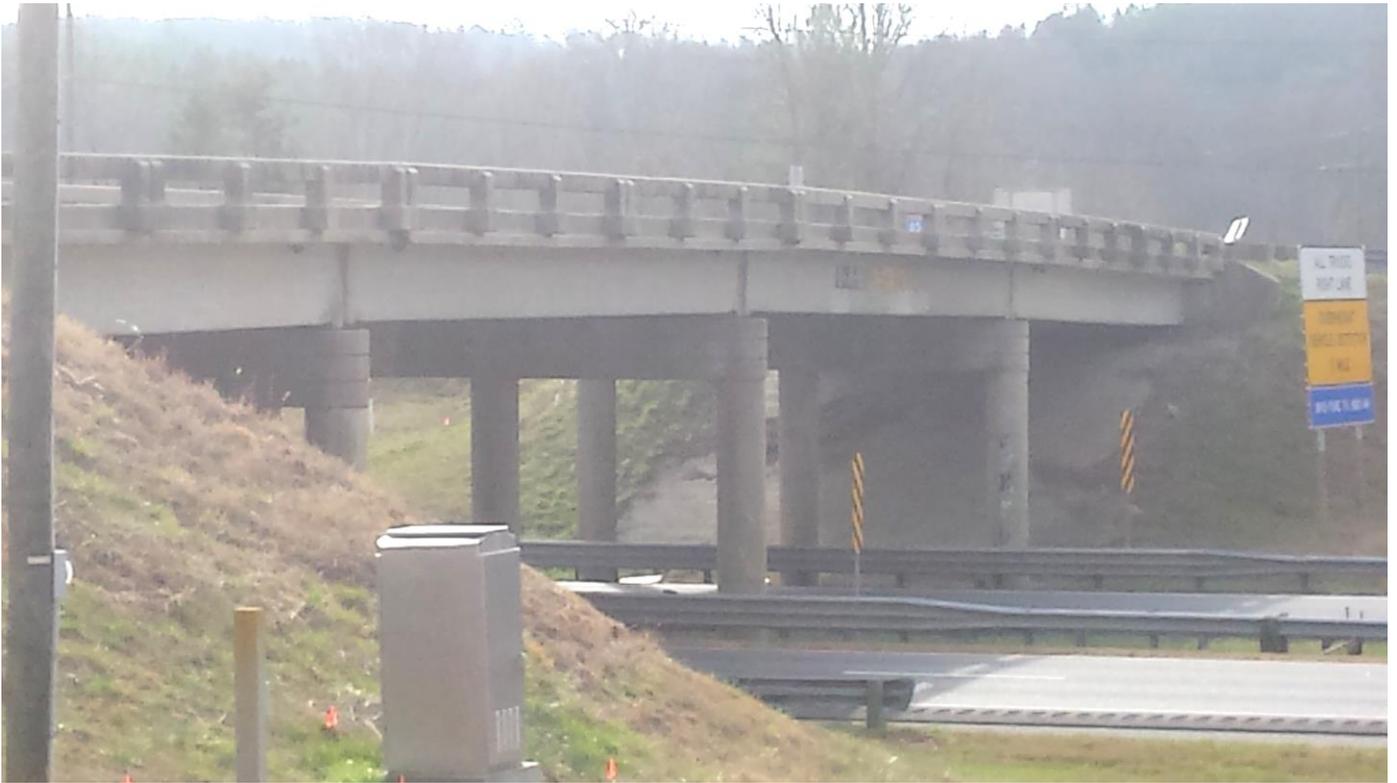
**Photograph 1** – View of bridge structure at S-11-83 (Blacksburg Highway) over I-85 in Cherokee County, SC.

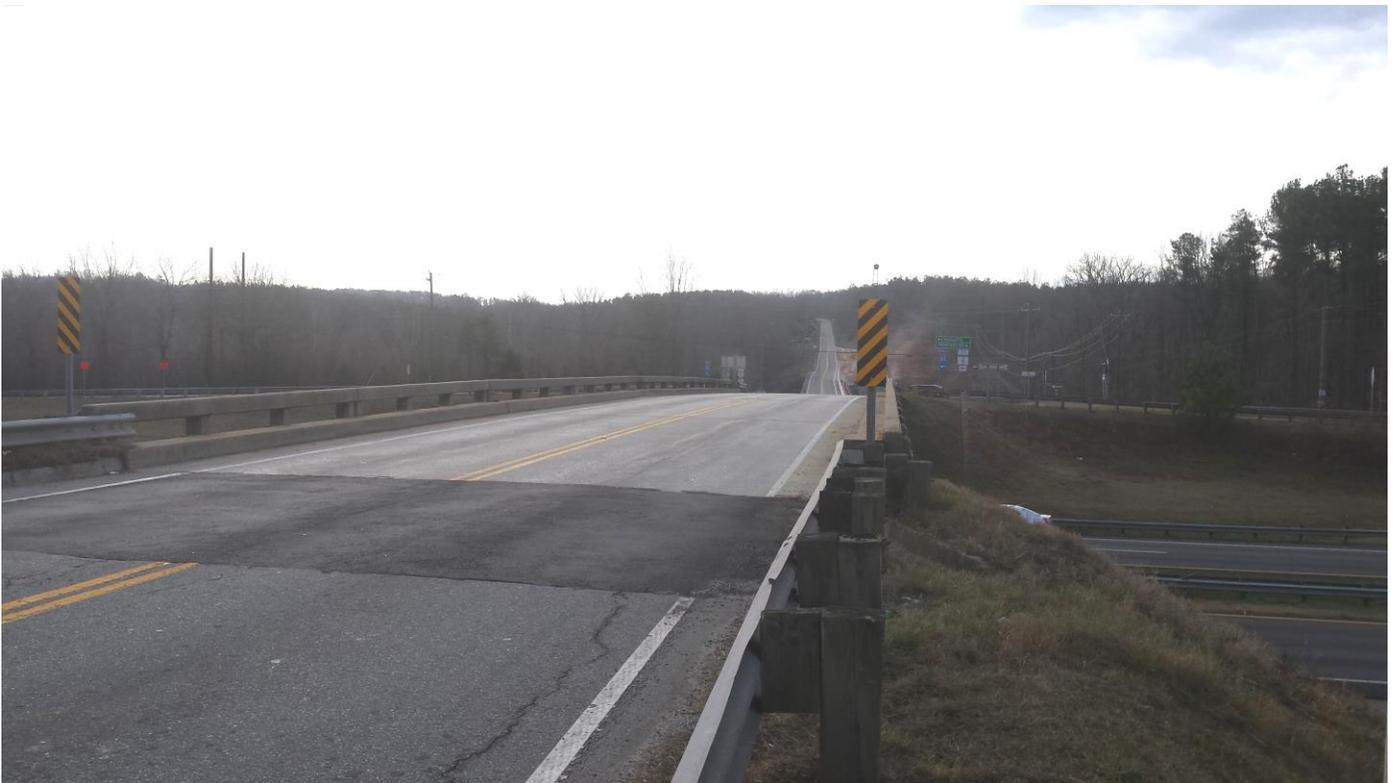
**Photograph 2** –View of the top side of the S-11-83 (Blacksburg Highway) bridge over I-85 in Cherokee County, SC.

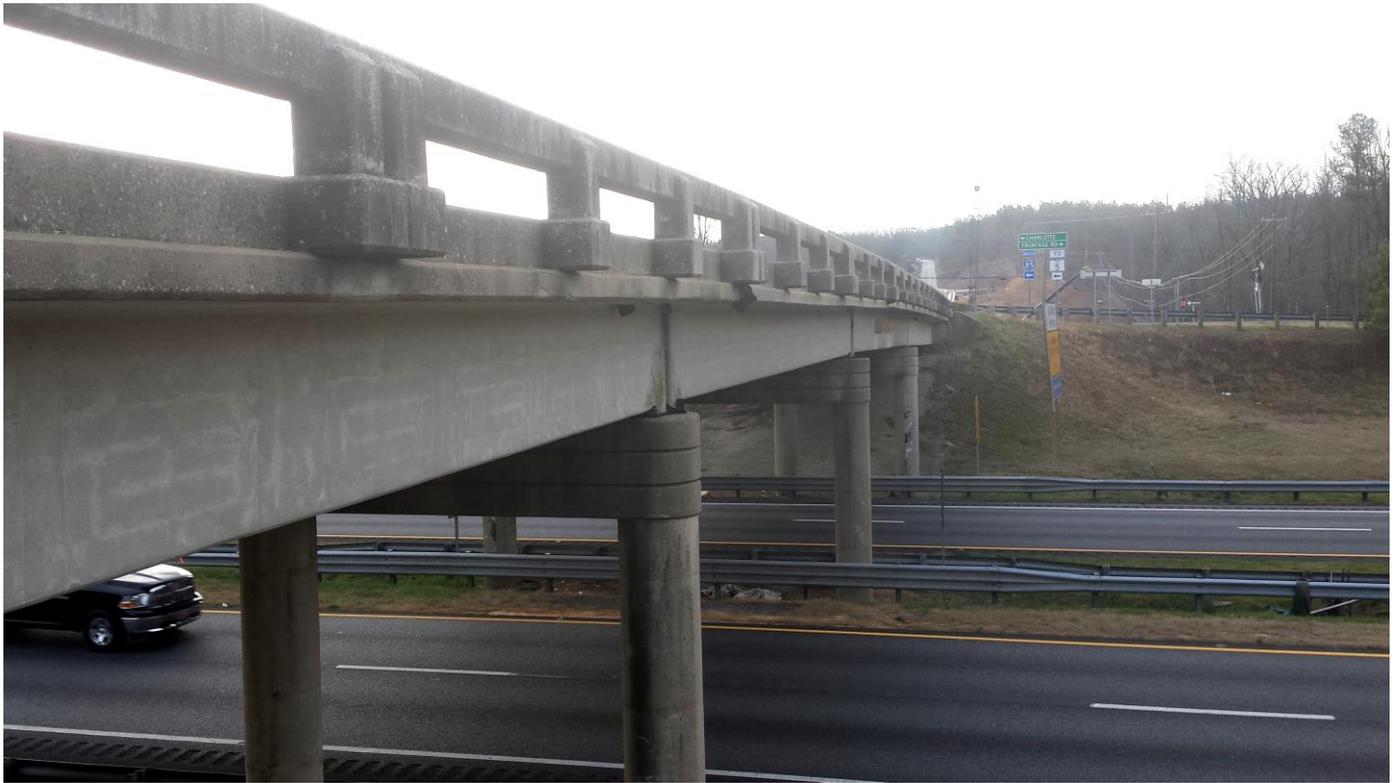
**Photograph 3** – View of the side of the S-11-83 (Blacksburg Highway) bridge over I-85 in Cherokee County, SC.

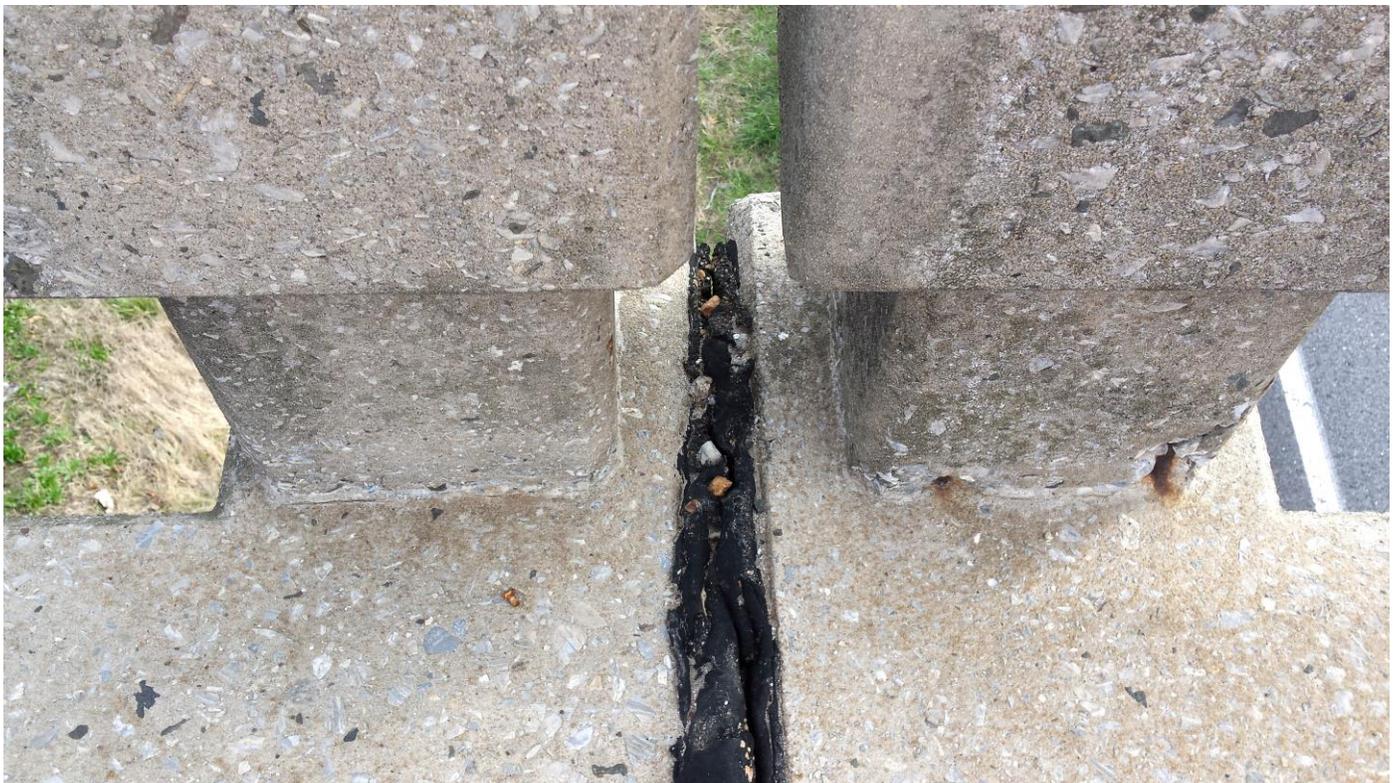
Sample Number	Suspect Material	Material Locations	Present Condition	Analytical Results*	Estimated Material Quantity
01,02,03	Black Buffer Material	Between Concrete Pier Caps and Concrete Deck	Damaged / F	No Asbestos Detected	100 Linear Feet
04,05,06	Black Expansion Joint Material	Between Concrete Deck Sections	Damaged / F	No Asbestos Detected	100 Linear Feet

**Based on the results of laboratory analysis, none of the sampled materials were confirmed to contain asbestos at a concentration greater than one percent (>1%).** The laboratory results are included in Appendix C of this report.

**Photograph 4** – View of the black expansion joint material between concrete deck sections that was tested for asbestos.

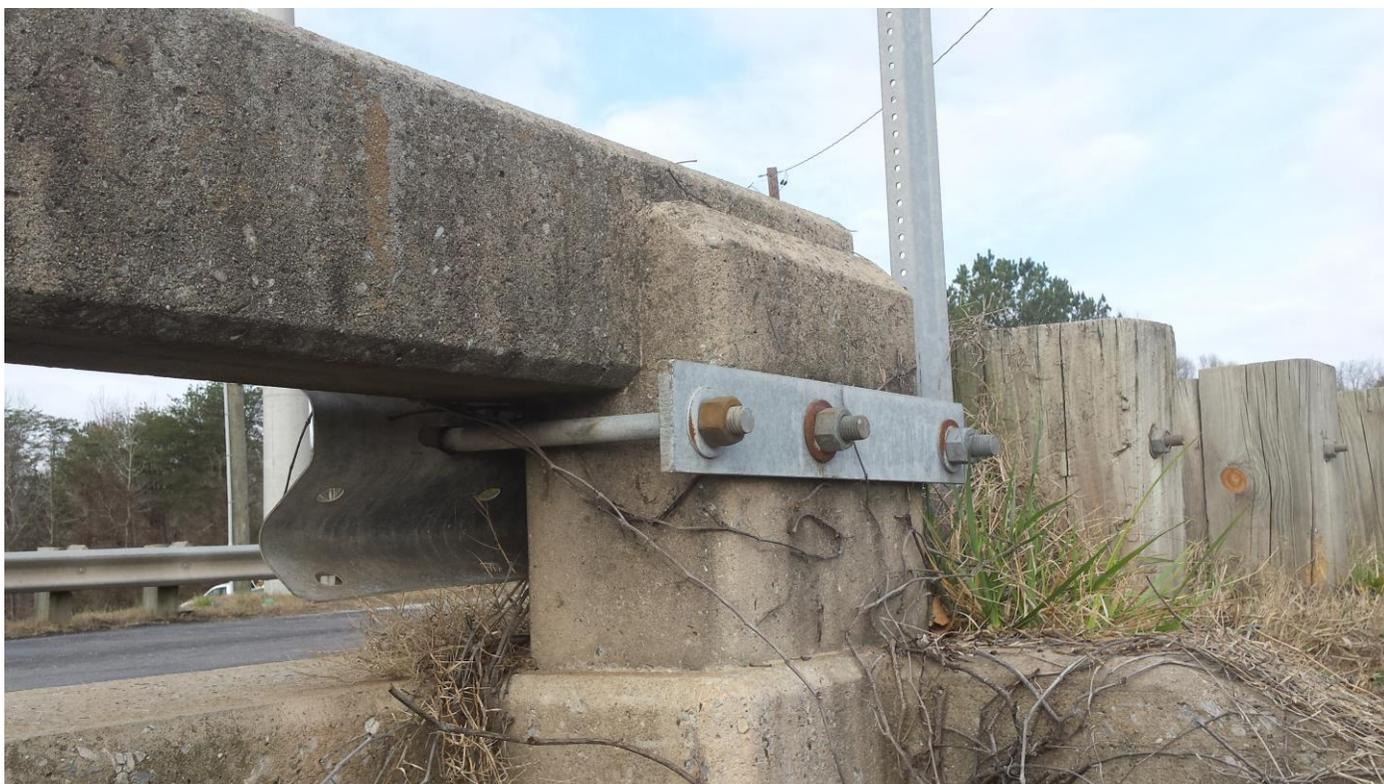
The bridge structure is primarily composed of unpainted concrete. The only materials sampled for lead based paint were the metal guardrails and metal guardrail brackets. **The results of the XRF analyses indicate that no bridge materials were found to contain lead-based paint** as summarized in Table 2 below.

**Photograph 5** – View of the metal and wood guardrails on the side of the S-11-83 Bridge at Exit 100 that were tested for lead-based paint.

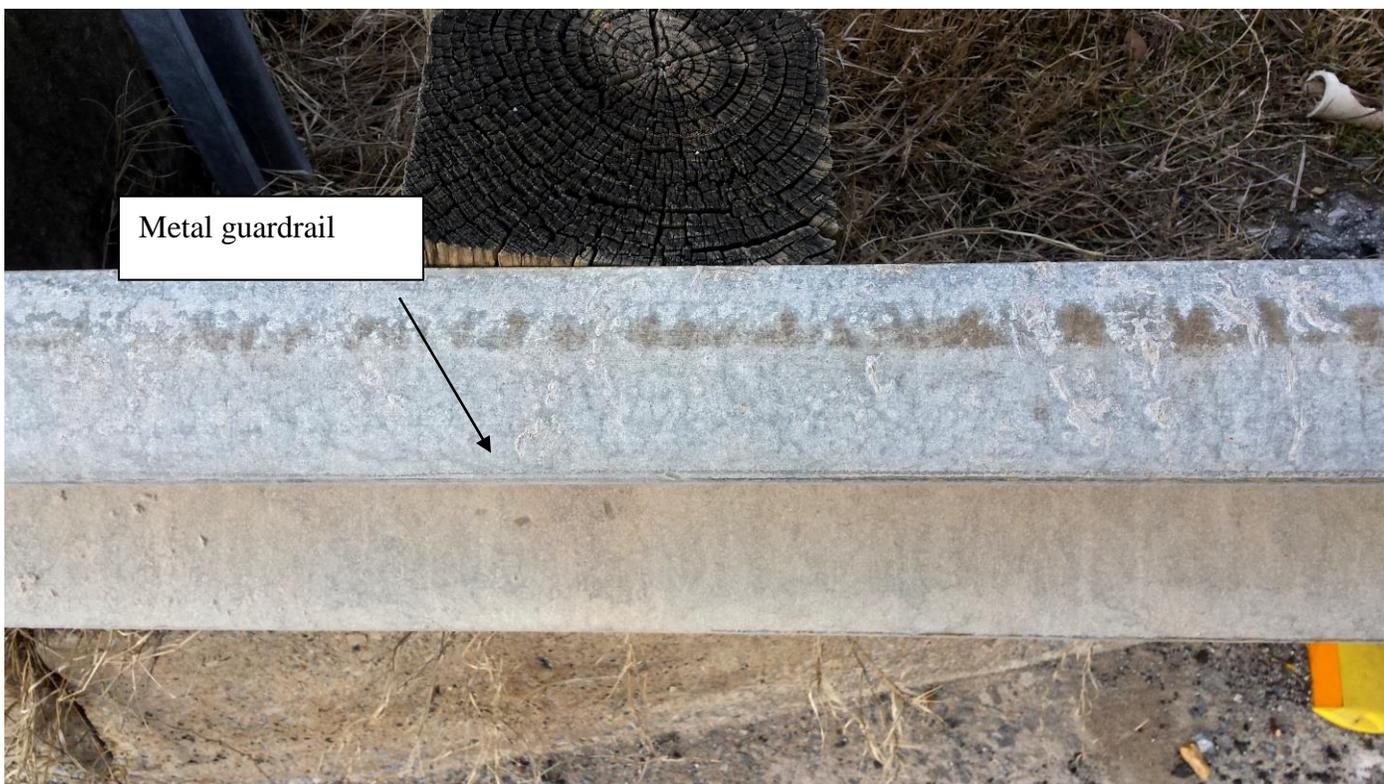
The results of these analyses indicate that the metal guardrails and the guardrail brackets tested negative for lead-based paint. The XRF data results are presented in Appendix D. Photographs of the site are located in Appendix F.

**Photograph 6** – View of the metal guardrail that was tested for lead-based paint.
