## 5. Appendix

## 5.1 Miscellaneous Outfall Analysis Notes

## 5.2 Miscellaneous Cross-Line Analysis Notes

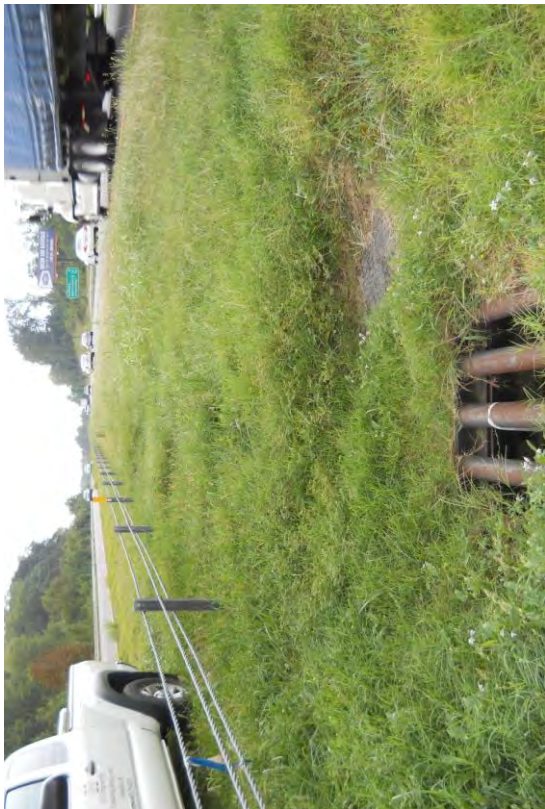
U/S has evidence of buried paved channel.

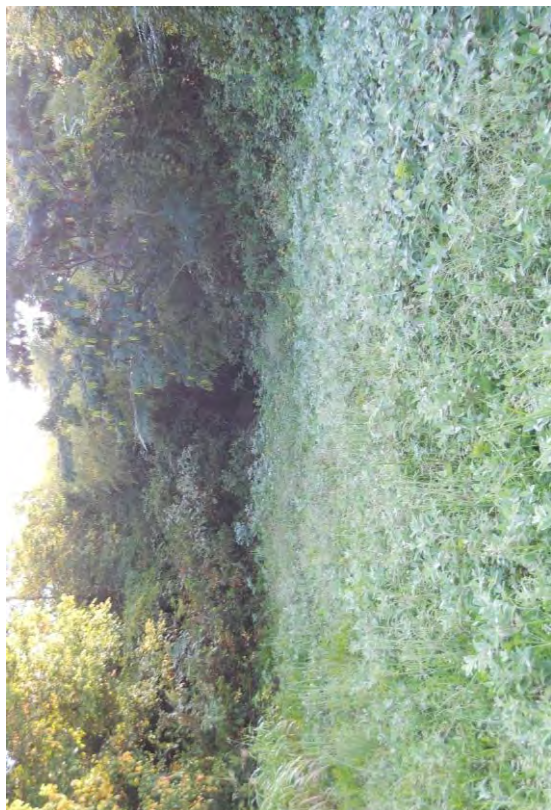
D/S large scour hole. Broken PVC pipe crossing just below outlet.

Clear vegetation U/S of culvert. Repair downstream scour hole and construct energy dissipator.

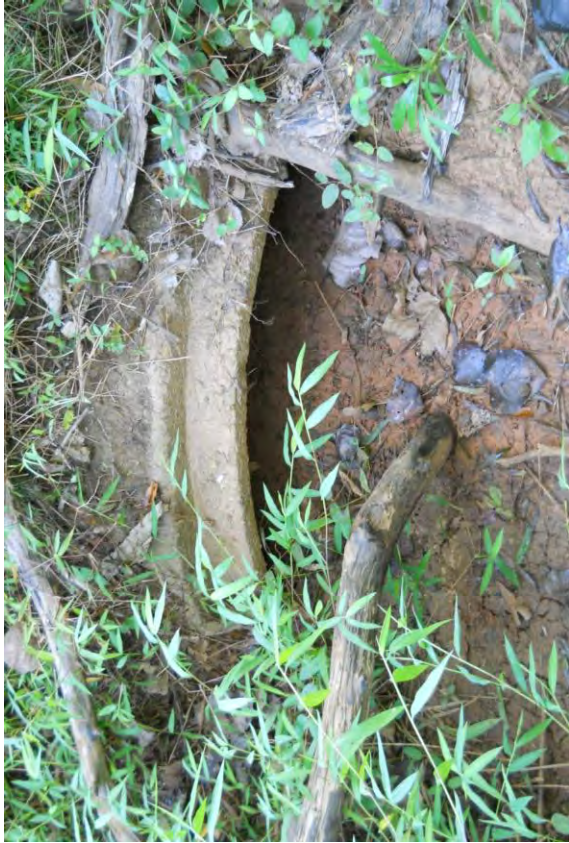
Difficult to find or distinguish between Site 22 and 23. U/S 22 was not found but D/S 22 was located as 80% filled 48".

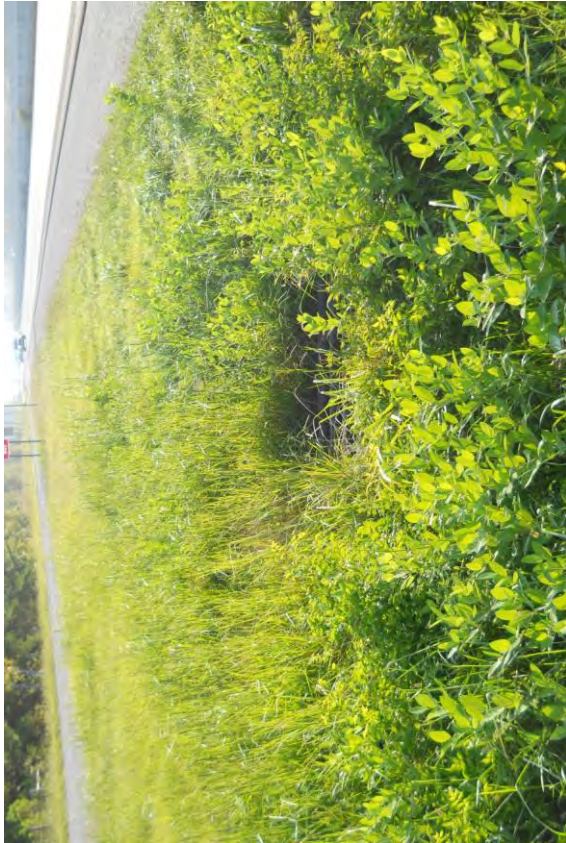
Difficult to find (and rate above). Survey had outfall (of 18" Site 23) at location of Site 22 (48" pipe). And 18" outfall was not located in the area. U/S inlet found, D/S outlet not located.

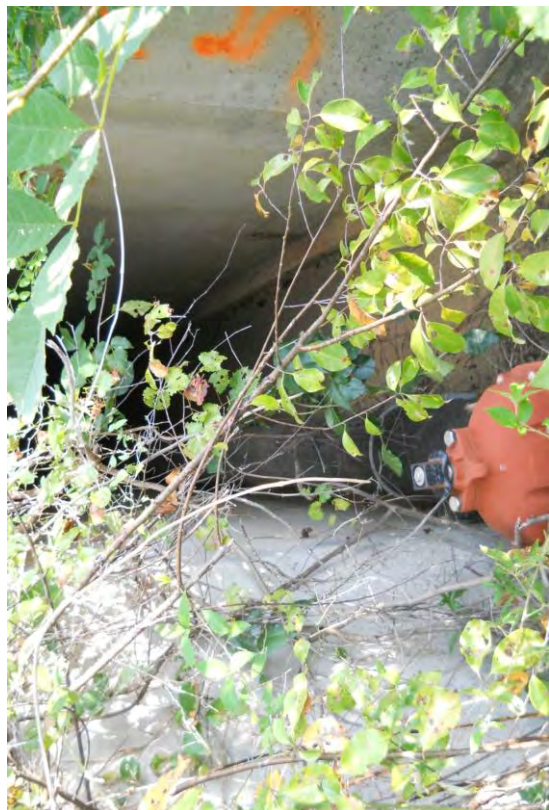
U/S

Heavy vegetation in upstream channel but clear at inlet.

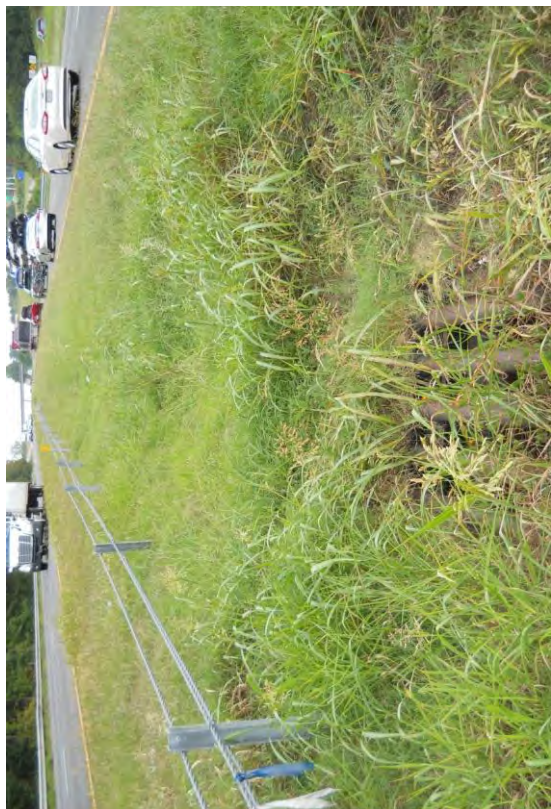
U/S

D/S outfall has a paved flume towards frontage road.

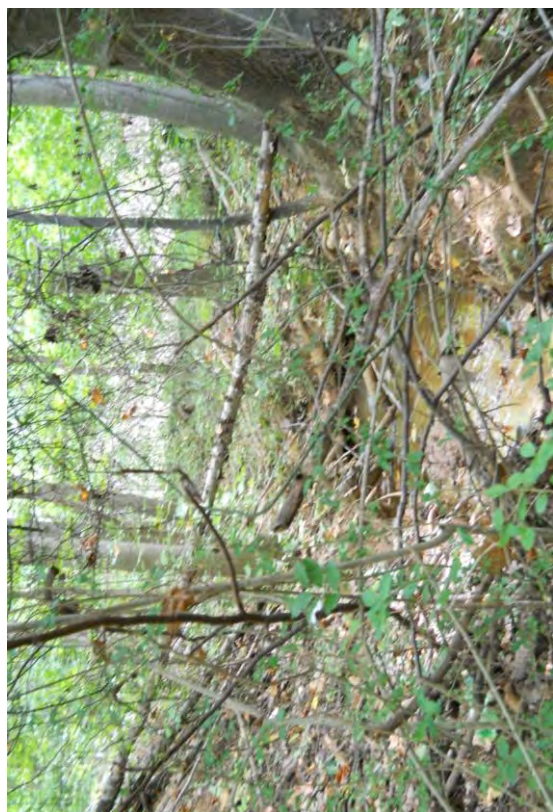
Site No. 38A PHOTO

- Site 38A (STMP 54C to STMP 54B) - Survey points label the pipe under the Frontage Road as 36" R.C. pipe. It is believed the pipe was mismeasured due to record drawing 11.347 As-Builts, which show an in place 42" R.C. pipe. Analysis assumes a 42" R.C. pipe.
- Site 38B (STMP 54A to STMP 54F) - A straight grade was assumed for pipe breaks because 11.347 As-Builts specify two T-joints.
- The headwater for Site 38B was used to set the tail water conditions for Site 38A.
- Roadway drainage on the East side of North Mountain Street was assumed to tie to CB-55.

Clear vegetation; stabilize channel

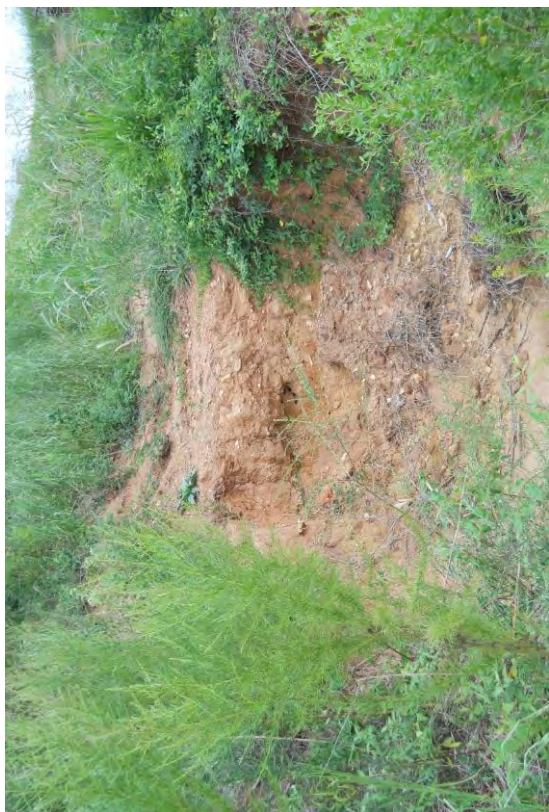
U/S

D/S has a long paved channel outfall. Very large erosion and paved channel failure ~500 yards D/S resulting in ponded water.

Clean infall and stabilize outfall channel.

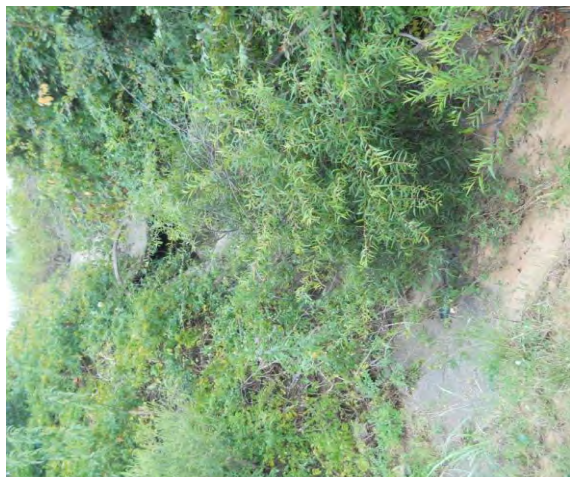
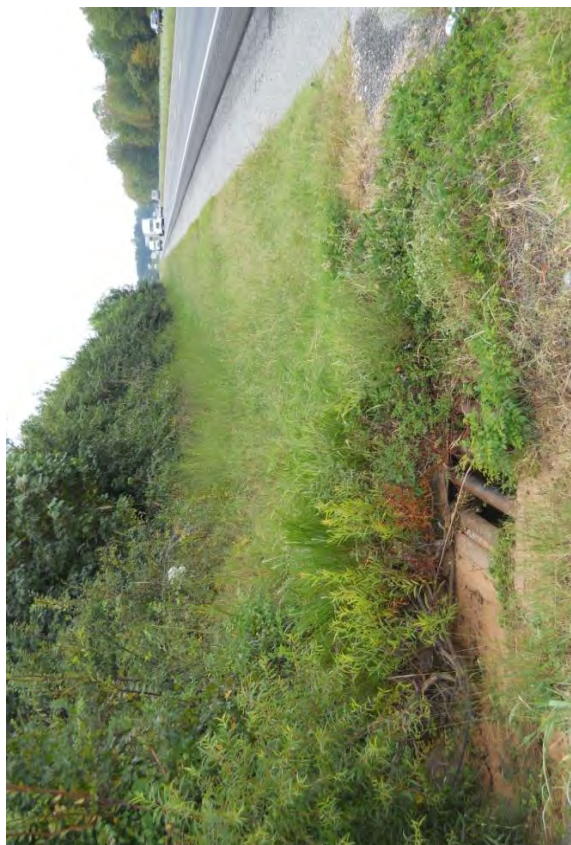
Site No. 40 PHOTO

An upstream concrete spillway (from site 42) is damaged. Site 41 and 40 are the same system just different sized pipe that changes at a box.

Repair U/S spillway if necessary. Stabilize inlet.

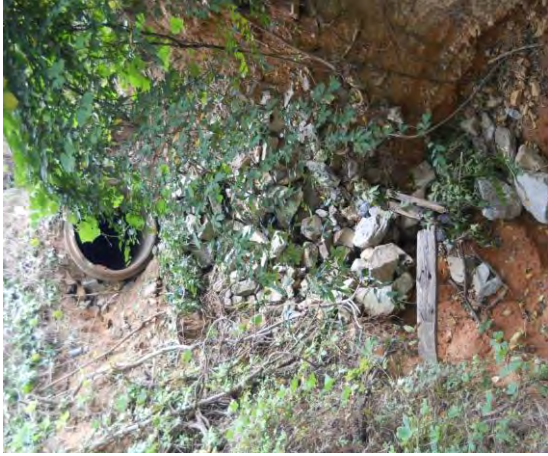
Massive scour and erosion D/S. Some riprap has been placed and has failed. D/S pipes outfall into this eroded channel. A paved channel may have existed at some time.

D/S energy dissipation needed. Stabilize D/S channel.

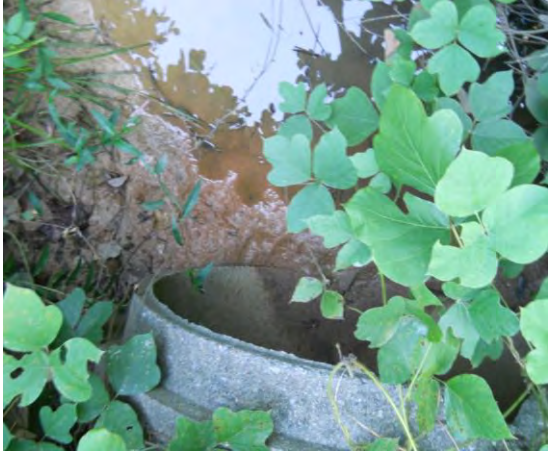
D/S ponded water with scour., could not see very far downstream to comment on downstream conditions due to heavy vegetation. D/S pipe separation.

Clean outfall. Stabilize downstream outlet and construct energy dissipator. Repair joint separation.

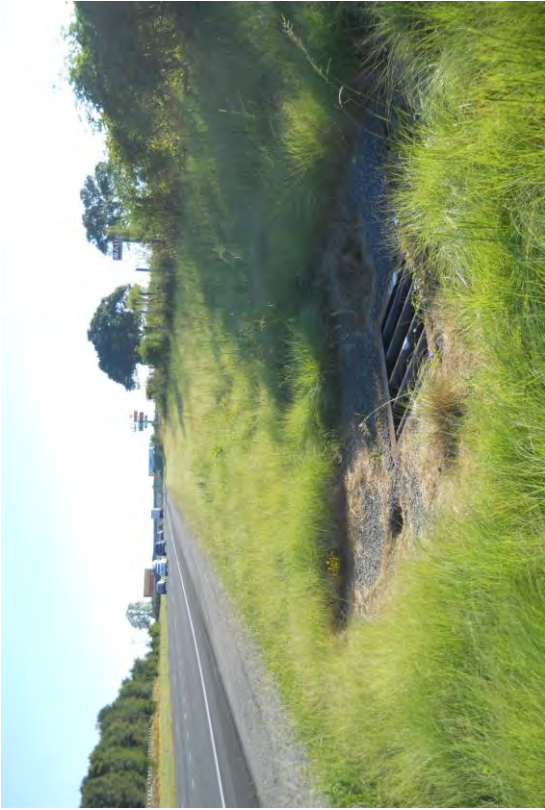
U/S

D/S scour &amp; heavy vegetation. Some type of broken concrete at pipe end, assuming not part of drainage system

Clear outfall and stabilize channel.
