Video Pipe Inspection Report

I-85 Widening Phase III – Cherokee County
From MM 98 to MM 106

Cherokee County, South Carolina
February 24, 2017

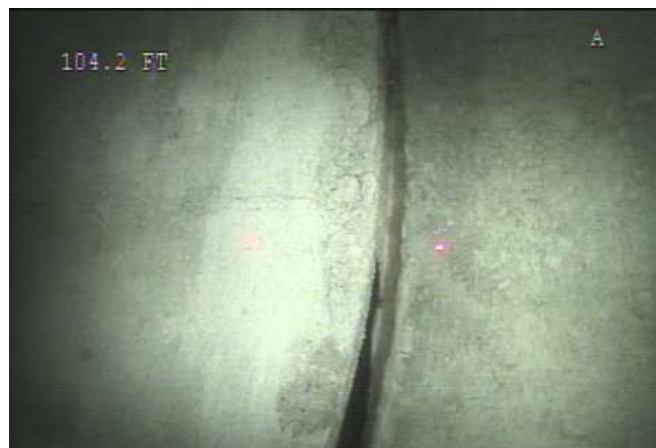
DEFICIENCIES
There is a misaligned joint at 87.6' and 104.2'.
There is a major structural crack (> 12") at 105'.

Misaligned Joint at 104.2'

RECOMMENDATION
Pipe is located in paved median section. Slip line pipe.

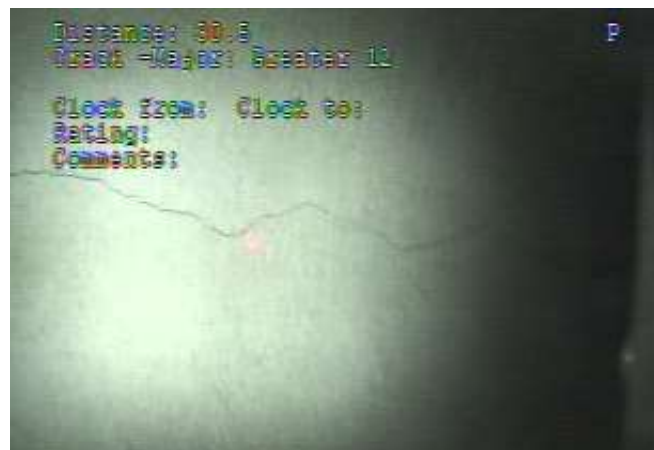
DEFICIENCIES
Obstruction (debris) throughout
30.5' (top) - hole in the pipe adjacent to a major longitudinal structural crack (>12")
64.6' (left) - major longitudinal structural crack (>12")
137.5' - joint separated by >1"

CRACK >12" AT 30.5' (TOP)

RECOMMENDATION
The pipe is located within the existing paved median. Clean pipe and slip line.

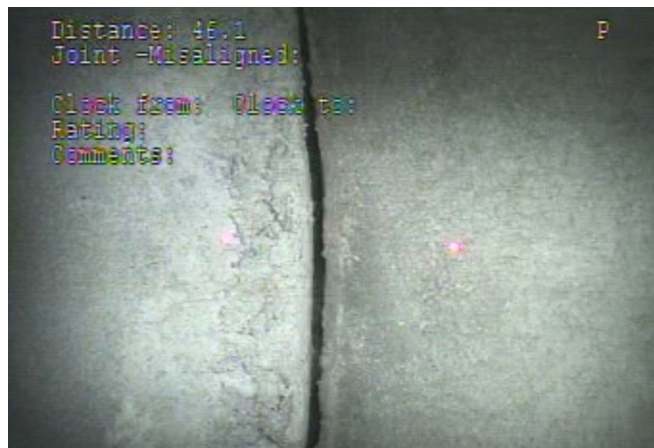
DEFICIENCIES
Obstruction (debris) at the last 35' of the downstream end of the pipe.
46' - misaligned joint

46' - MISALIGNED JOINT

RECOMMENDATION
The pipe is located within the existing paved median. Clean pipe and retain. No apparent issues with misaligned joint.

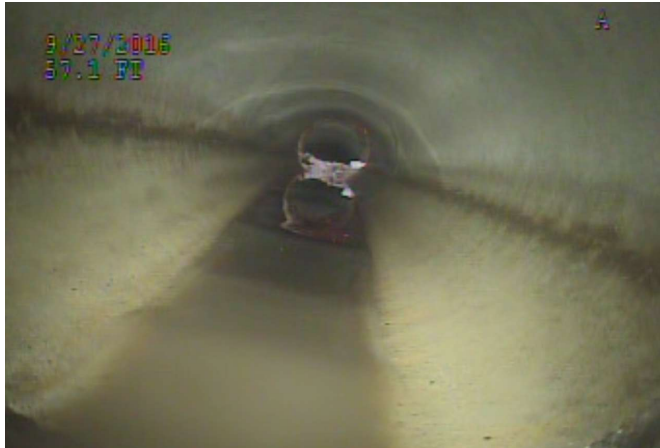
DEFICIENCIES
Obstruction (debris) at downstream end.

DEBRIS AT DS END CAUSING PONDING IN PIPE

RECOMMENDATION
The pipe is located within the existing paved median. Clean pipe and retain.

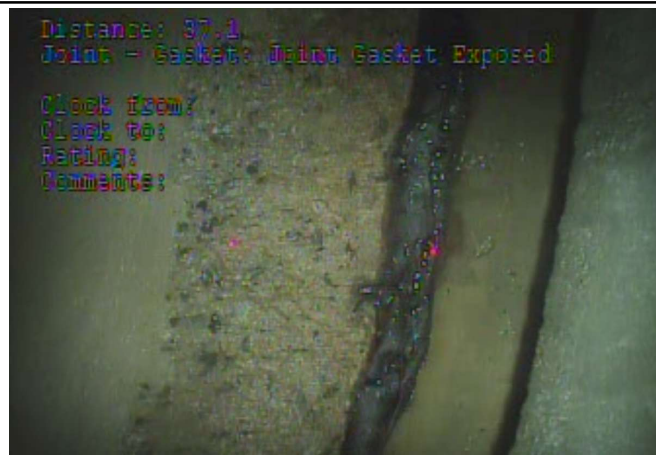
DEFICIENCIES
37' - JOINT GASKET EXPOSED

37' - JOINT GASKET EXPOSED

RECOMMENDATION
The pipe is located within the existing paved median. Exposed gasket poses potential future issues. Slip line.

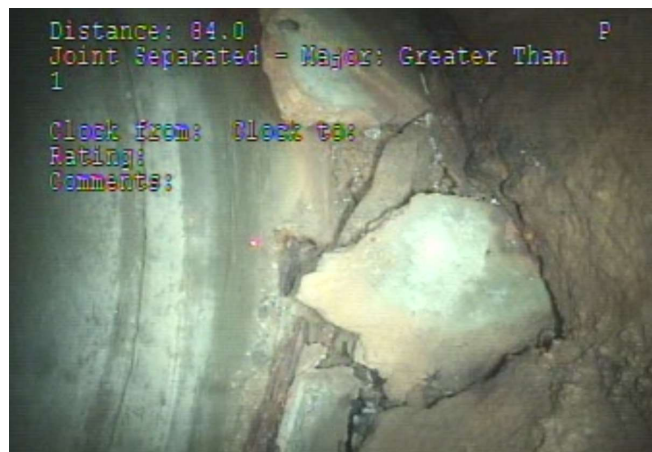
DEFICIENCIES
57.2' (TOP) - MAJOR STRUCTURAL CRACK (> 12")
84' - JOINT SEPERATED >1"

84' - JOINT SEPERATED >1"

RECOMMENDATION
Joint separation occurs outside of roadway pavement behind guardrail.
Replace last joint of pipe. Slip line remainder.

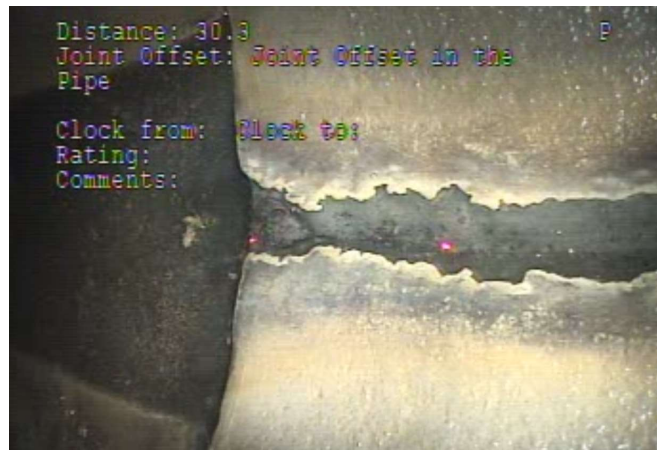
DEFICIENCIES
<u>Numerous cracks and offset joints/separations throughout the length of the pipe.</u>

30.3' - JOINT OFFSET IN THE PIPE

RECOMMENDATION
<u>Pipe is located in grassed median. Replace pipe due to number of deficiencies.</u>

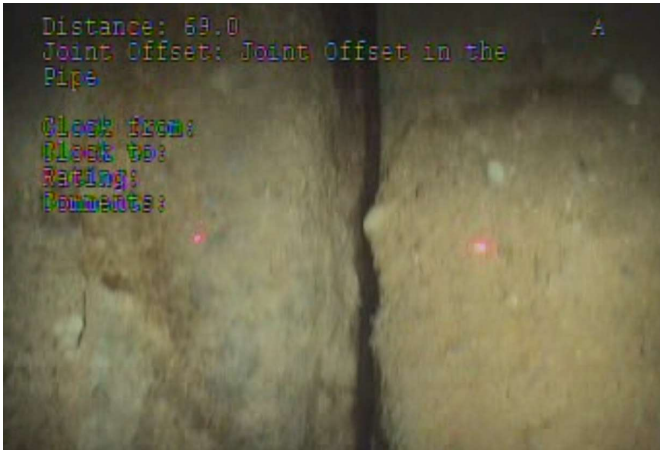
DEFICIENCIES
63.1' - CRACK > 12"; 64.7' - JOINT OFFSET IN PIPE;
69' - JOINT OFFSET IN PIPE; 74.2' - ANGULAR JOINT;
78.3' - GASKET EXPOSED

69' - JOINT OFFSET IN PIPE

RECOMMENDATION
The pipe is located under I-85 NB. Slip line.

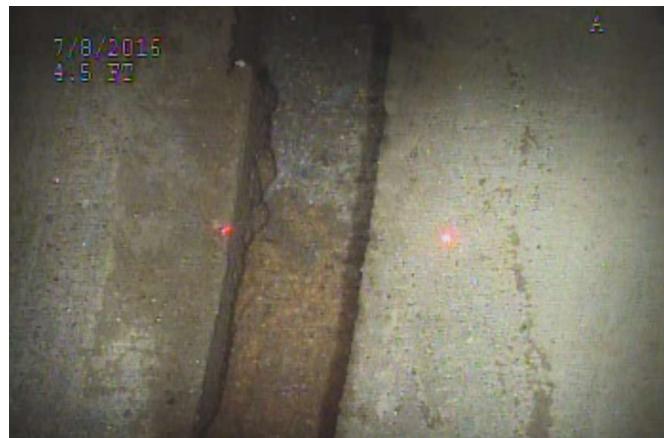
DEFICIENCIES
4.5' - JOINT > 1";
44.1' - CHIP;
Water and Debris at downstream end

4.5' - JOINT > 1"

RECOMMENDATION
The pipe is located outside of I-85 pavement and the exit ramp will be closed.
No apparent issues with pipe joints. Clean and retain pipe.

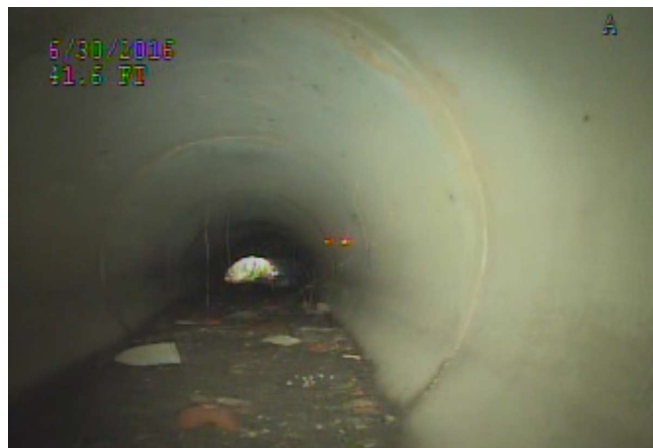
DEFICIENCIES
Obstruction (debris) near the downstream end of pipe.

DEBRIS NEAR PIPE OUTLET

RECOMMENDATION
Based on the Video Pipe Inspection, Pipe 11A should be cleaned and retained.

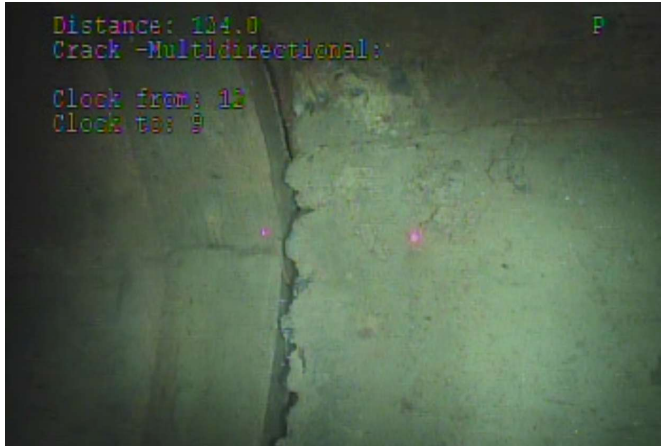
DEFICIENCIES
94.1 - CRACK > 12"
118.5' - JOINT OFFSET
124' - MULTIDIRECTIONAL CRACK

124' - MULTIDIRECTIONAL CRACK

RECOMMENDATION
Pipe is located outside of I-85 pavement. Slip line.

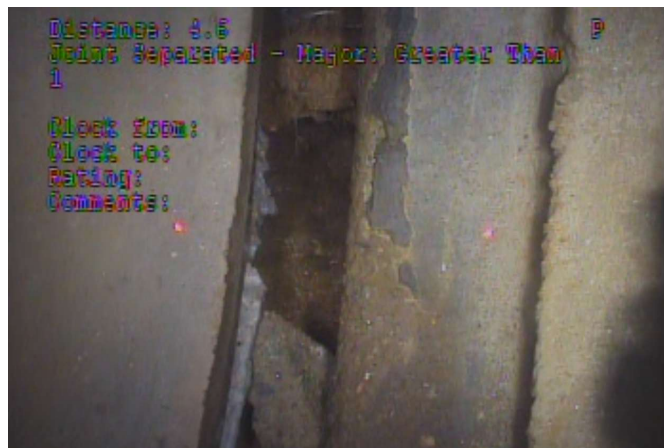
DEFICIENCIES
4.6' - JOINT SEPARATED; 12.6' - JOINT GASKET EXPOSED; 41.6' - INFILTRATION;
57.4' - CRACK > 12"; 86.4' - INFILTRATION; 97.5'-CRACK > 12"; 102.6' CRACK > 12";

4.6' - JOINT SEPARATED

RECOMMENDATION
Joint separation located at pipe end. Repair/replace joint separation and slip line remainder.

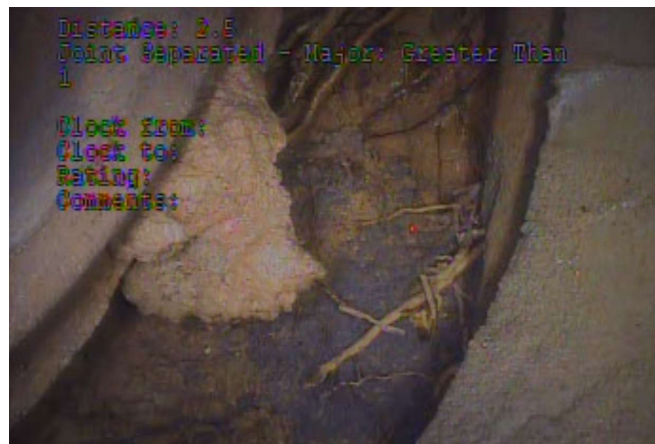
DEFICIENCIES
2.5' - JOINT SEPARATED > 1"
44' - CRACK > 12"

2.5' - JOINT SEPARATED > 1"

RECOMMENDATION
Based on the Video Pipe Inspection, Pipe 14A should be cleaned and retained.
Joint separation along Frontage Road, replace the first section of pipe.

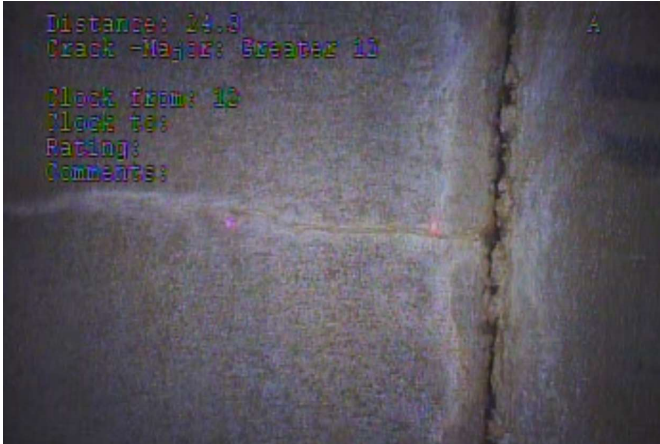
DEFICIENCIES
24.8' - CRACK > 12" (ENTIRE LENGTH OF PIPE)
117.6' - INFILTRATION

24.8' - CRACK > 12" (ENTIRE LENGTH OF PIPE)

RECOMMENDATION
Pipe is located under I-85 SB. Slip line pipe due to infiltration and cracking.

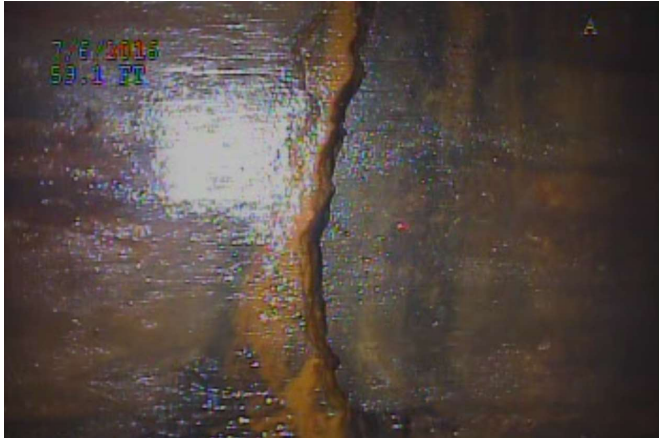
DEFICIENCIES
59.1' - CRACK > 12" - LT. SIDEWALL
74.8' - CRACK > 12" - LT. SIDEWALL
102.3' - CRACK > 12" - LT. SIDEWALL

59.1' - CRACK > 12" - LT. SIDEWALL

RECOMMENDATION
Based on the video pipe inspection, Pipe 14B should be retained.
Repair the cracks at 59', 75', and 102'.

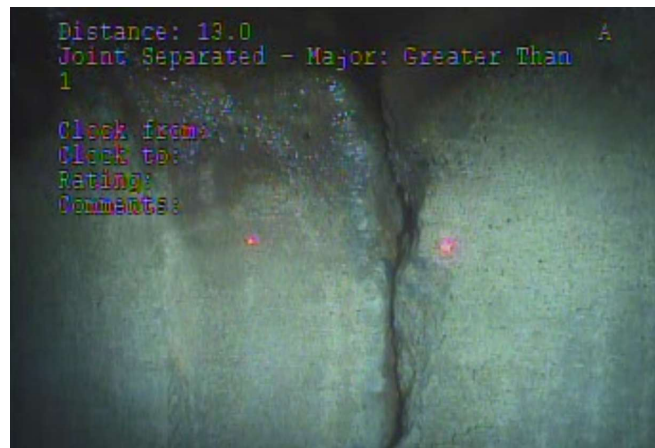
DEFICIENCIES
<u>13' - JOINT SEPARATED > 1"</u>
<u>18' - CHIP</u>
<u>50.4' - SEALING GROUT</u>

13' - JOINT SEPARATED > 1"

RECOMMENDATION
<u>Based on the Video Pipe Inspection, Pipe 16 should be retained.</u>
<u>Replace first 18' of pipe from the upstream end.</u>

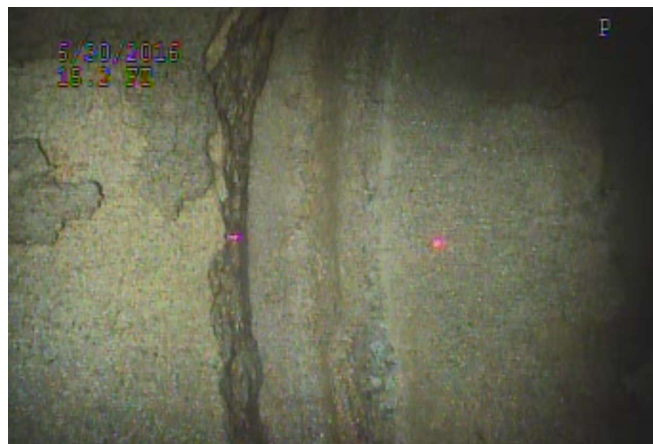
DEFICIENCIES
15.2' - CHIP
50.8' - CRACK > 12"
66.1' - SEALING GROUT
159.6' - LAST PIPE JOINT FAILED

15.2' - CHIP

RECOMMENDATION
No apparent issues from chip or cracking. Clean and retain pipe. Replace last joint outside of pavement.

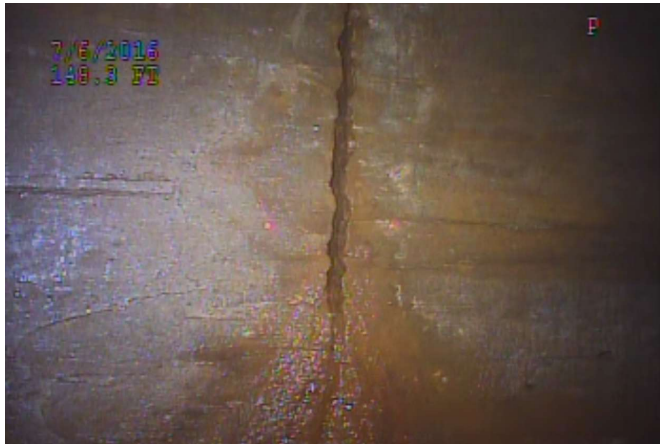
DEFICIENCIES
32.2' - CRACK > 12";
78.6' - CRACK > 12";
148.3' - CRACK > 12"

148.3' - CRACK > 12"

RECOMMENDATION
Remove debris and seal cracks.

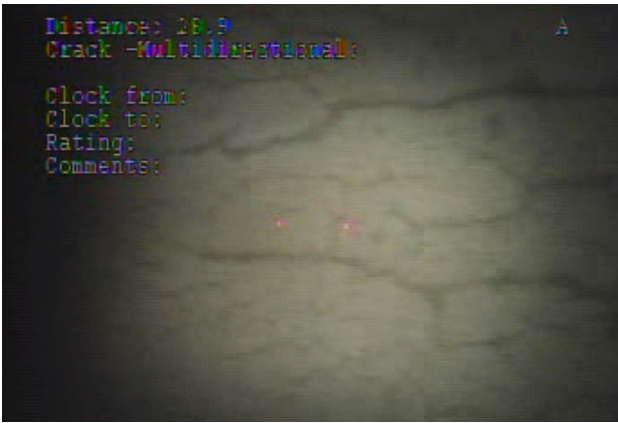
DEFICIENCIES
<u>Multidirectional cracks, 28.9'</u>

28.9' - Multidirectional Crack

RECOMMENDATION
<u>No apparent issues from cracking. Clean and retain pipe.</u>

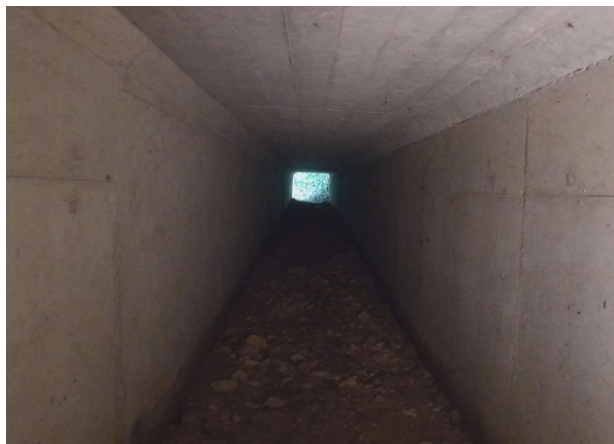
DEFICIENCIES
DEBRIS NEAR THE DOWNSTREAM END.

DEBRIS NEAR DOWNSTREAM END

RECOMMENDATION
Clean and retain.

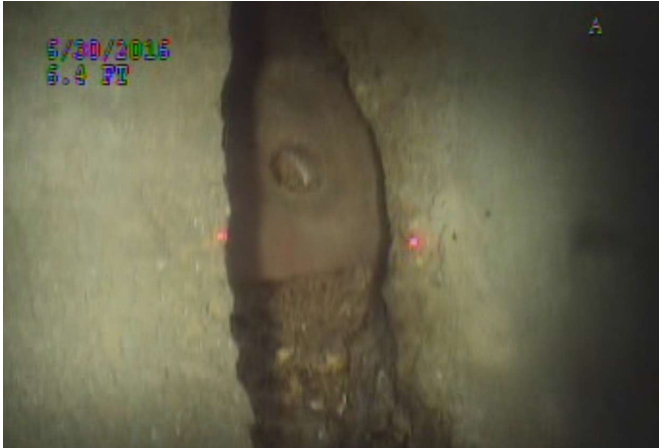
DEFICIENCIES
2.0' - JOINT OFFSET; 6.4' - JOINT OFFSET > 1"; 28.9' - CRACK > 12";
44.2' - CRACK > 12" (BOTTOM OF PIPE);
53.2' - CRACK > 12" (BOTTOM OF PIPE); 87.6' - JOINT OFFSET

6.4' - JOINT OFFSET > 1"

RECOMMENDATION
Slip line pipe due to cracking and joint issues.

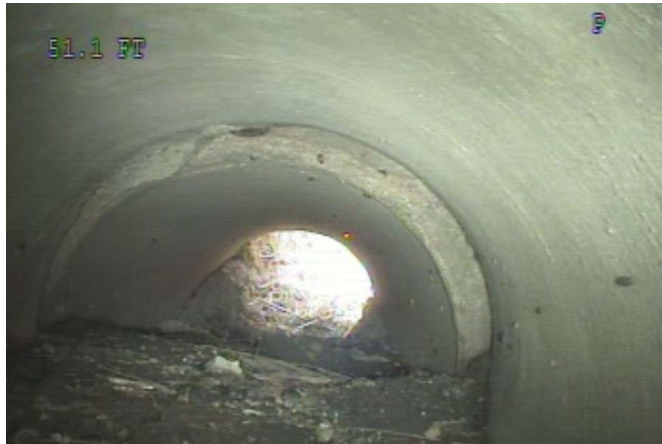
DEFICIENCIES
Joint Offset & Obstruction (debris) at 51 ft; VPI incomplete

51.1' - JOINT SEPARATED > 1"; DEBRIS

RECOMMENDATION
Replace last section of pipe outside of pavement. Clean and retain remainder.

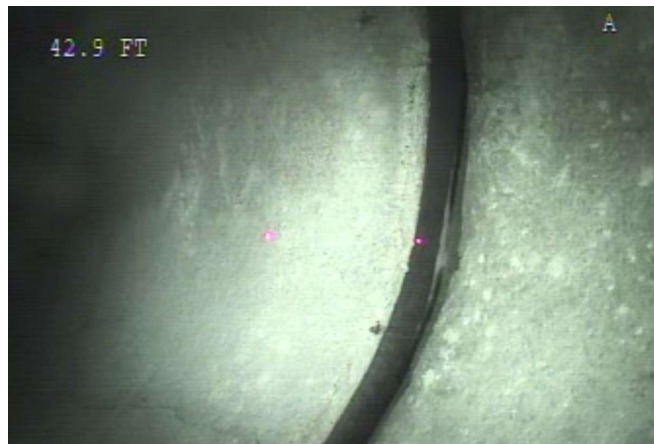
DEFICIENCIES
26.1' - Joint Offset; 42.9' - Joint Offset; 42.9' - Crack > 12"; 83.2' - Joint Offset;
179.3' - Crack > 12"; 181.7' - Joint Offset; 213.6' - Joint Offset

42.9' - JOINT OFFSET

RECOMMENDATION
Pipe located in existing paved median. Clean and slip line pipe due to multiple joint offsets.

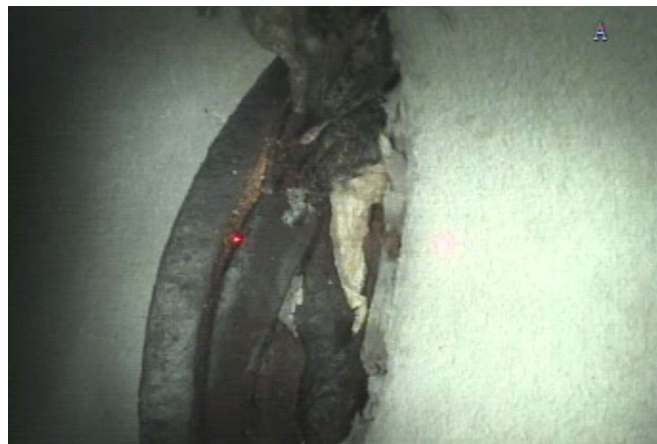
DEFICIENCIES
67.8' - Joint Gasket Exposed; 190.4' - Joint Gasket Exposed; 214.6' - Joint Offset

67.8' - JOINT GASKET EXPOSED

RECOMMENDATION
Pipe is located in an existing paved median, slip line.

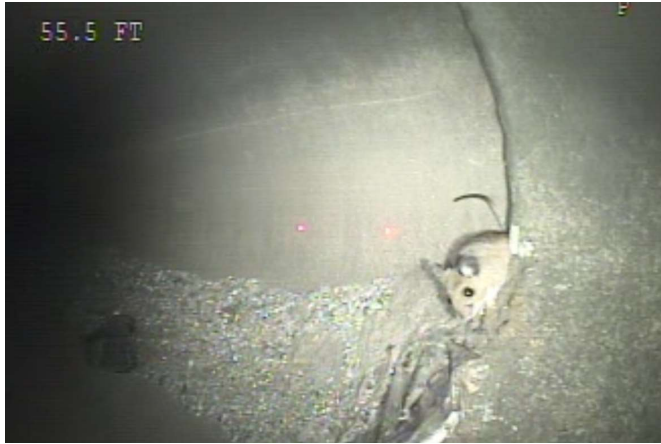
DEFICIENCIES
<u>55.5' - JOINT OFFSET;</u>
<u>64.8' - JOINT OFFSET;</u>
<u>129.6' - JOINT OFFSET</u>

55.5' - JOINT OFFSET

RECOMMENDATION
<u>Pipe is located in existing paved median. Slip line pipe due to multiple joint issues.</u>

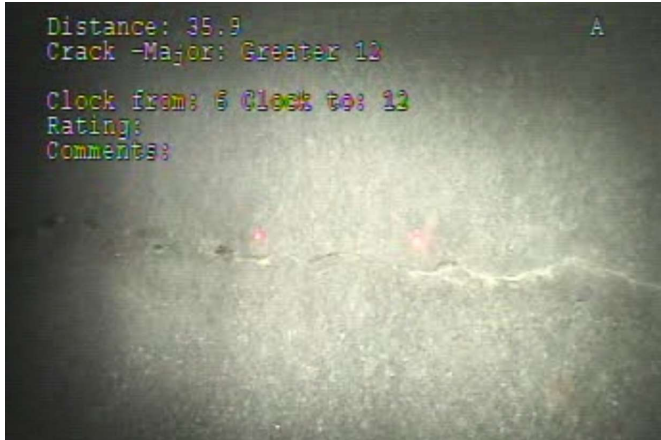
DEFICIENCIES
11.7' - CRACK > 12"

35.9' - CRACK > 12"

RECOMMENDATION
Pipe is located in existing paved median. Slip line due to cracking.

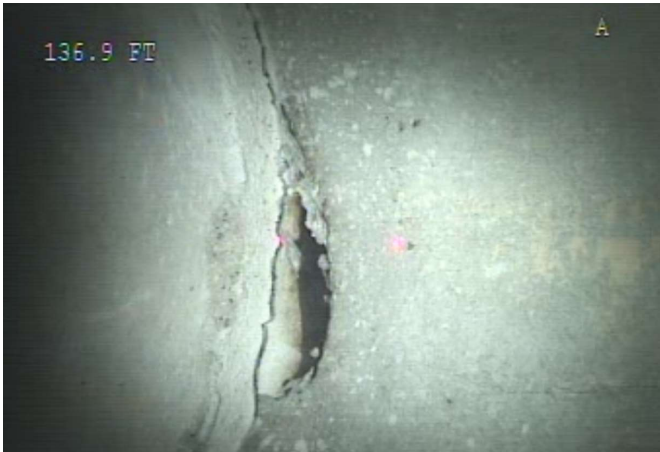
DEFICIENCIES
<u>100.4' - Crack > 12";</u>
<u>115.6' - Crack > 12";</u>
<u>128.7' - Joint Offset;</u>
<u>136.9' - Joint Offset</u>

136.9' - JOINT OFFSET

RECOMMENDATION
<u>Pipe is located in existing paved median. Slip line pipe due to multiple deficiencies.</u>

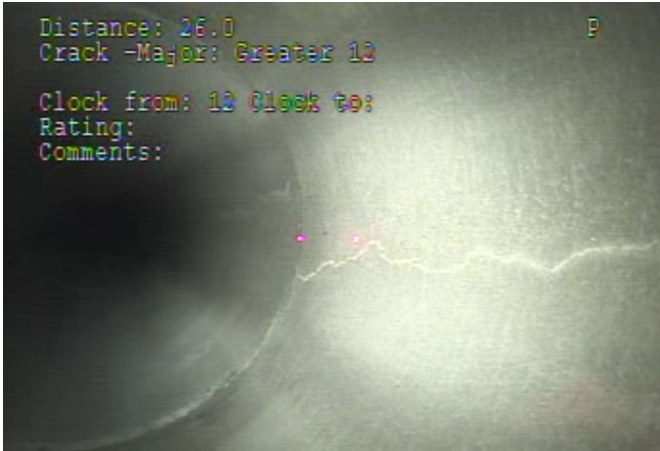
DEFICIENCIES
26' - CRACK > 12";
37' - JOINT GASKET EXPOSED;
68.3' - CRACK > 12";
142' - CRACK, JOINT GASKET EXPOSED

26' - CRACK > 12"

RECOMMENDATION
Pipe is located in existing paved median. Slip line pipe due to multiple deficiencies.

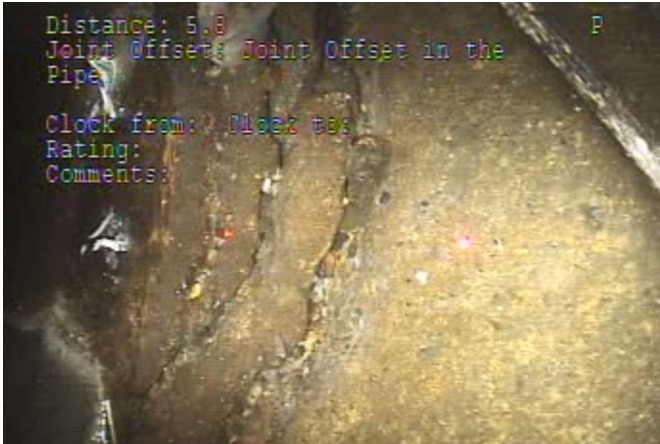
5.8' - JOINT OFFSET

RECOMMENDATION
Pipe is located in existing paved median. Replace pipe.

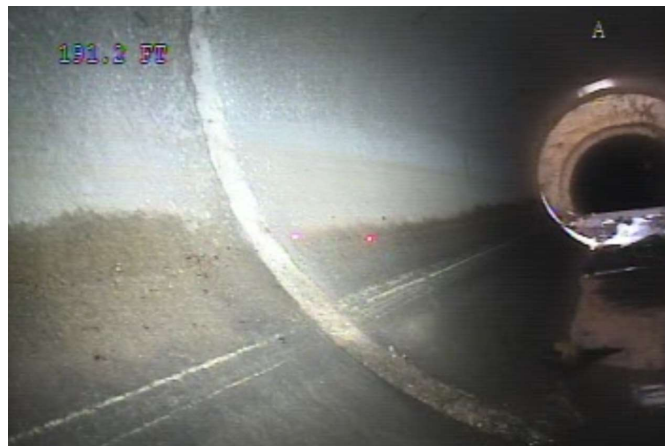
191.2' - JOINT OFFSET

RECOMMENDATION
Pipe is located in existing paved median. Slip line due to deficiencies.

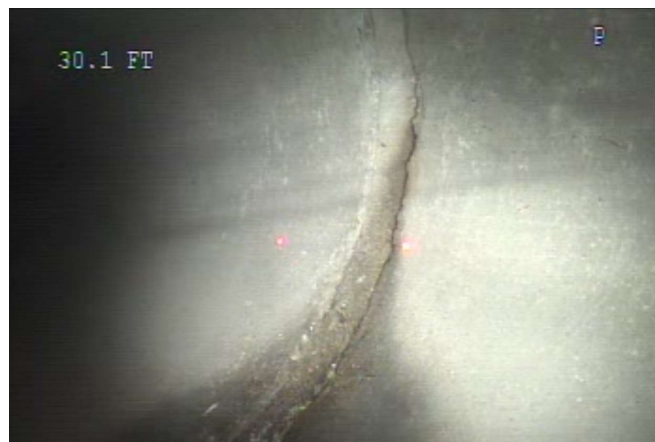
30' - JOINT OFFSET

RECOMMENDATION
Pipe is located in existing paved median. Slip line due to multiple deficiencies.

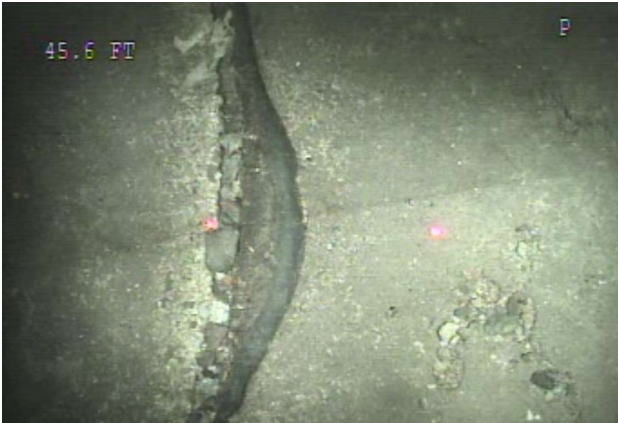
45.6' - JOINT GASKET EXPOSED

RECOMMENDATION
Pipe is located in existing paved median. Slip line due to multiple deficiencies.

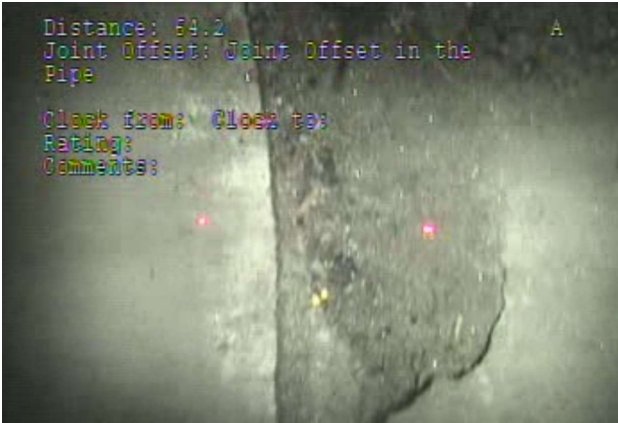
64.2' - JOINT OFFSET/BROKEN

RECOMMENDATION
Pipe is located in existing paved median. Slip line due to multiple deficiencies.

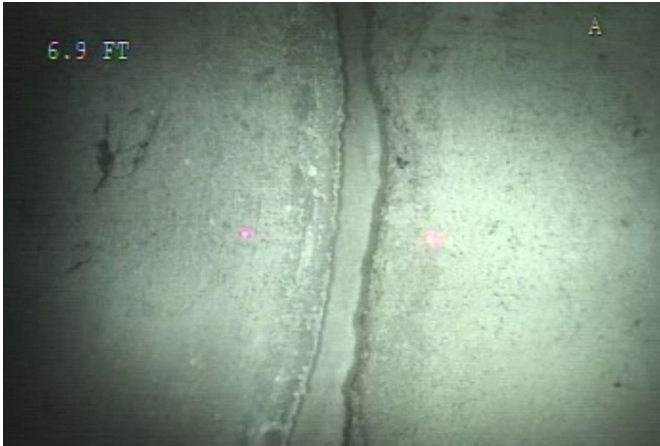
6.9' - JOINT OFFSET

RECOMMENDATION
<u>No apparent issues from joint offset. Clean and retain pipe.</u>

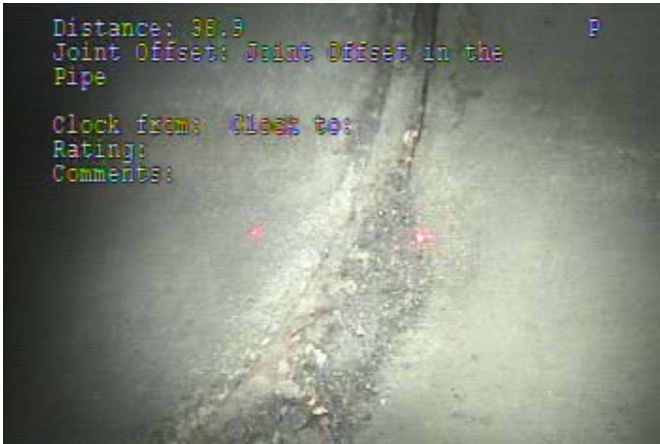
38.9' - JOINT OFFSET

RECOMMENDATION
<u>No apparent issues from joint offset. Clean and retain pipe.</u>

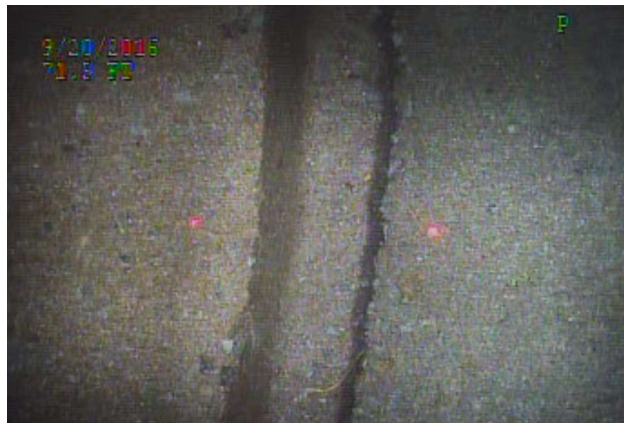
71.2' - Joint Offset

RECOMMENDATION
<u>No apparent issues from joint offset. Clean and retain pipe.</u>

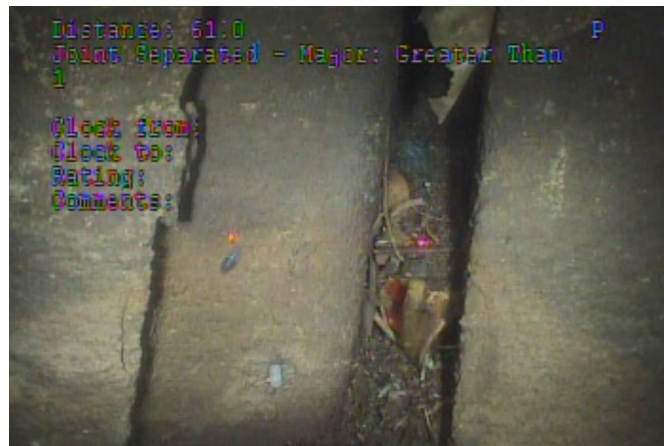
61' - JOINT > 1"

RECOMMENDATION
Joint separation located outside of pavement. Repair joint. Clean and retain remainder.

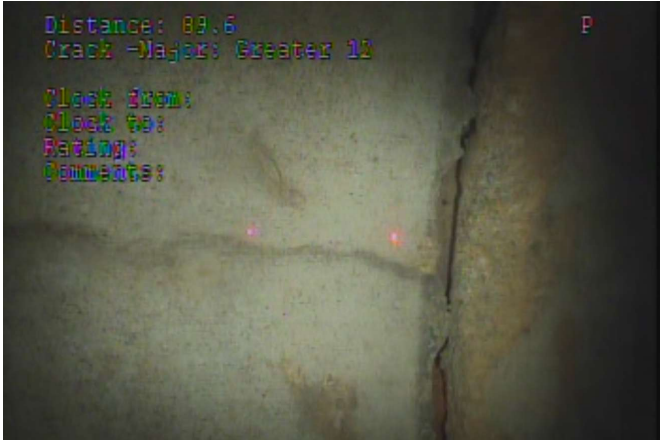
89.6' - CRACK > 12"

RECOMMENDATION
Clean and Retain. Pipe is in good condition.

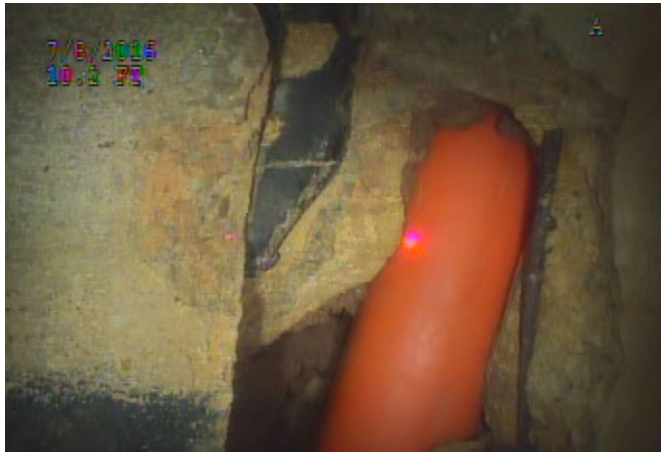
10.2' - BORE CABLE

RECOMMENDATION
Pipe is located outside of Interstate pavement in right shoulder and under Frontage Road. Replace pipe due to significant structural issues.

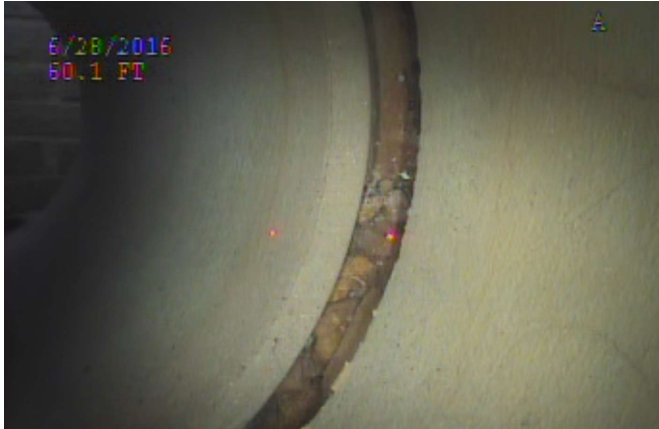
60.1' - Joint Separated

RECOMMENDATION
Joint separation located at edge of pavement. Slip line due to joint issues.

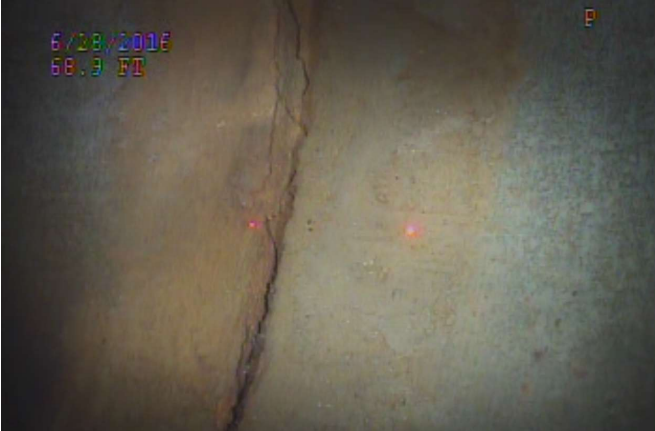
68.9' - JOINT OFFSET

RECOMMENDATION
<u>No apparent issues from joint offsets and cracking. Replace last section of pipe at</u>
<u>joint separation. Retain remainder of pipe.</u>

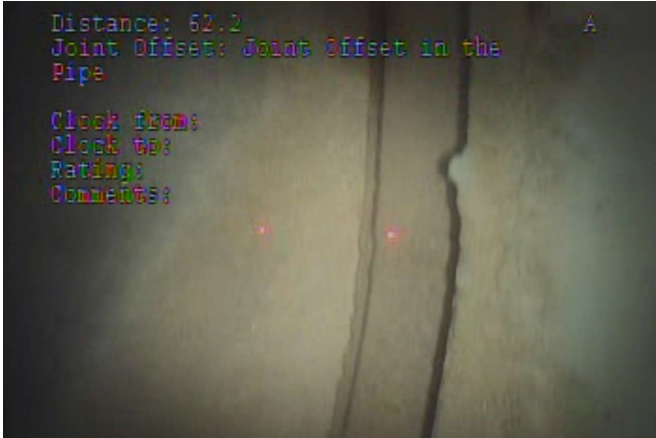
62.2' - JOINT OFFSET

RECOMMENDATION
No apparent issues from joint offset. Pipe is in good condition.

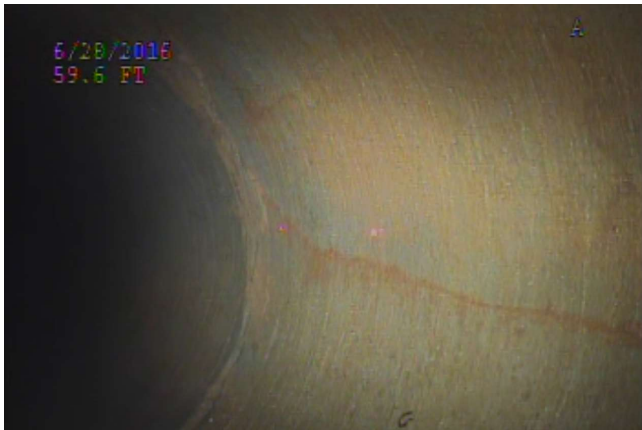
59.6' - CRACK > 12"

RECOMMENDATION
No apparent issues from cracking. Clean and retain pipe. Pipe is in good condition.

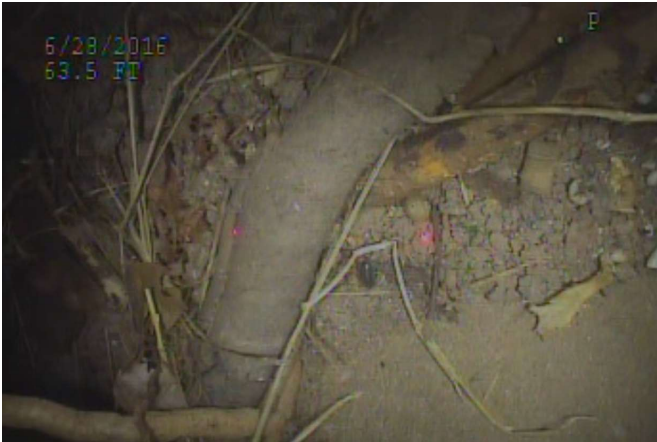
63.5' - Root Problem

RECOMMENDATION
Joint offset located outside of interstate pavement. Replace from joint offset to pipe end. Retain remainder.

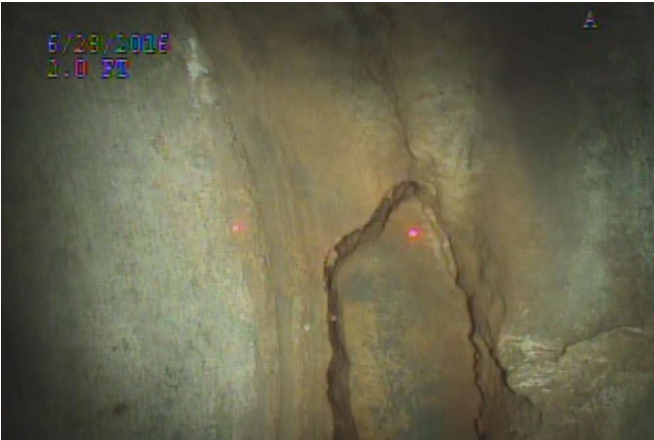
2' - Joint Offset

RECOMMENDATION
No apparent issues from cracking. Clean and Retain. Pipe is in good condition.

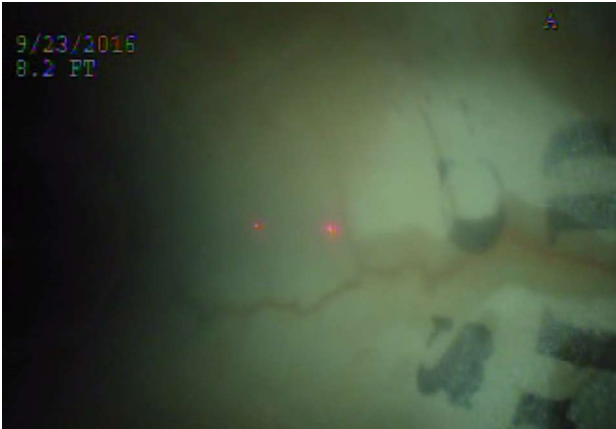
9' - Crack > 12"

RECOMMENDATION
<u>Replace pipe due to excessive root intrusion.</u>

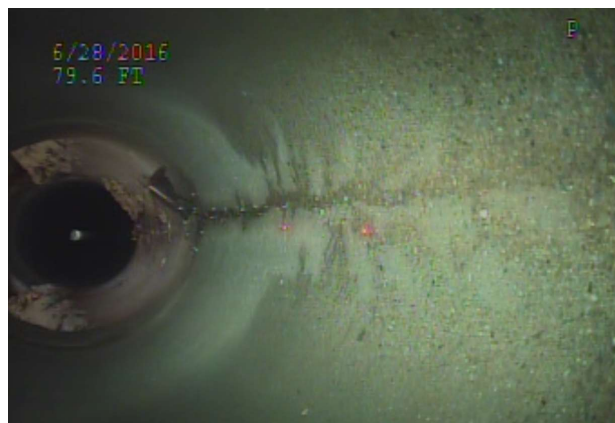
79.6' - CRACK > 12"

RECOMMENDATION
<u>No apparent issues from cracking. Pipe is in good condition.</u>

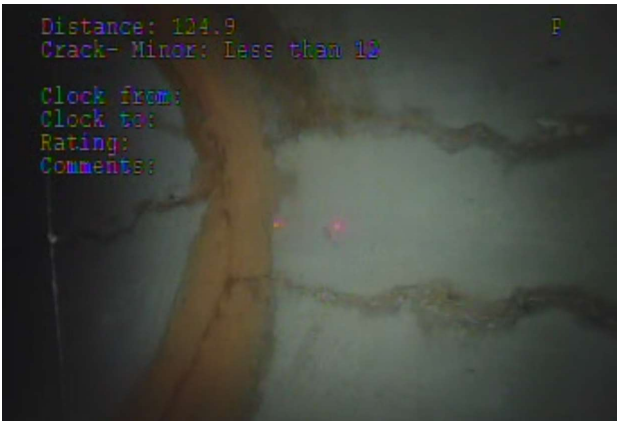
125' - Multidirectional Crack

RECOMMENDATION
<u>Pipe is located under I-85 SB. Slip line pipe due to joint issues.</u>

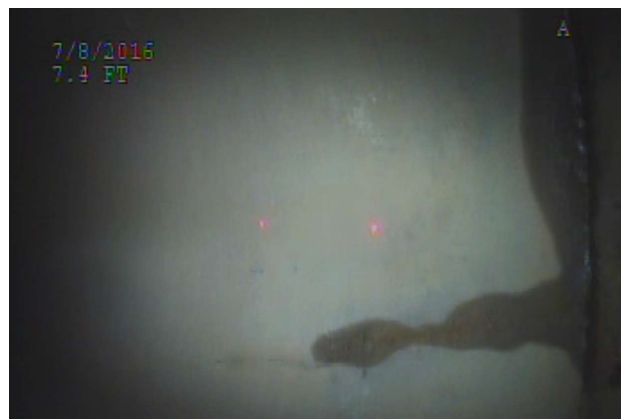
7' - Multidirectional Crack

<u>RECOMMENDATION</u>
<u>No apparent issues from crack. Pipe is in good condition. Retain.</u>

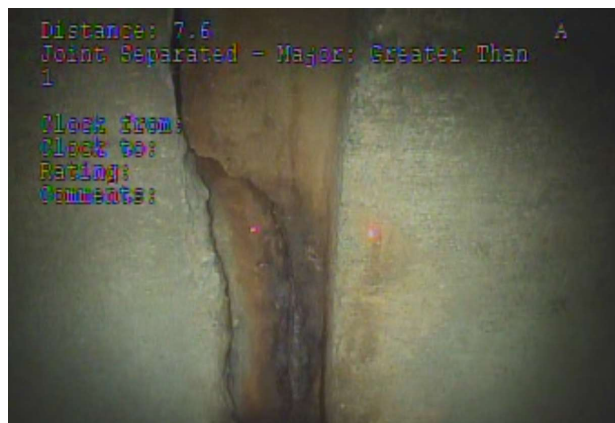
8' - Joint Separated > 1"

RECOMMENDATION	
Multiple joint and breaks as well as hydraulic issues. Replace pipe.

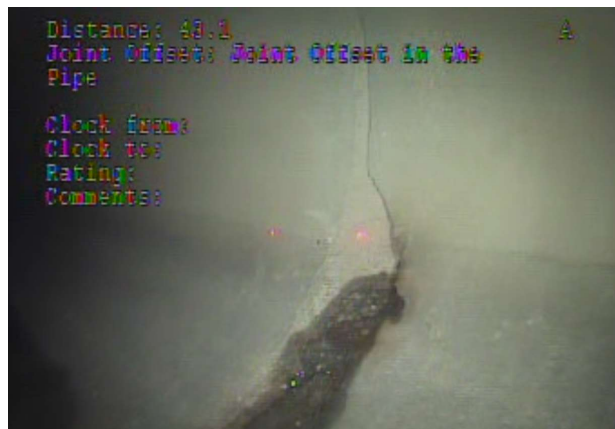
43' - Joint Offset

<u>RECOMMENDATION</u>
No apparent issues from joint offset other than minor debris accumulation.
Clean pipe and retain.

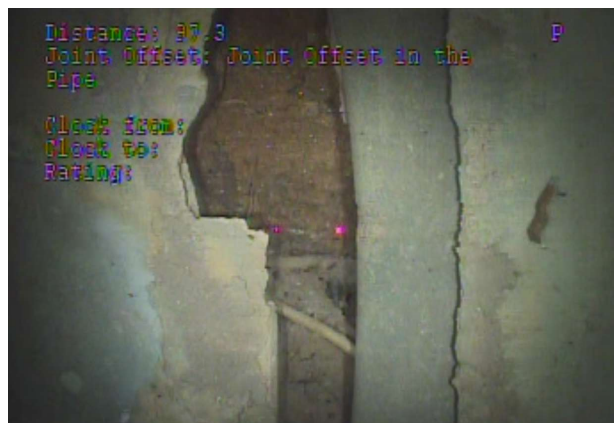
97' - Joint Offset

RECOMMENDATION
Replace last segment of pipe at the outfall. Cracking occurs within the median and NB lanes. Some infiltration from cracking. Slip line pipe.

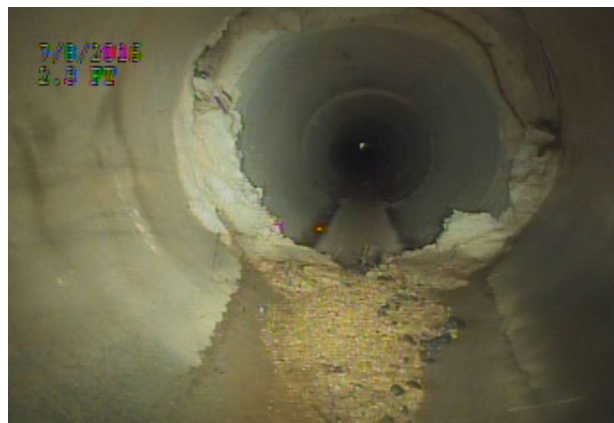
5' - Joint Collapsed

<u>RECOMMENDATION</u>	
Repair joint on upstream end. Slip line.	
<hr/>	
<hr/>

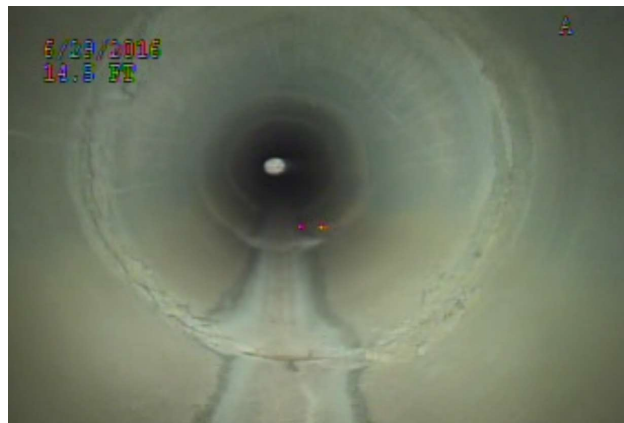
15' - Intruding Sealing Grout

RECOMMENDATION
Pipe is in good condition. Retain.
