LEAD BASED PAINT INVESTIGATION REPORT

US-15 RBO INDIAN FIELD SWAMP CULVERT
PO 37127
DORCHESTER COUNTY, SOUTH CAROLINA

F&ME Project No.: G6100.120

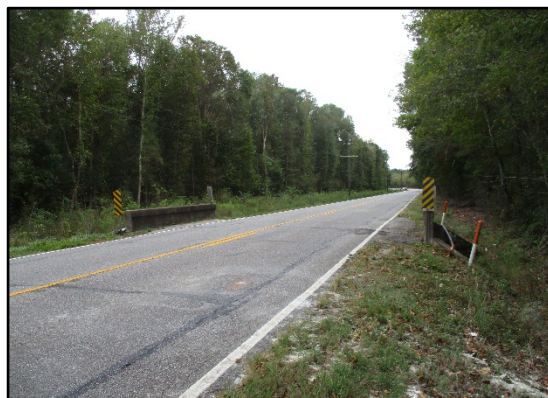
The existing culvert structure (~23.0'L x 32.2'W, inside curb to inside curb), is located on US-15 and crosses over Indian Field Swamp in Dorchester County, South Carolina. The date of construction of the culvert (SCDOT bridge # 182001501101) is noted on the National Bridge Inventory Database as 1929 with an expansion noted to have occurred in 1938. The existing culvert structure is a one (1) span, two lane cast in place concrete culvert, with an asphalt overlay. The bridge deck rests on concrete wing walls. No drainage supports were noted on either side of the culvert. Precast concrete guardrails were also noted. Two (2) utility conduits

Photo 1 – Culvert associated with US-15 RBO Indian Field Swamp, Dorchester County, South Carolina.

were attached on the east side of the culvert deck, and one (1) utility conduit was attached on the west side of the culvert deck. Refer to Appendix A – Site Vicinity Map, for the location of the structure.

The visual inspection portion of our LBP Investigation determined that there were **no visible suspect surfaces to be sampled that were associated with the culvert**. Appendix C - Personnel Certification provides the LBP certifications for FME personnel.

The results of this LBP investigation determined that there were no visible lead-based paints or coatings found on the culvert. During the culvert demolition activities, some painted surfaces may be exposed. If paint is exposed and it is determined to contain levels of lead ≥ 0.7 mg/cm², the coated/painted components will need to be handled and disposed of properly. Proper handling includes the avoidance of creating lead dust, as well as the creation of lead-contaminated soil hazards. Activities that would generate lead dust include abrasion, scraping, or sanding. As previously stated, OSHA has not defined lead-containing paint, but states that paint having any measurable level of lead may pose a substantial exposure hazard during construction work, depending upon the work performed. In these cases, OSHA regulations and procedures should be followed to protect the personnel carrying out the work on a culvert component containing any amount of lead.
