Underwater Inspection Report

South Carolina Department of Transportation

US 21

Harbor River

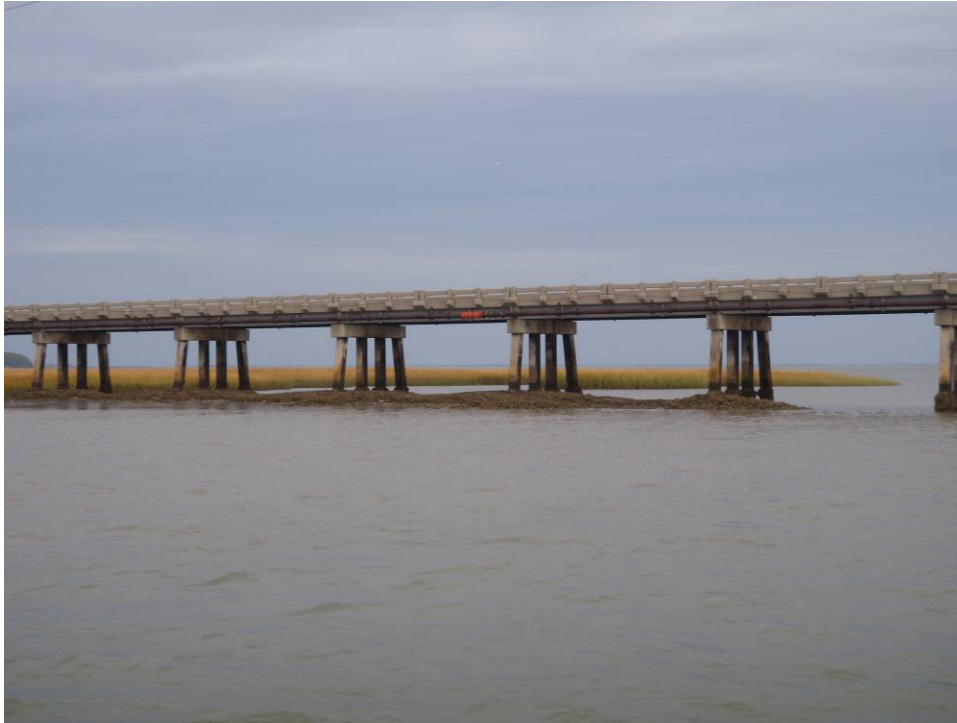
The banks along the Harbor River in the vicinity of the bridge are in stable condition. Embankment protection in the form of riprap and vegetation is present on the west and east banks. There is no sign of active erosion. Refer to Photographs 7 and 8 in Appendix B for a view of the west and east embankments, respectively. The channel bottom primarily consists of sand and shells.

Photograph 7. West Embankment.

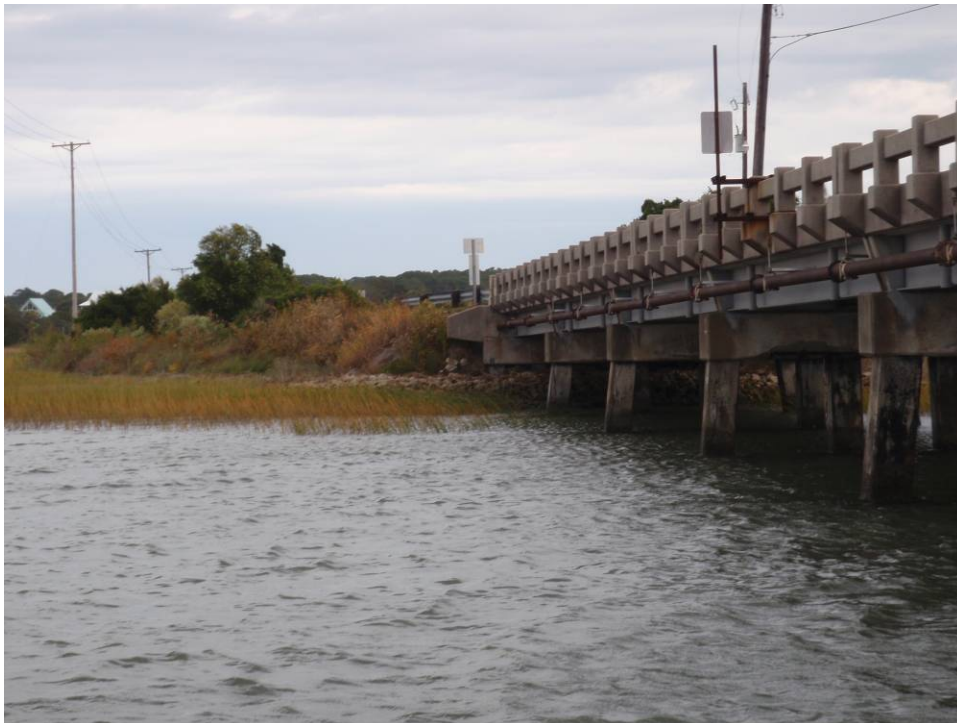
Photograph 8. East Embankment.

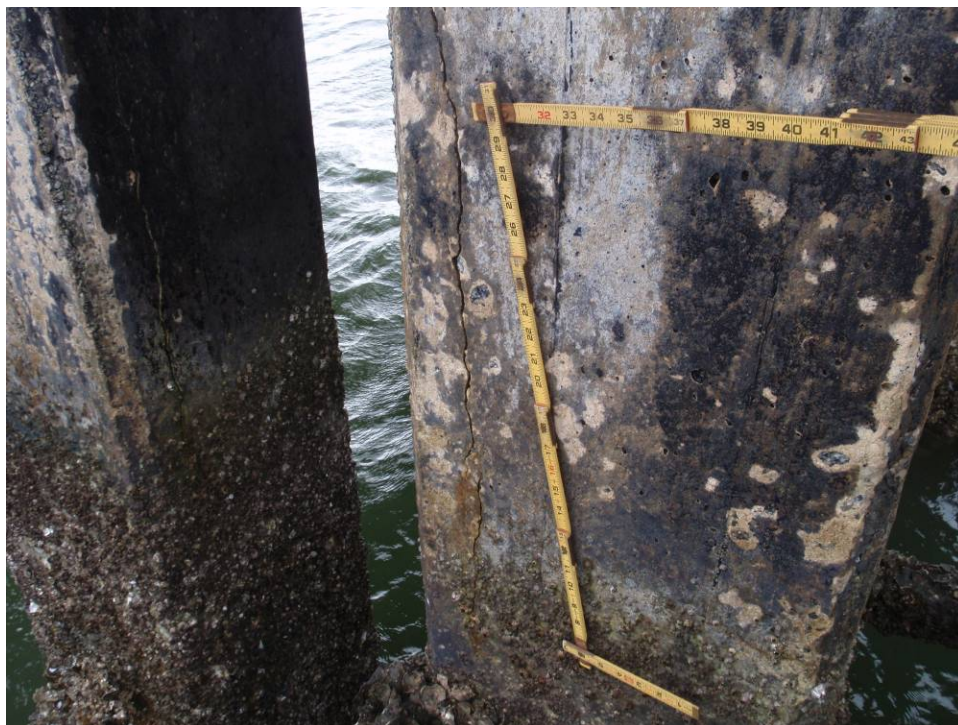
The substructure units located in water at the time of inspection included Bents 30 through 63 and Piers A through E. All inspected substructure units have moderate to heavy marine growth in the form of oysters from the high water mark to the channel bottom. Piles at Bents 33, 45, 56, 57, 61, and 62 and Pier B have up to 1/4-in. wide by 3 ft long vertical cracks with rust stains. Piles at Bents 30, 34, 36, 40, 44, 48, 52 through 55, and 58 have up to 1/8-in. wide by up to 4 ft long vertical cracks with rust stains. Piles at Bents 31, 43, 49, 51, and 60 and Pier E have up to 1/16-in. wide by 3 ft long vertical cracks with rust stains. Refer to Photograph 11 in Appendix B for a view of a typical crack in a pile.

Photograph 11. View of a Typical Vertical Crack in a Pile.

It is recommended that all cracks be cleaned and sealed. Spalls and voids should be cleaned down to sound concrete and patched with grout suitable for a marine environment. In accordance with NBIS recommendations, the next routine underwater inspection for this bridge should be conducted on an interval not to exceed 60 months. In addition, bridge soundings should be taken as part of biennial above-water inspections, as well as following significant flooding events.

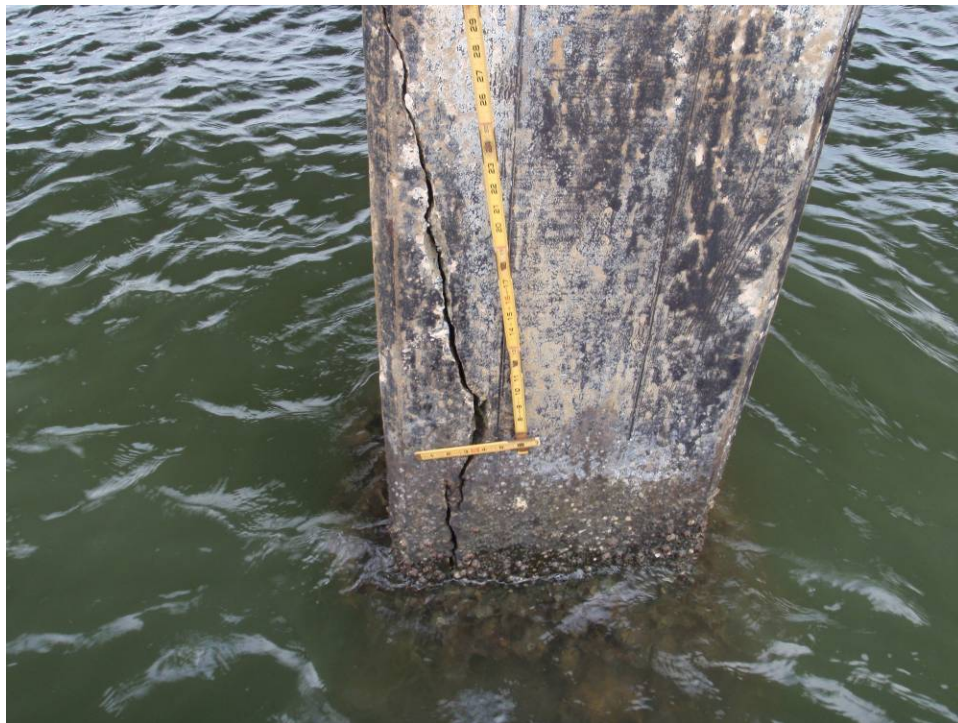
Bent 61 has a 1/2-in. wide by 4 ft long vertical crack with rust stains on the south face at the waterline. Refer to Photograph 12 in Appendix B for a view of this crack.

Photograph 12. View of Crack in Pile 1 at Bent 61. Typical of larger cracks.

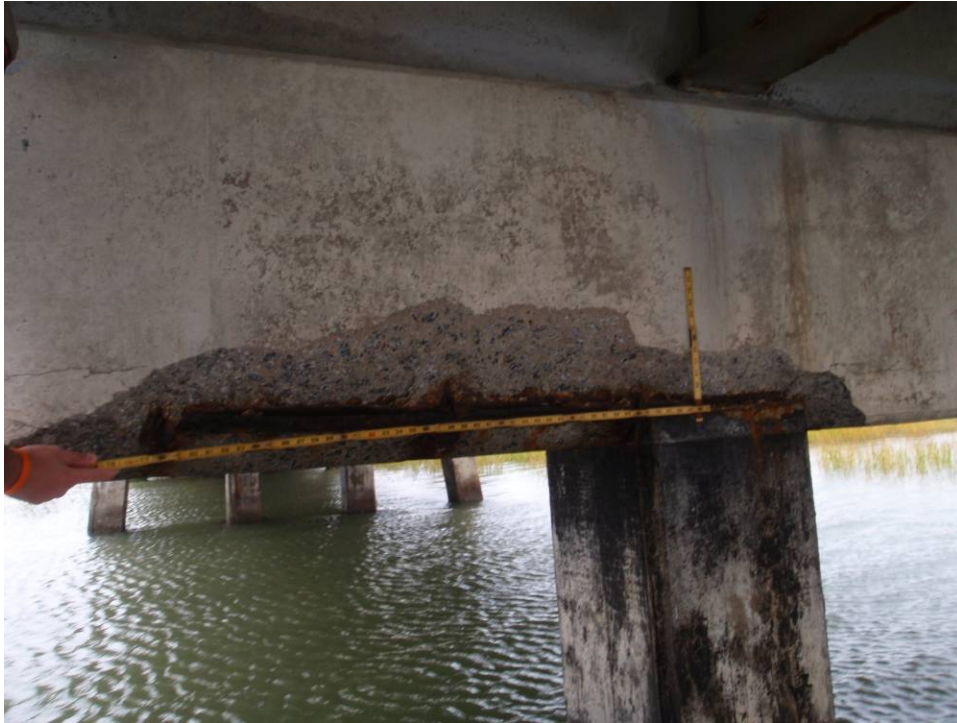
There is a void measuring 1 ft long by 1 1/2 in. high by 4 in. deep on the east face of the column at the first step-out at Pier C 3 ft below the waterline. There is a spall measuring 2 ft long by 1 ft high with 4 in. of penetration with exposed reinforcing on the east face of the cap at Bent 56. There is a spall measuring 5 ft long by 1 ft high with 6 in. of penetration with exposed reinforcing at the bottom of the west face of the cap at Bent 63. Refer to Photograph 13 in Appendix B for a view of this spall. Refer to Figures 1 through 3 in Appendix A for detailed inspection notes and a plan view showing the existing conditions at each of the inspected bents.

Photograph 13. Spall in west face of Bent 63 cap.
