## SCDOT BRIDGE INSPECTION FORM

(008) BRIDGE ID: **072002100200**  
 (005) ROUTE: BEAUFORT US 21  
 (006) CROSSING: HARBOR RIVER

## **Bridge Element Group Textual Data**

**Bridge ID: 072002100200**

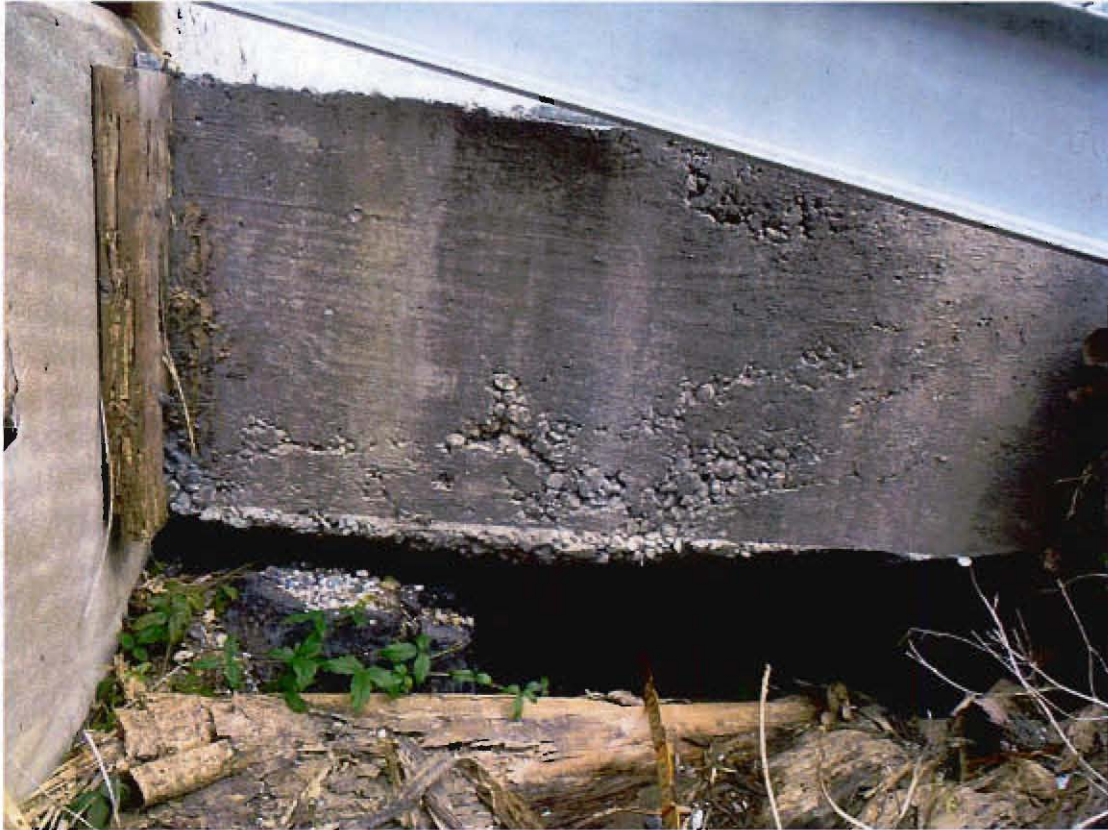
**Abutments and/or Headwalls- Photo 1**

[6] SAT – The southeast corner of Abutment 69, adjacent to the wingwall, exhibits a 2 ft. x 3 ft. x 1 ft. undermined and washed out area. Refer to Photo 1.

The southeast corner of Abutment 69, adjacent to the wingwall, exhibits a 2 ft. x 3 ft. x 1 ft. undermined and washed out area.

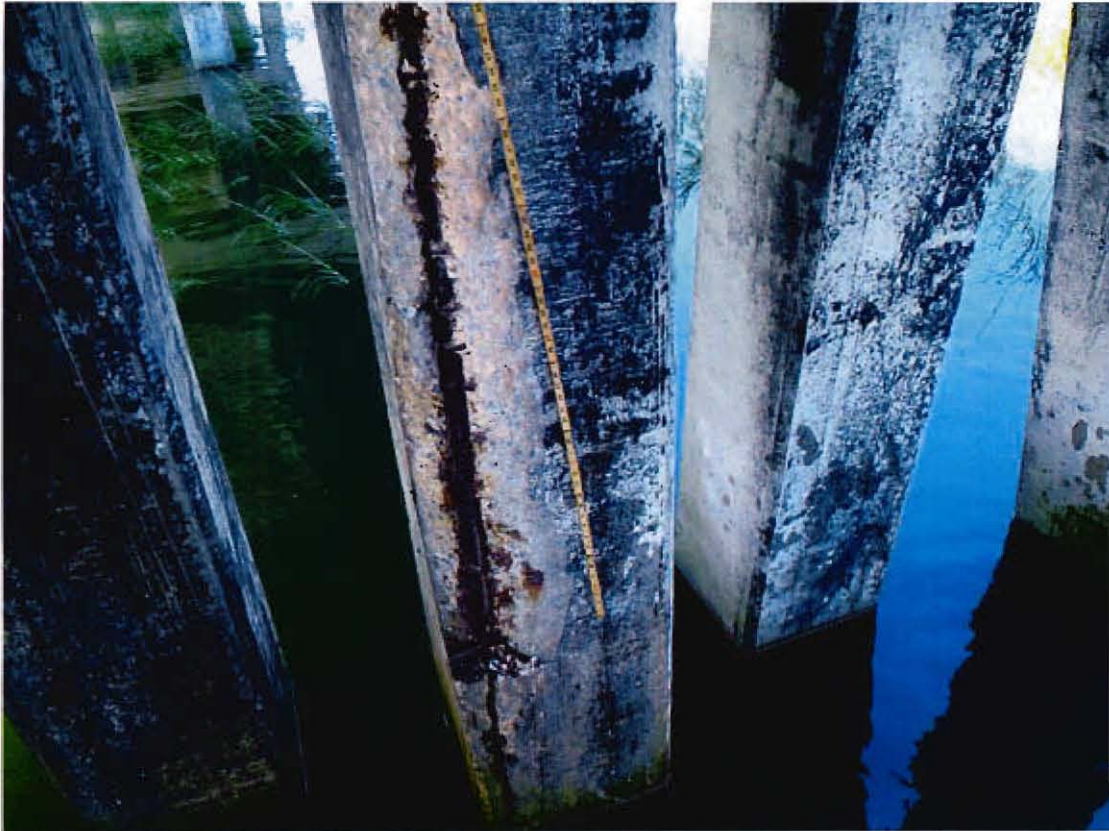
**Bents and/or Piers- Photo 2**

[6] SAT – Many piles exhibit delaminations and spalls some with exposed steel, and cracks with corrosion bleed out throughout the structure. Refer to Photo 2.

Many piles exhibit delaminations and spalls some with exposed steel, and cracks with corrosion bleed out throughout the structure (Pile 21-3, 6 ft. x 18 in. x 3 in. spall, delamination with exposed steel shown).

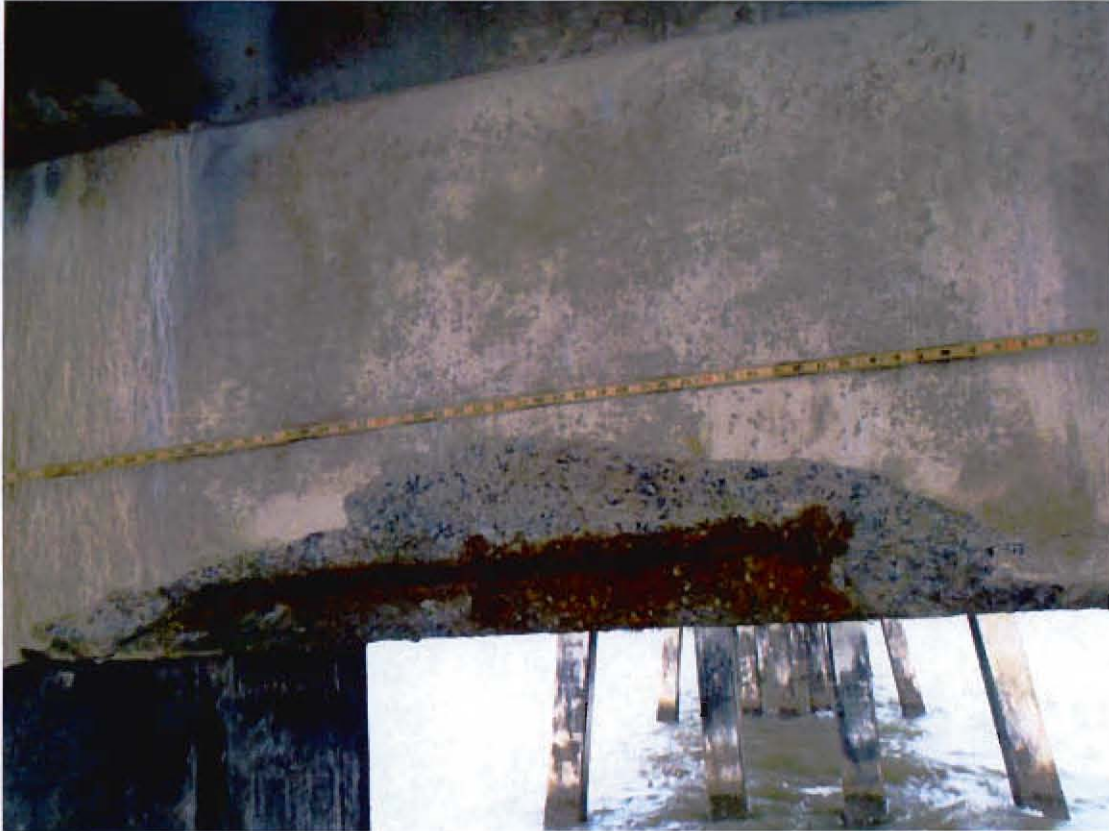
**Bents and/or Piers- Photo 3**

Some caps exhibit delaminations, and spalls some with exposed steel, and cracks with corrosion bleed out throughout the structure. Refer to Photo 3.

Some caps exhibit delaminations, and spalls some with exposed steel, and cracks with corrosion bleed out throughout the structure (Bent 59 between Piles 2 and 3, 4 ft. x 1 ft. x 3 in. spall with exposed steel shown).

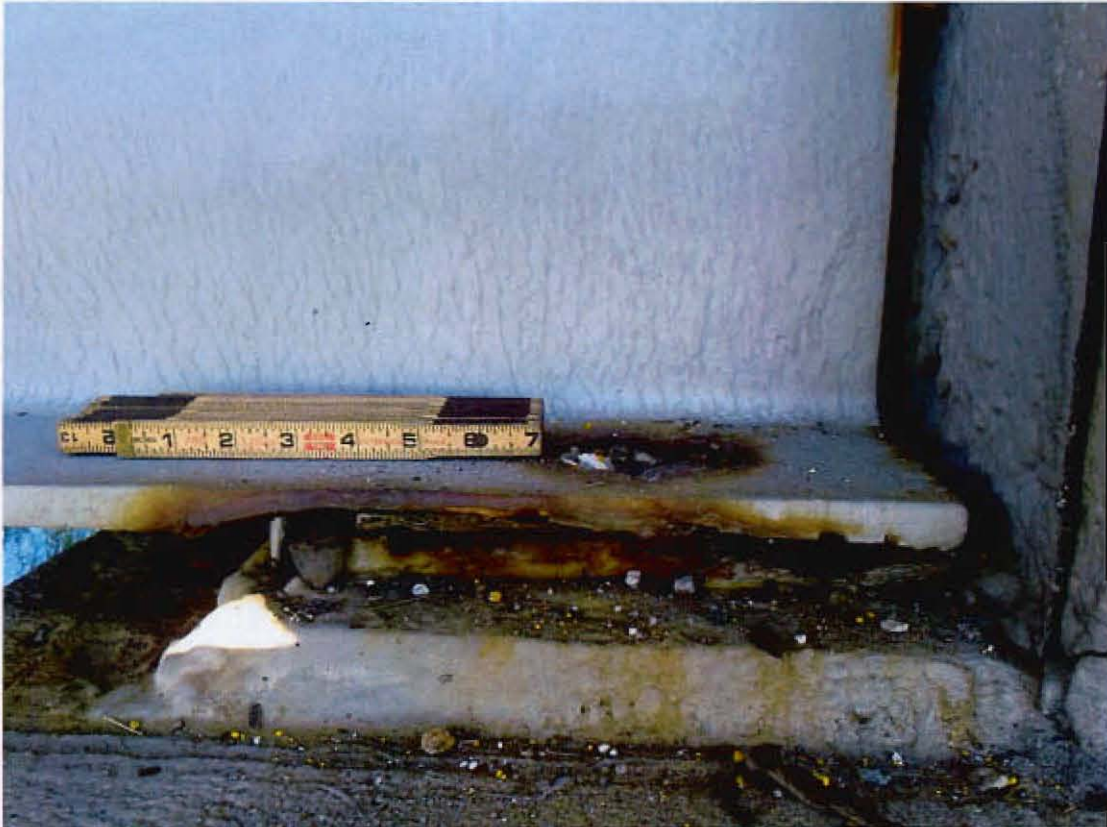
**Bearings- Photo 4**

[4] POOR – The connecting hardware of a few bearings exhibits section loss to 100%. Refer to Photo 4.

The connecting hardware of a few bearings exhibits section loss to 100% (Bearing 21-4 at Bent 22 shown).

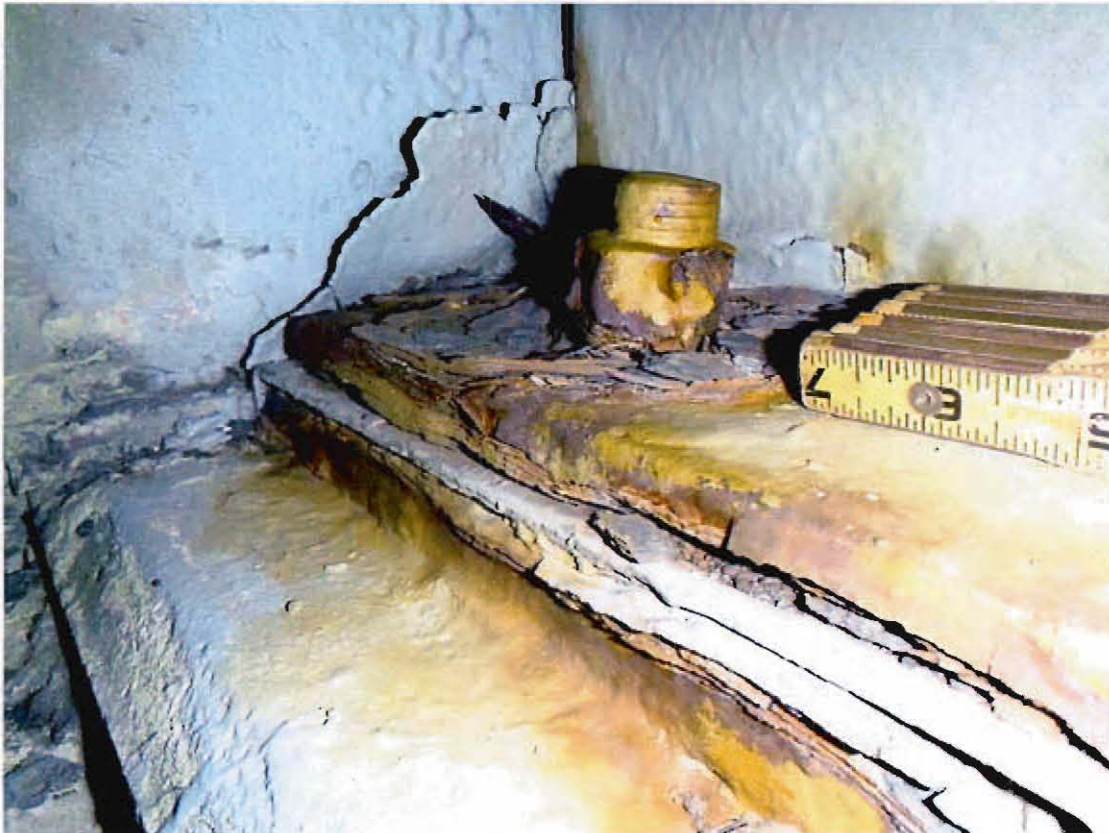
**Bearings- Photo 5**

The bearings exhibit heavy corrosion, section loss, and corrosive pitting. Refer to Photo 5.

The bearings exhibit heavy corrosion, section loss, and corrosive pitting (Bearing 42-3 at Bent 42 shown).

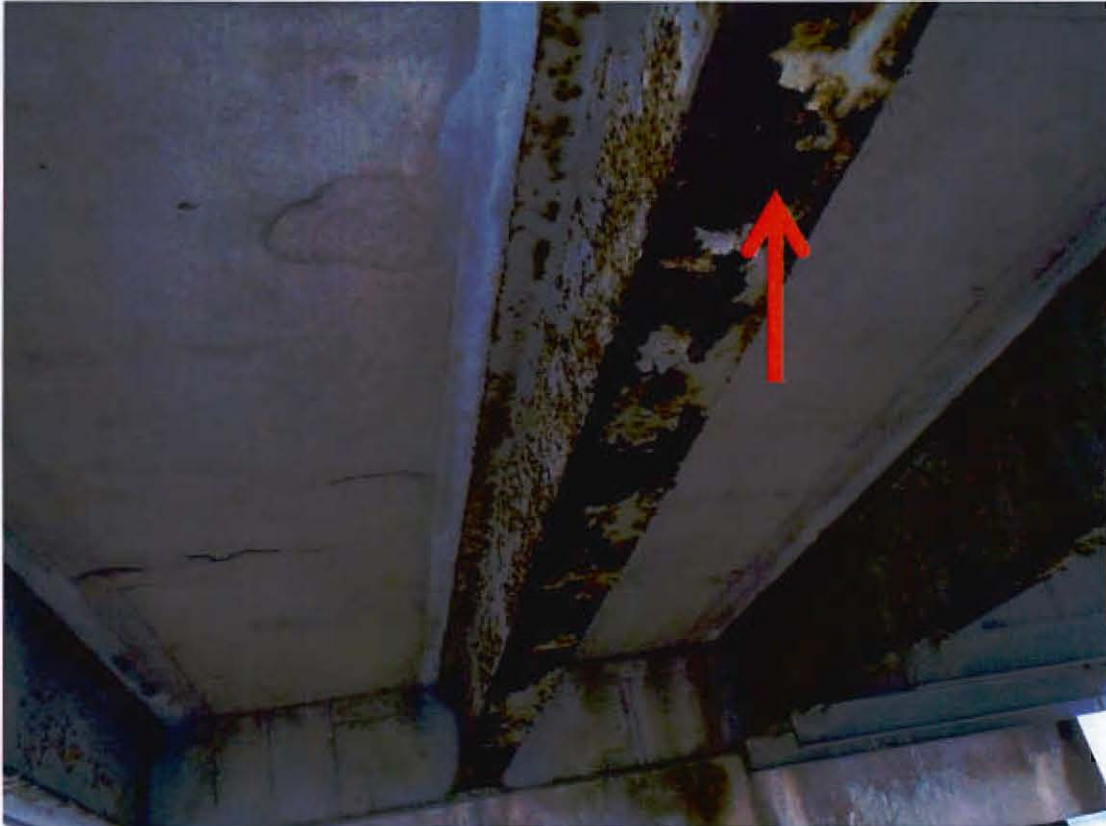
**Girders/Floor Beams/Stringers and/or Beams- Photo 6**

[4] POOR – The beams of the approach spans exhibit heavy corrosion, knife edging, section loss, resulting in reduced section near the ends of the beams throughout. Refer to Photos 6, 7, and 8.

Typical of heavy corrosion in the bottom flange of the approach span beams (Beam 37-3 shown).

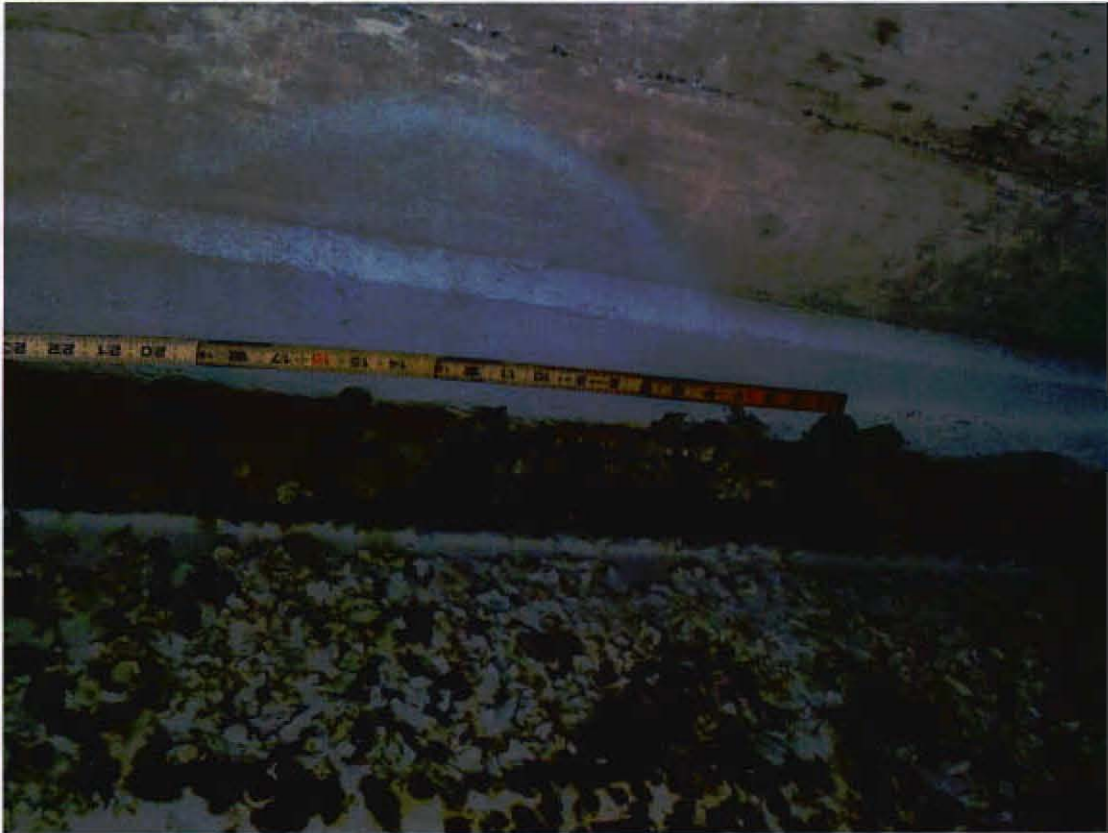
**Girders/Floor Beams/Stringers and/or Beams- Photo 7**

Typical of heavy corrosion in the web and top flange of the approach span beams (Beam 36-4 shown).

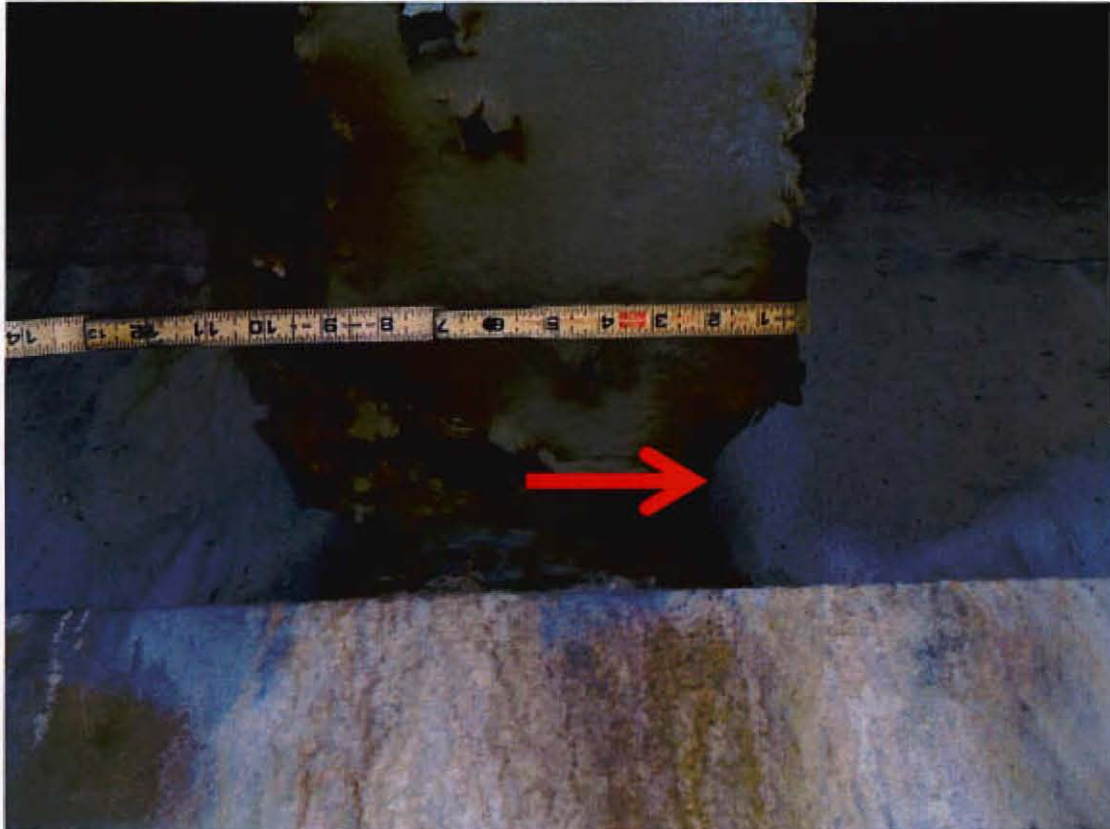
**Girders/Floor Beams/Stringers and/or Beams- Photo 8**

The beams of the approach spans exhibit heavy corrosion, knife edging, section loss, resulting in reduced section near the ends of the beams throughout (Beam 44-2 at Bent 44 shown).

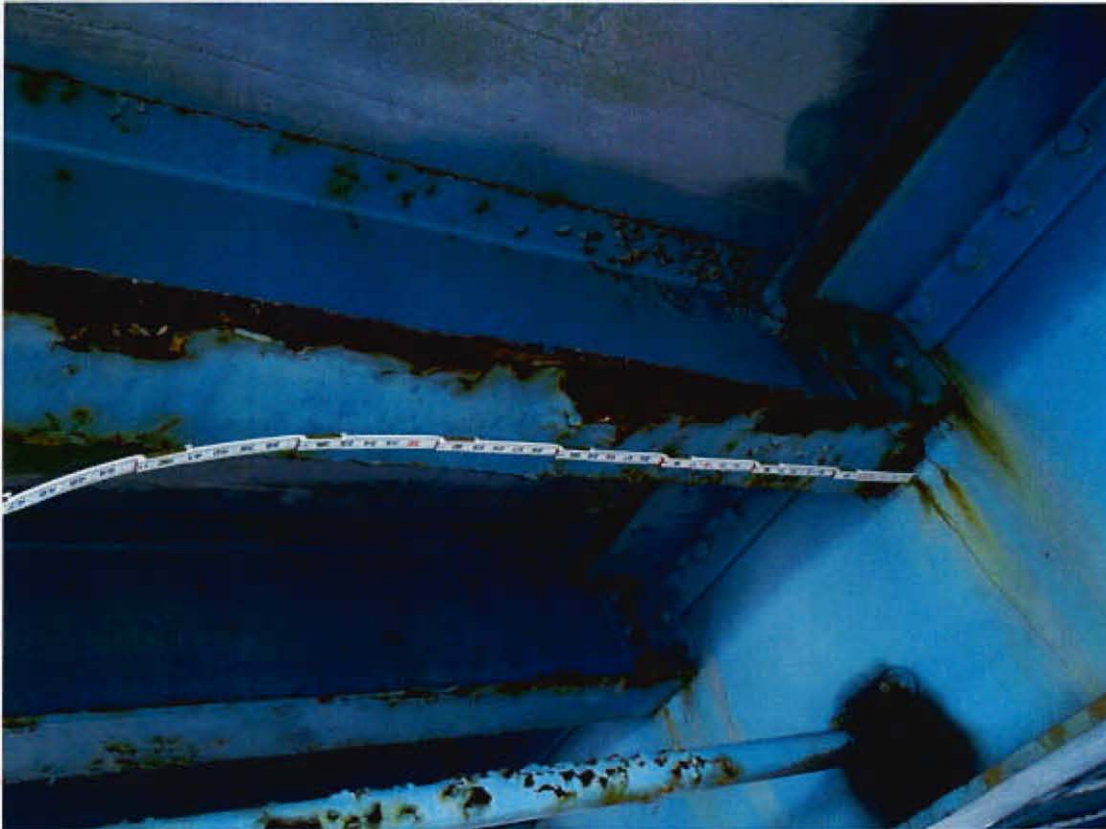
**Girders/Floor Beams/Stringers and/or Beams- Photo 9**

A few stringers of the main span exhibit heavy corrosion and section loss resulting in reduced section near the beam ends. Refer to Photos 9 and 10.

A few stringers of the main span exhibit heavy corrosion and section loss near the beam ends. (bottom flange of Stringer 3 at Floor Beam 2 east face shown).

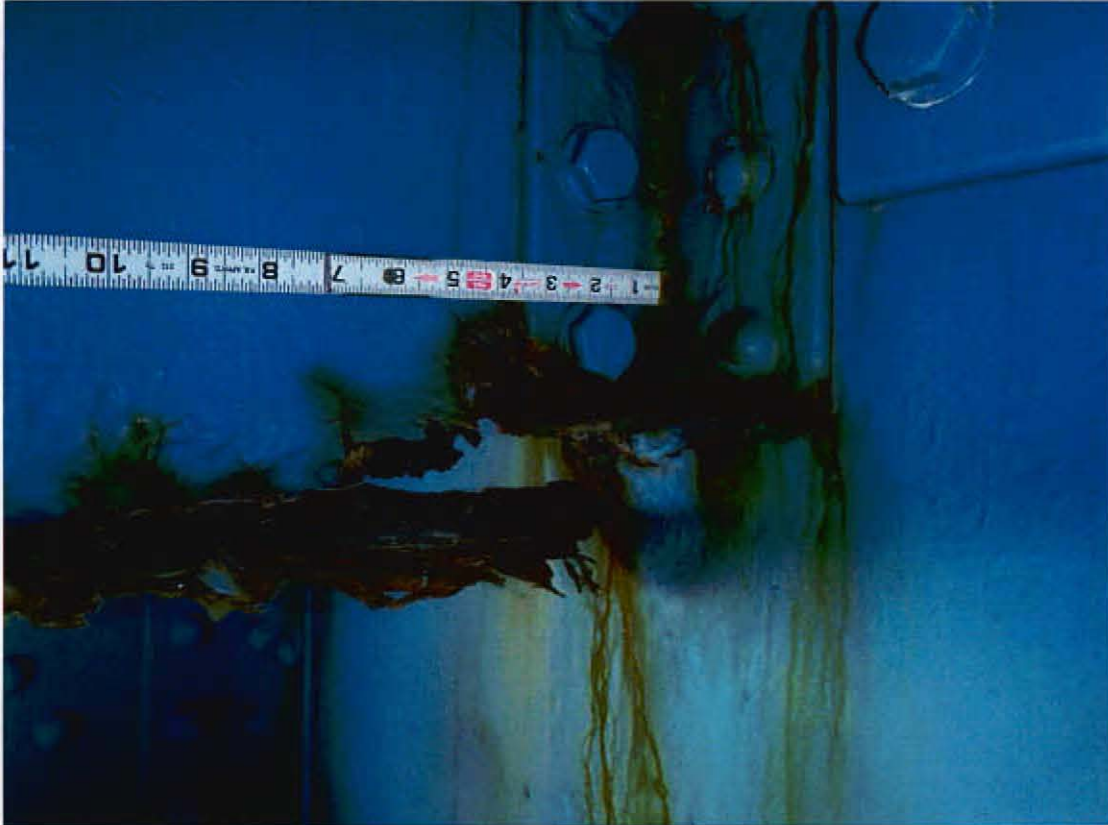
**Girders/Floor Beams/Stringers and/or Beams- Photo 10**

A few stringers of the main span exhibit heavy corrosion and section loss resulting in reduced section near the beam ends. (7 in. x 3 in. section loss in bottom flange of Stringer 46-9 at Floor Beam 46-2 shown).

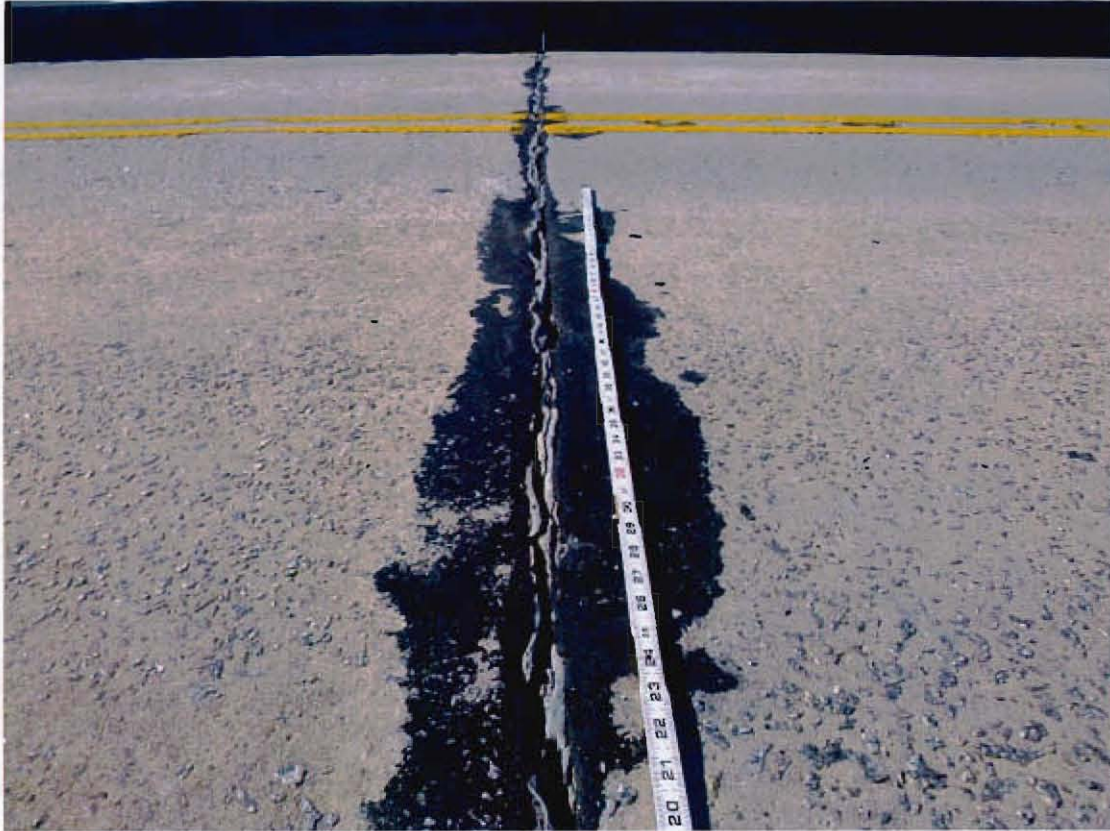
**Expansion Joints- Photo 11**

[4] POOR – Pourable joint sealant exhibits significant adhesion loss and missing sections of joint sealant at all bents. Refer to Photo 11.

Pourable joint sealant exhibits significant adhesion loss and missing sections of joint sealant at all bents (Bent 39 shown).

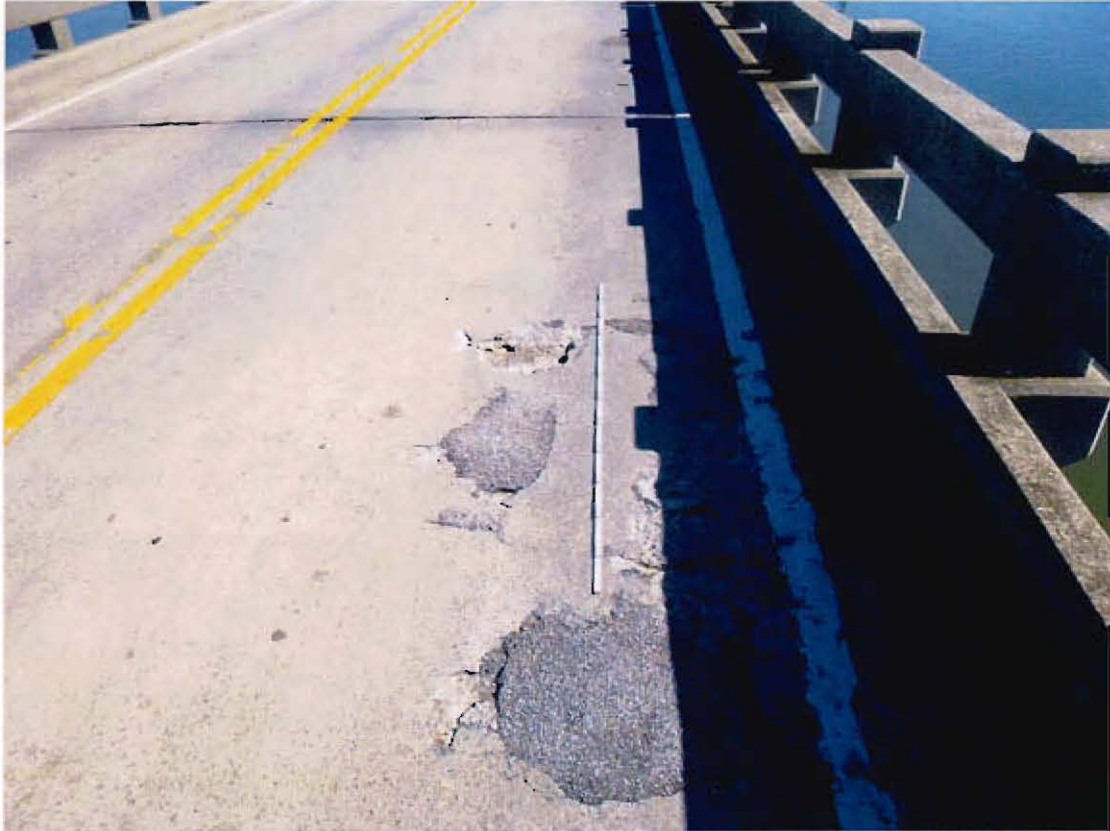
**Decks and/or Slabs- Photo 12**

[5] Fair – Spans 9 and 31 exhibit failed patches and spalls with exposed steel to 1 ft. dia. x 2 in. deep in Lane 2. Refer to Photo 12.

Spans 9 and 31 exhibit failed patches and spalls some with exposed steel to 1 ft. dia. x 2 in. deep in Lane 2 (Span 9 shown).

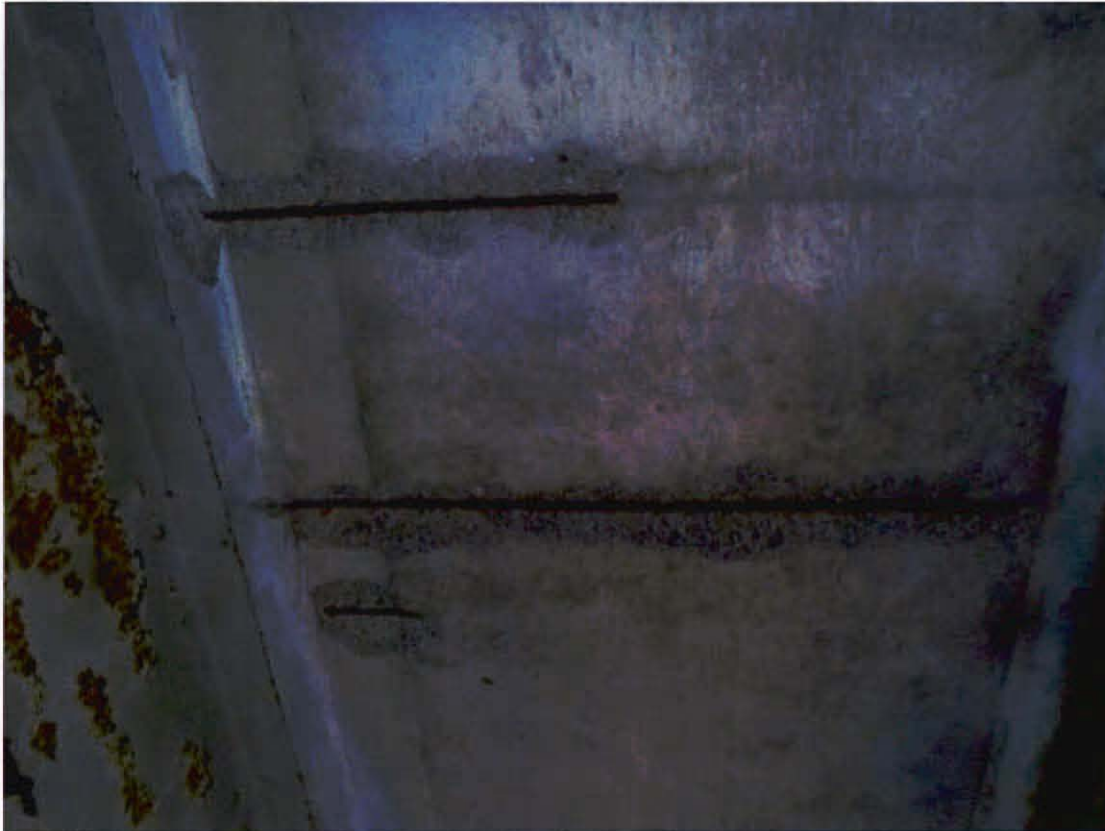
**Decks and/or Slabs- Photo 13**

The deck underside exhibits delaminations and spalls with exposed steel throughout the approach spans. Refer to Photo 13.

The deck underside exhibits delaminations and spalls some with exposed steel throughout the approach spans (Bay 50-3, 4 ft. area x 4 ft. long x 1-1/2 in. deep with exposed steel near mid-span shown).

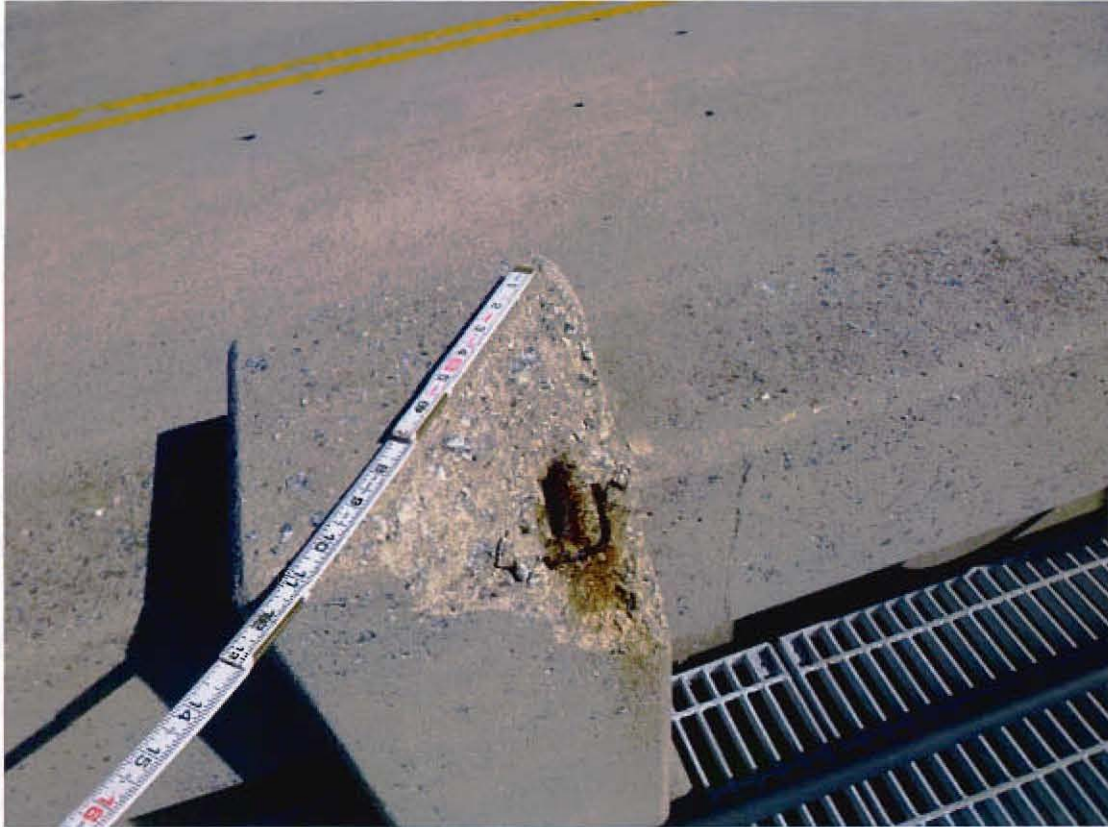
**Bridge Railing/Parapets and/or Median Barriers- Photo 14**

[6] SAT – Most bridge rail posts exhibits spalls to 9 in. x 8 in. x 4 in. with exposed steel primarily at the base. Refer to Photo 14.

Most bridge rail posts exhibit spalls to 9 in. x 8 in. x 4 in. with exposed steel primarily at the base (Post 58-6 right shown).

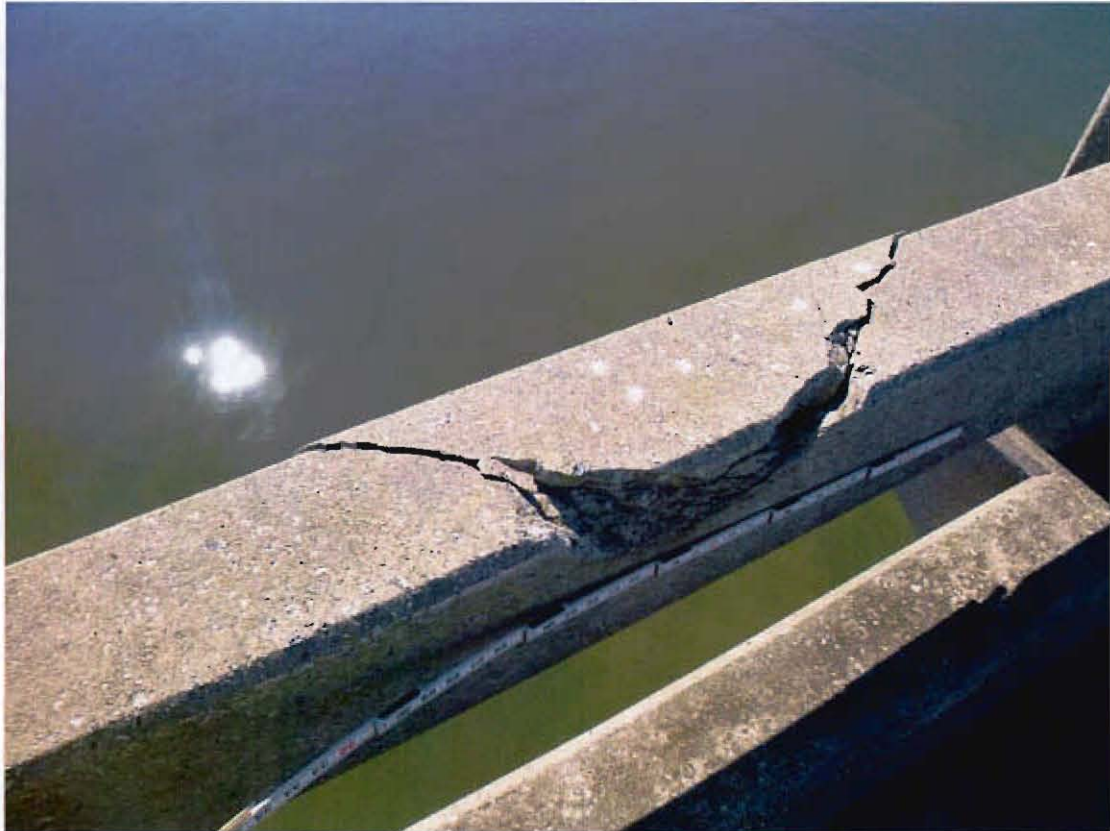
**Bridge Railing/Parapets and/or Median Barriers- Photo 15**

The bridge railing exhibits isolated areas of impact damage and spalls with exposed steel to 32 in. x full width x 2 in. deep. Refer to Photo 15.

The bridge railing exhibits isolated areas of impact damage and spalls with exposed steel to 32 in. x full width x 2 in. (Span 31 right rail, 2 ft. east of Bent 31 shown).

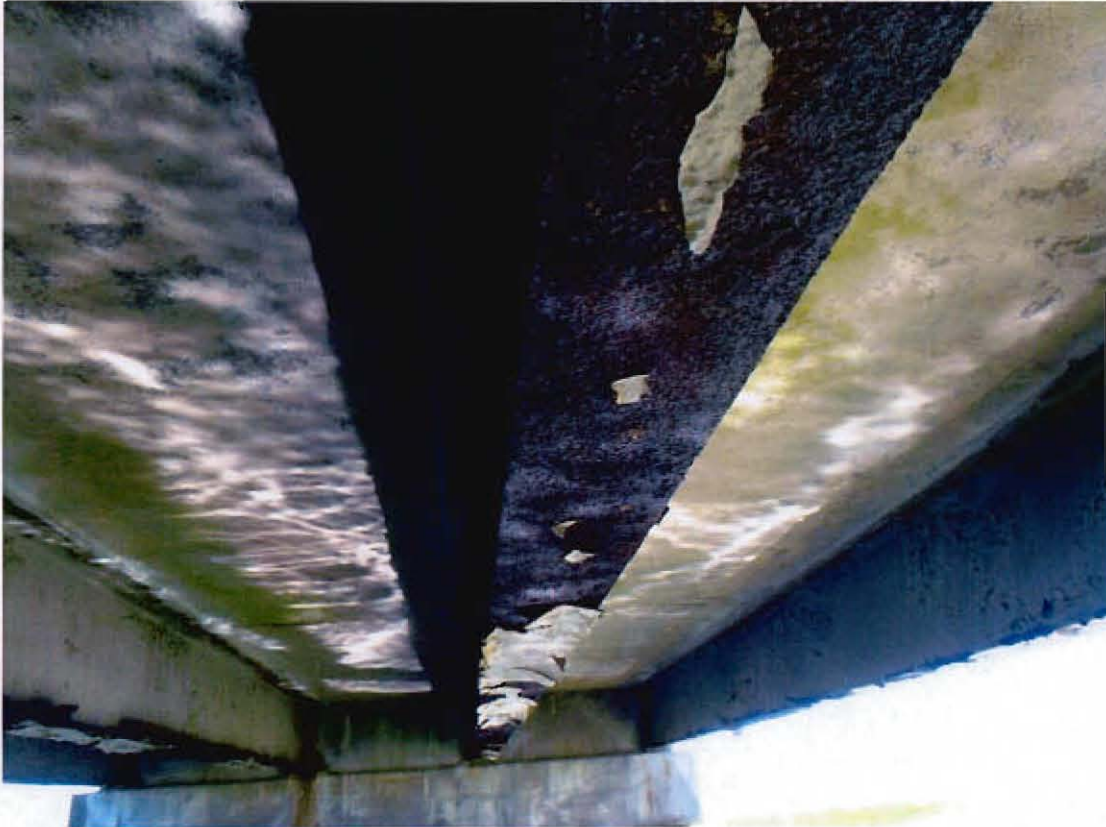
**Paint Systems- Photo 16**

[4] Poor – The beams of the approach spans exhibit heavy corrosion throughout. Refer to Photo 16.

Typical condition of the paint system of the approach spans steel beams (Beam 16-3 shown).

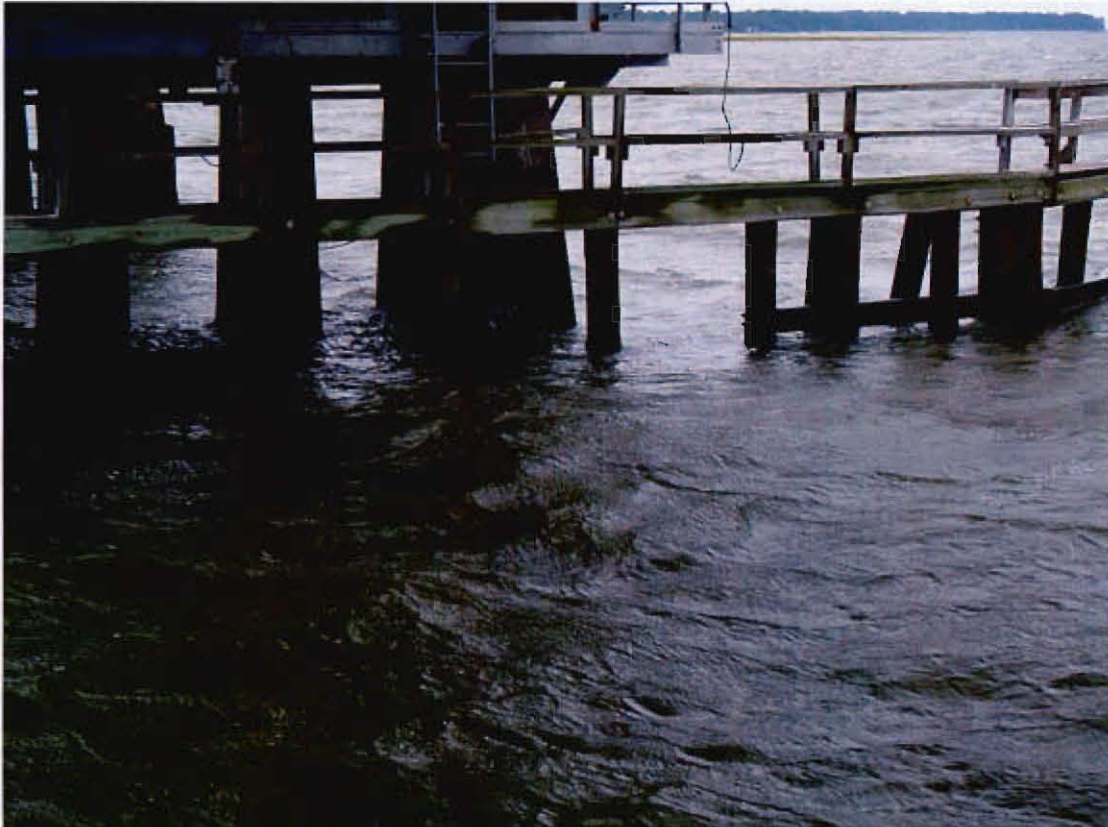
**Fender System- Photo 17**

[4] POOR – There are missing wales throughout, heavy corrosion on connecting hardware, overall loose connections, resulting in the west and east fenders being extremely unstable. Refer to Photo 17.

There are missing wales throughout, heavy corrosion on connecting hardware, overall loose connections, resulting in the west and east fenders being extremely unstable (west fender shown).
