LEAD-BASED PAINT INVESTIGATION REPORT

S-86 (ROCK HOUSE RD.) RBO KINGS CREEK
CHEROKEE COUNTY, SOUTH CAROLINA

June 17, 2022

FME Project No.: G6655.005

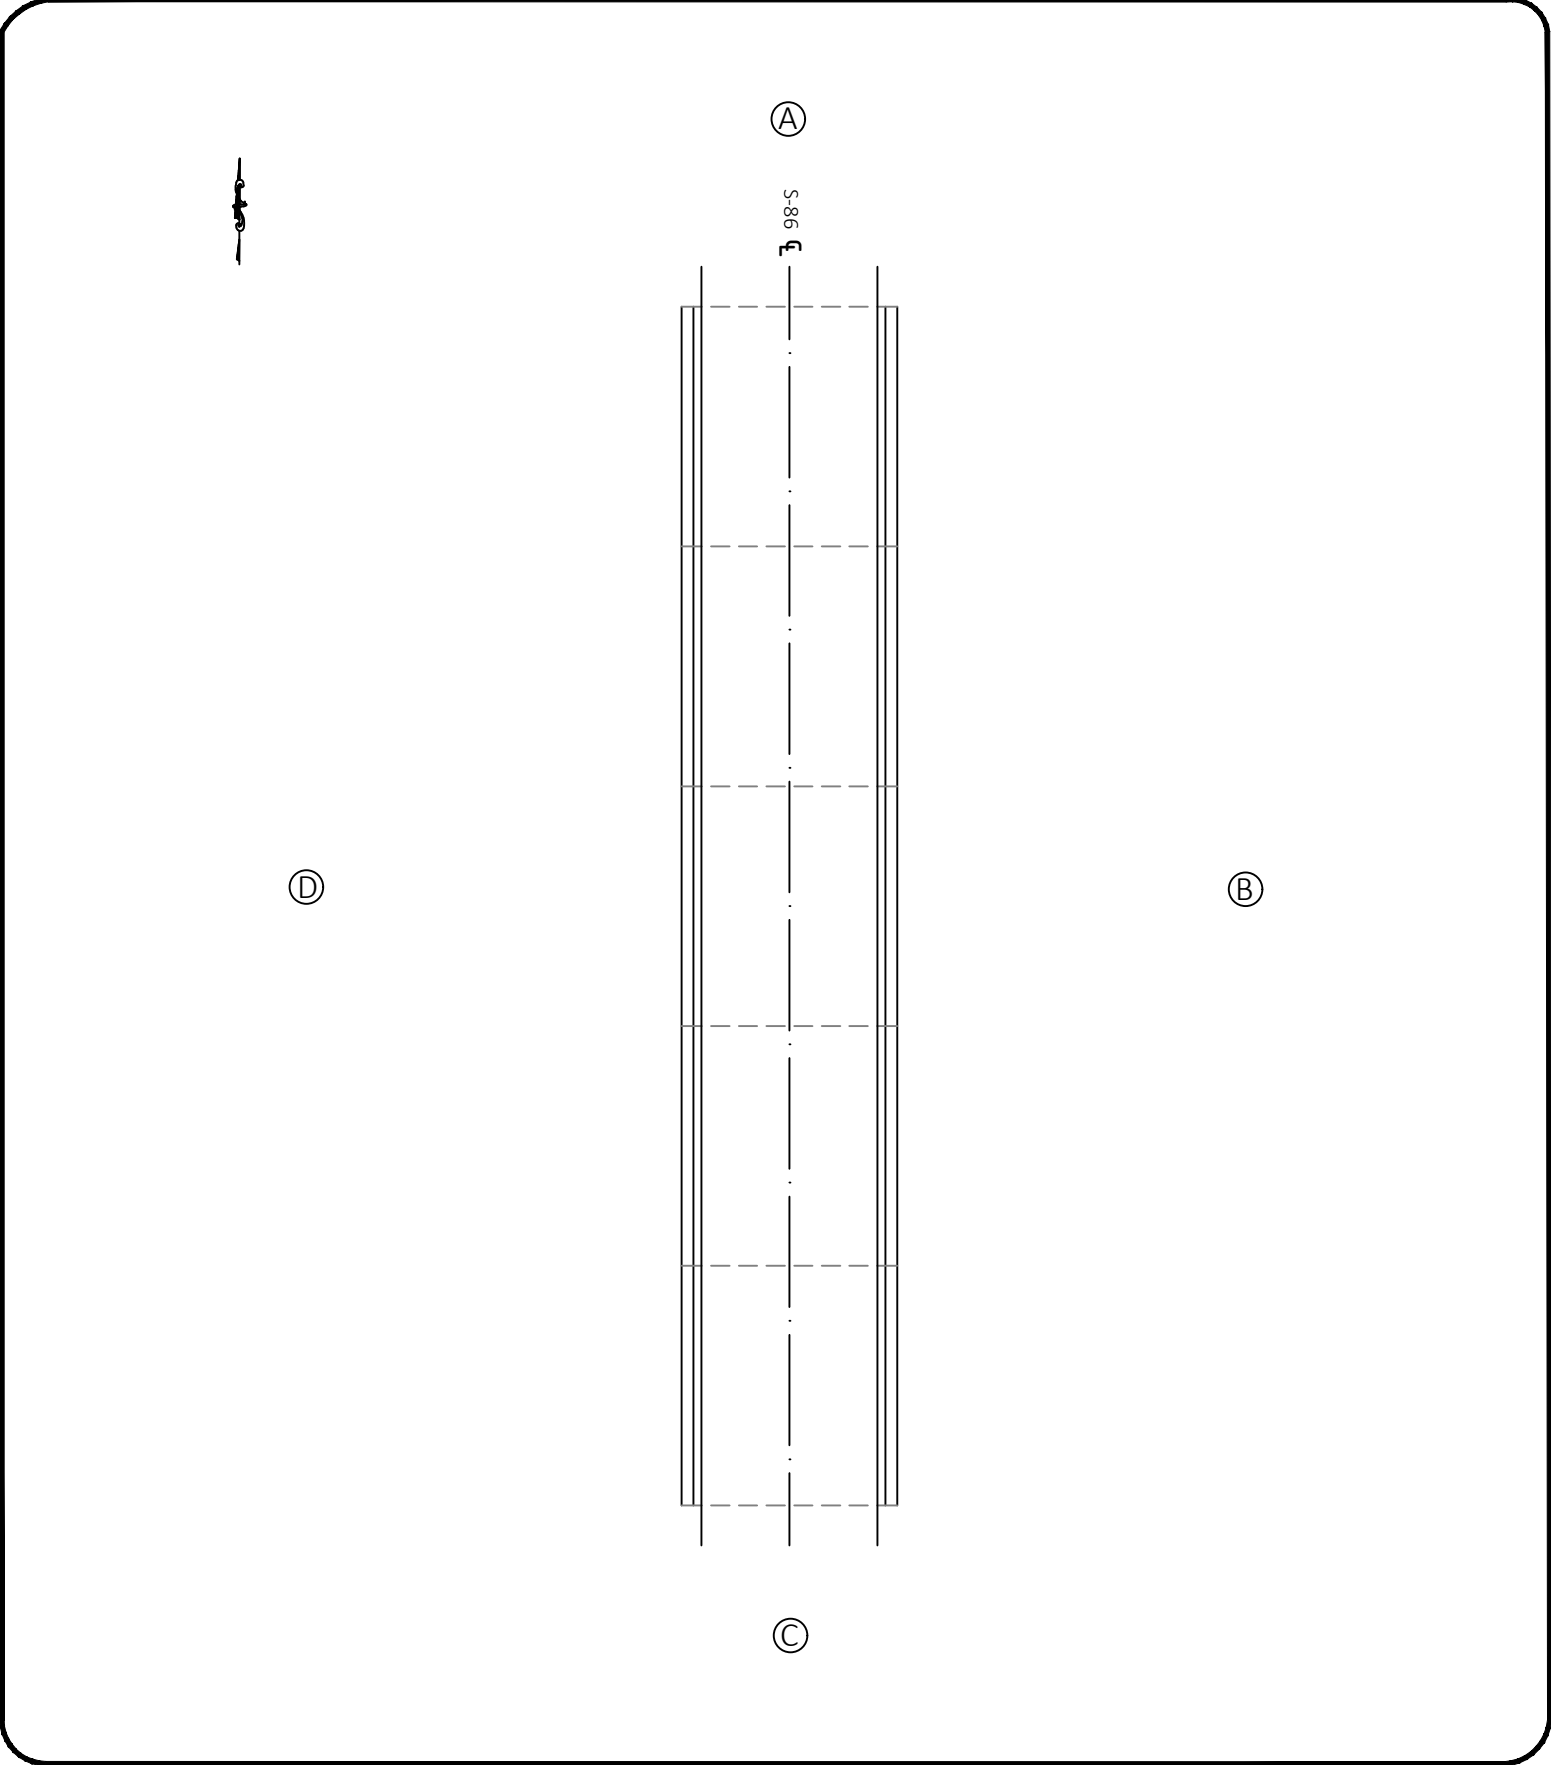
General Bridge Plans

attached to the concrete curb on each side of the Bridge. See Appendix A – Site Vicinity Map, for the location of the structure. See Appendix B –General Bridge Plan, for a layout of the Bridge.
