LEAD-BASED PAINT INVESTIGATION REPORT

S-106 (ISLAND CREEK RD.) RBO SUCK CREEK
CHEROKEE COUNTY, SOUTH CAROLINA

June 13, 2022

FME Project No.: G6655.002

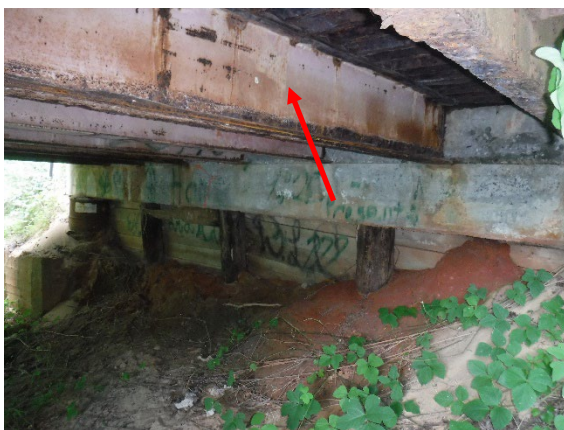
The results from the XRF quantitative testing of Bridge components scanned indicate that lead was found to be present in paint and/or coatings in concentrations greater than or equal to (\geq) 0.7 mg/cm² in the following Bridge components:

- Orange Steel Beams
- Orange Cross Braces

Photo 5. LBP on Orange Beams.

Therefore, OSHA regulations and procedures should be followed when impacting these components. If possible, they should be removed in whole and disposed of properly. Also, SCDHEC disposal requirements for lead containing materials should also be followed.

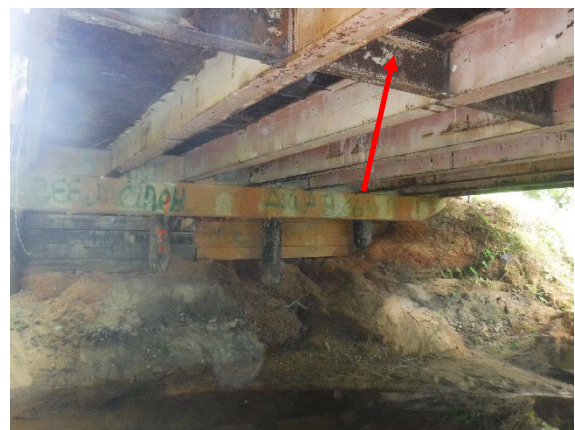
Photo 6 LBP on Orange Cross Braces.
