## LEAD-BASED PAINT INVESTIGATION REPORT

SC 215 (BUFFALO WEST SPRINGS HWY.) BRIDGE  
OVER FAIRFOREST CREEK  
SCDOT BRIDGE #444021500300  
UNION COUNTY, SOUTH CAROLINA

**February 24, 2023**

FME Project No.: G6658.006

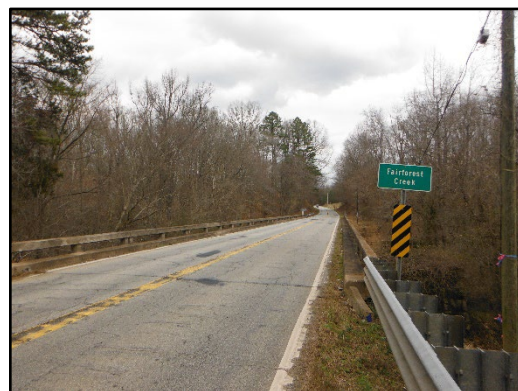
Photo 1: SC 215 (Buffalo West Springs Hwy.) Bridge over Fairforest Creek in Union County, South Carolina

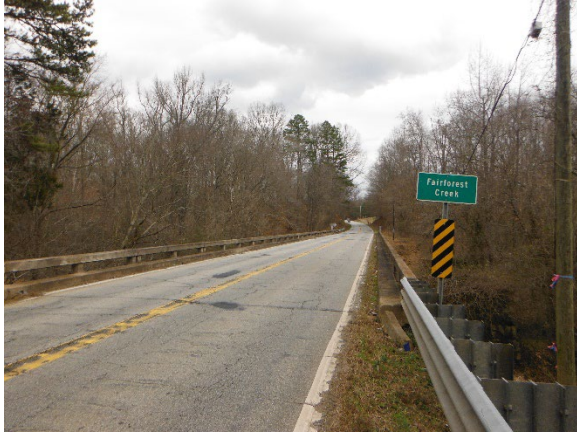
**Photo 1.** Top View of Bridge Deck.

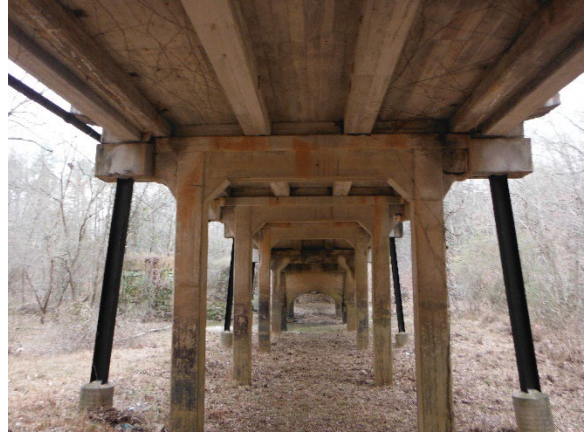
**Photo 2.** Underside View of Bridge.

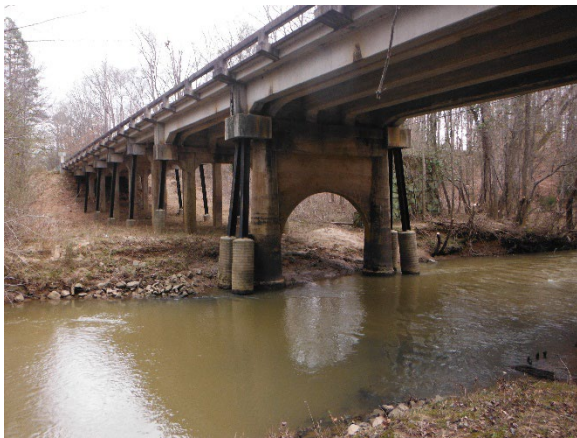
**Photo 3.** Northwest Side View of Bridge.

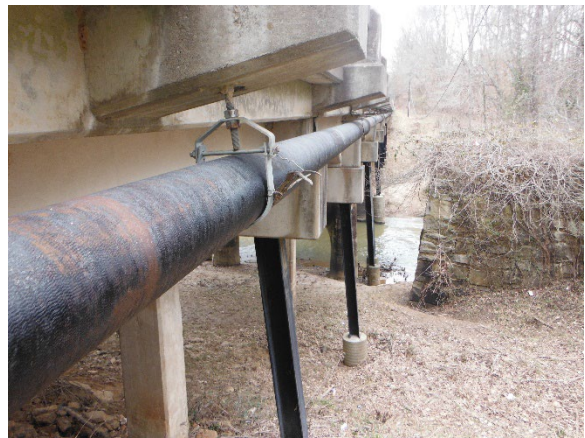
**Photo 4.** Southeast Side View of Bridge.

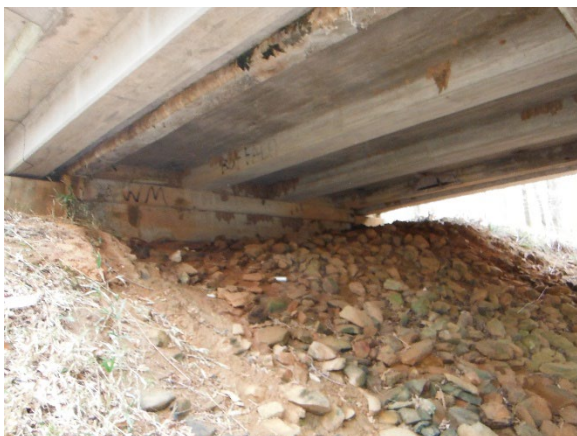
**Photo 5.** View of Bridge End Bent.

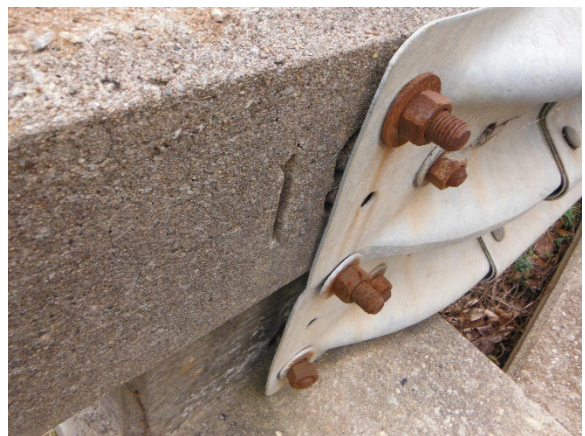
**Photo 6.** View of Bridge's date of construction covered over by bridge's guardrail.
