LEAD-BASED PAINT INVESTIGATION REPORT

SC - 72 (CARLISLE CHESTR HWY.) BRIDGE OVER COX CREEK
SCDOT BRIDGE #444007200400
UNION COUNTY, SOUTH CAROLINA

February 22, 2023

FME Project No.: G6658.001

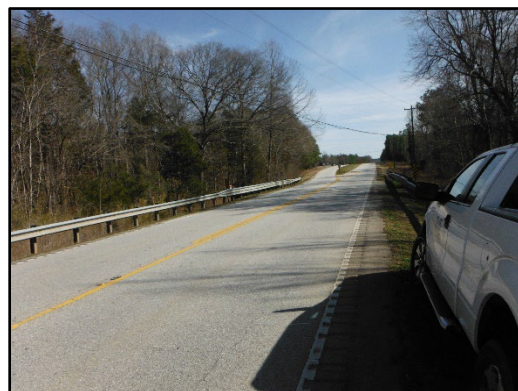
Photo 1: SC-72 (Carlisle Chester Hwy.) Bridge over Cox Creek in Union County, South Carolina

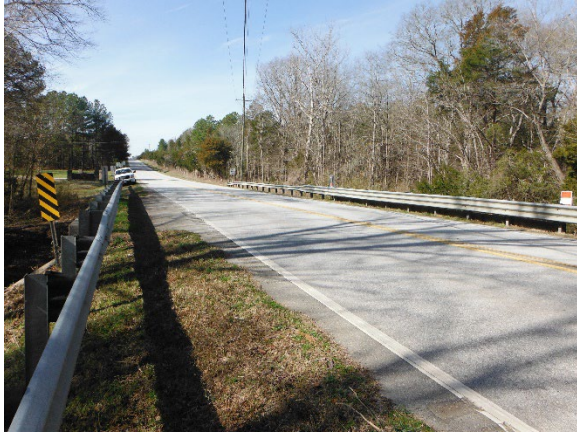
Photo 1. Top View of Bridge Deck.

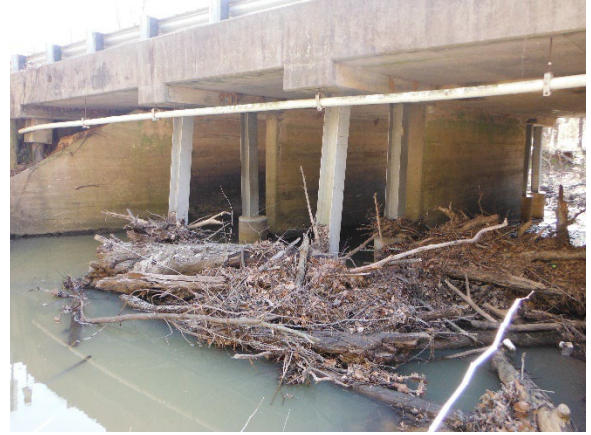
Photo 2. Underside View of Bridge.

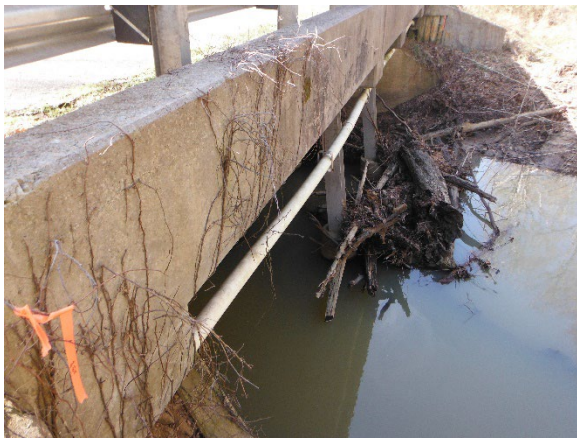
Photo 3. North Side View of Bridge.

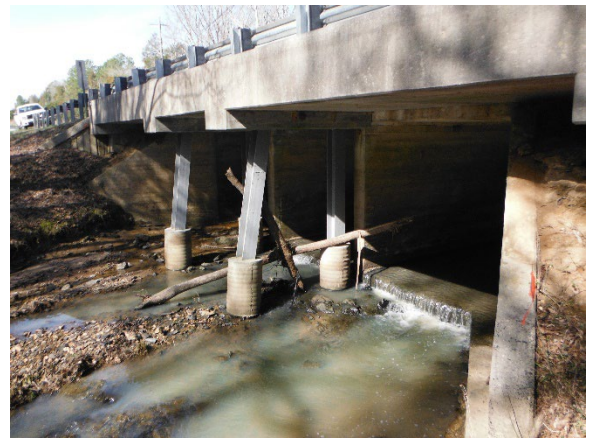
Photo 4. South Side View of Bridge.

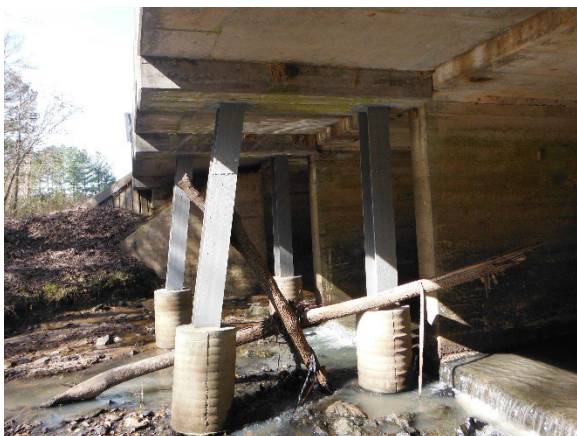
Photo 5. New Bridge Addition Underside View.

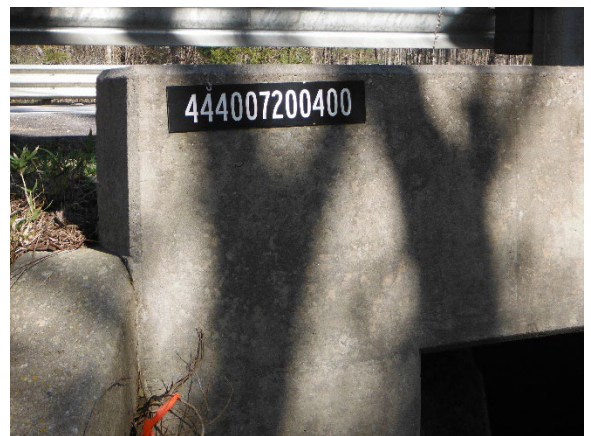
Photo 6. SCDOT Bridge Number Placard Attached to the Concrete Guardrail.
