ASBESTOS CONTAINING MATERIAL INVESTIGATION REPORT

SC 114 (BOBBY FAUCETTE RD.) BRIDGE OVER
SANDY RUN CREEK
SCDOT BRIDGE # 444011400100
UNION COUNTY, SOUTH CAROLINA

February 24, 2023

F&ME Project No.: G6658.005

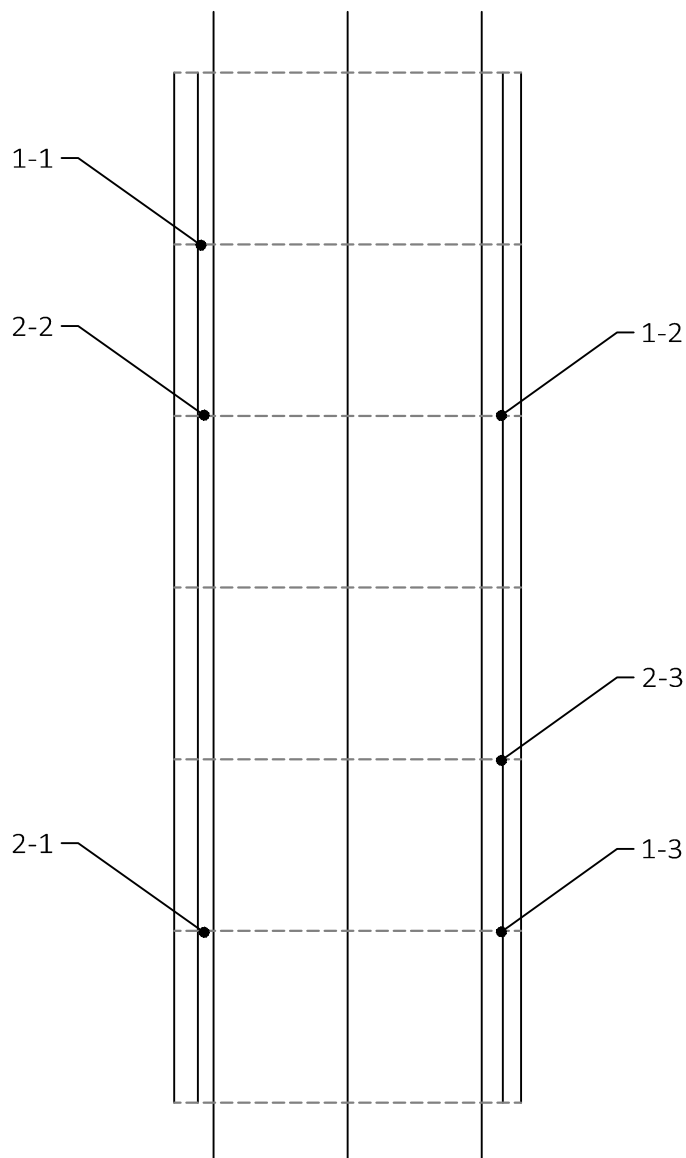
2

The suspect materials noted on the Bridge were timber pile cap felt and utilized along with timbers to make structural repairs. Samples of these materials were taken from random locations on the Bridge. See Appendix B – Sample Location Plan, for detailed sample locations. Also, see Appendix G – Site Photographs, for more details.
