LEAD-BASED PAINT INVESTIGATION REPORT

SC-49 (CROSS KEYS HWY.) RBO FAIRFOREST CREEK
SCDOT BRIDGE #444004900200
UNION COUNTY, SOUTH CAROLINA

February 24, 2024

FME Project No.: G6658.003

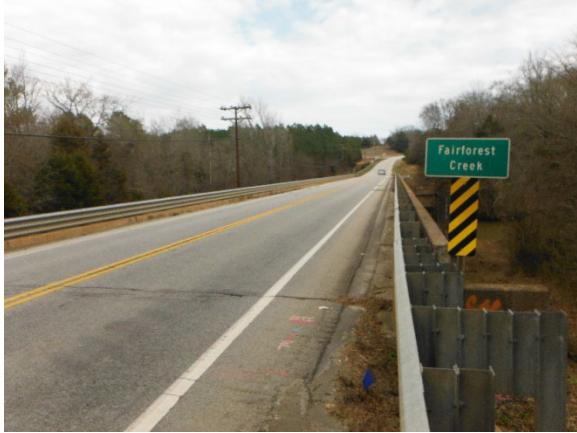
Photo 1. Top View of Bridge Deck.

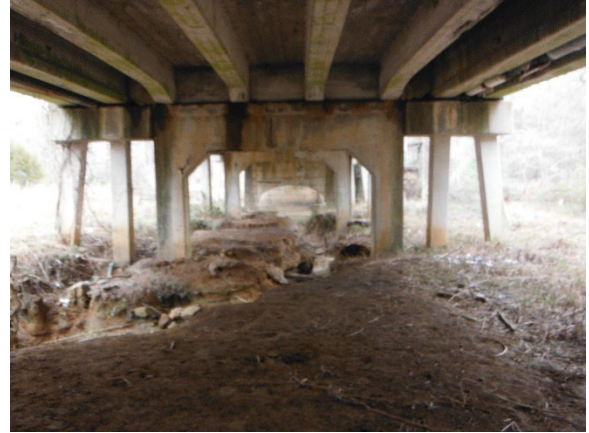
Photo 2. Underside View of Bridge with view of additions on each side of Bridge.

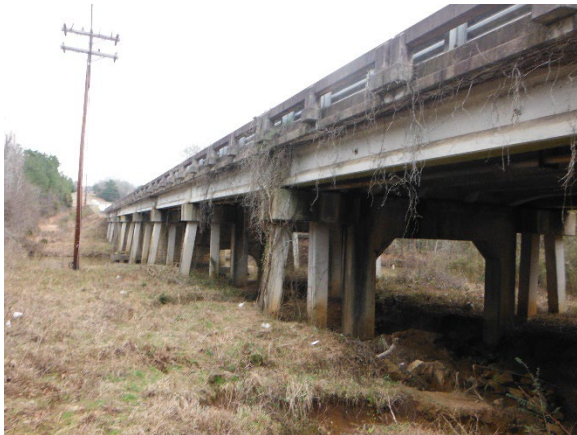
Photo 3. North Side View of Bridge.

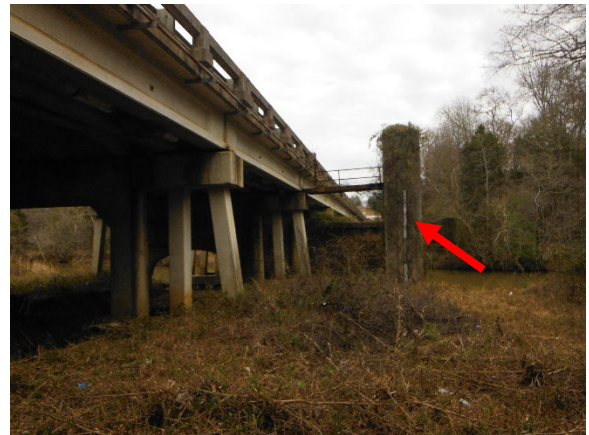
Photo 4. South Side View of Bridge with view of USGS water level monitoring structure.

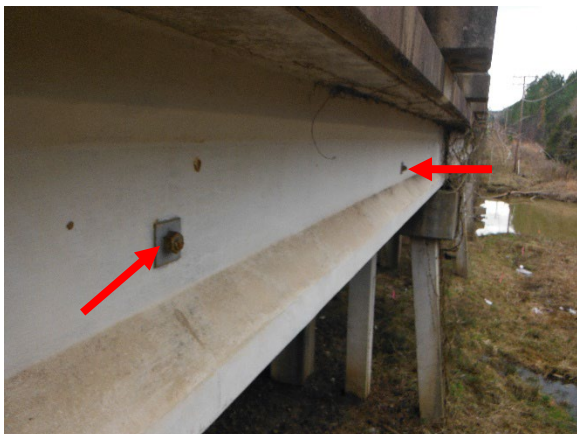
Photo 5. LBP on Bridge Tie-Rod Washers.

Therefore, OSHA regulations and procedures should be followed when impacting these components. If possible, they should be removed in whole and disposed of properly. Also, SCDHEC disposal requirements for lead containing materials should also be followed.

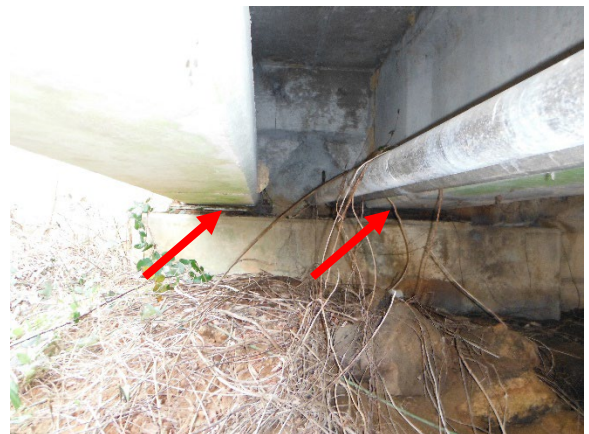
Photo 6. LBP on Bridge Beam Bearing Plates.
