ASBESTOS CONTAINING MATERIAL INVESTIGATION REPORT

SC 215 (BUFFALO WEST SPRINGS HWY.) BRIDGE
OVER FAIRFOREST CREEK
SCDOT BRIDGE # 444021500300
UNION COUNTY, SOUTH CAROLINA

February 24, 2023

F&ME Project No.: G6658.006

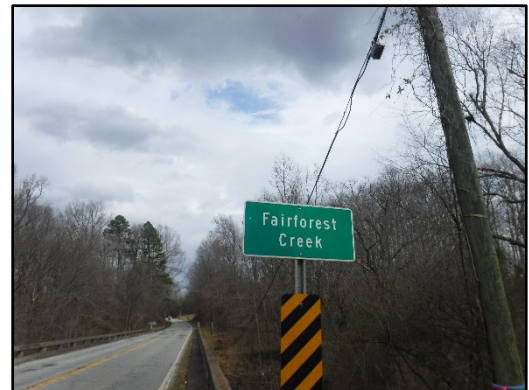
Photo 1: SC 215 (Buffalo West Springs Rd.) over Fairforest Creek in Union County, South Carolina

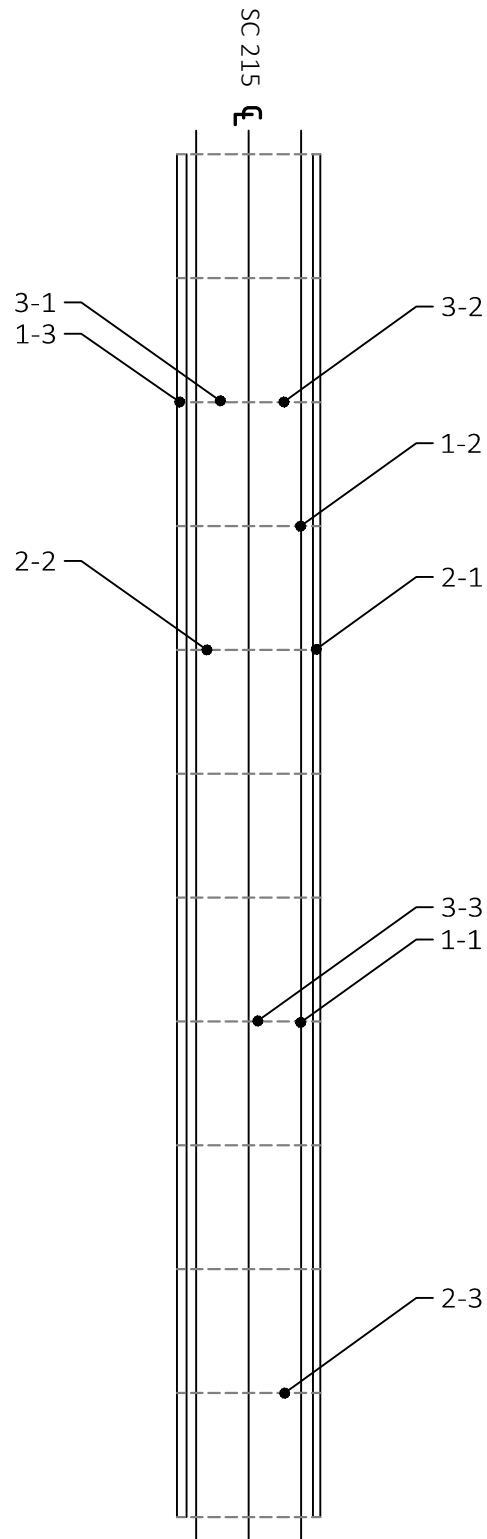
2

During the investigation, all accessible bridge components (i.e., bent caps, H-piles, scuppers, expansion joints, etc.) were visually inspected for suspect ACM. Examples of possible suspect materials include bond break bearing pads, expansion joint material, and drainage scuppers. The concrete bridge deck rested directly on the horizontal concrete beams. The concrete bent caps were supported by concrete piers at each bent with no suspect materials noted. Three (3) suspect materials were observed/visible on the Bridge. The suspect materials noted on the Bridge were expansion joint material, a black coating on steel columns and a black coating on concrete columns. Samples of these materials were taken from random locations on the Bridge. See Appendix B – Sample Location Plan, for detailed sample locations. Also, see Appendix G – Site Photographs, for more details.

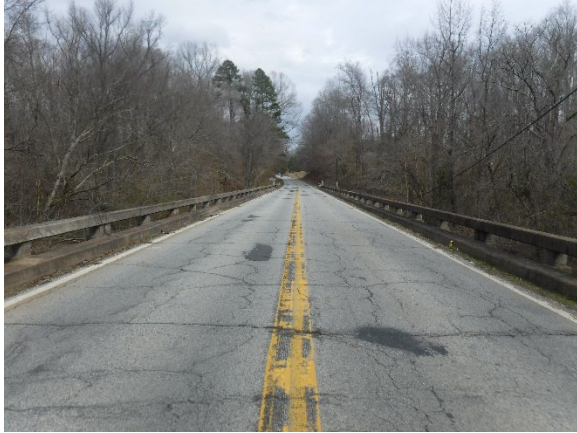
Photo 1. Top View of Bridge Deck.

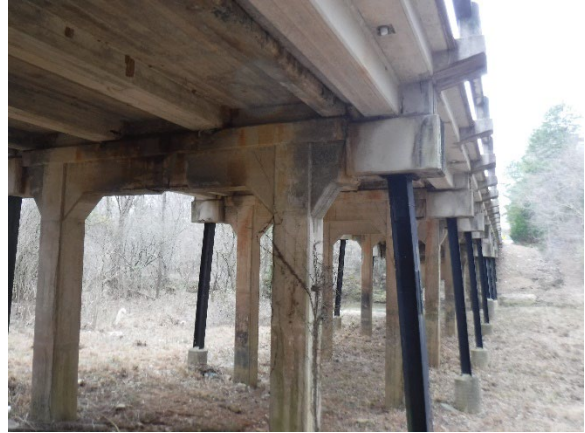
Photo 2. Underside View of Bridge.

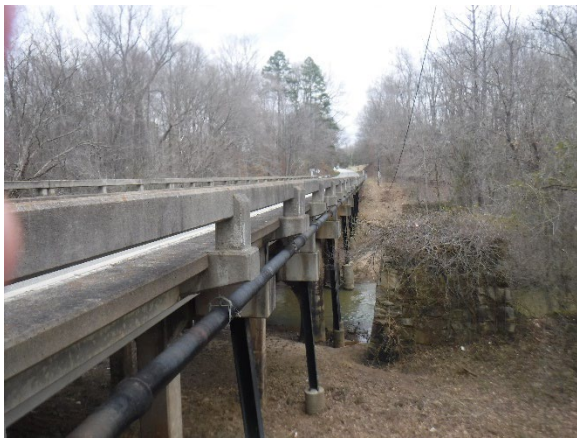
Photo 3. Southeast Side View of Bridge.

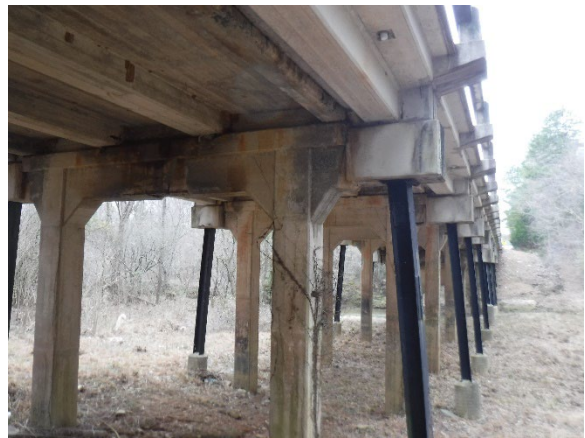
Photo 4. Northwest Side View of Bridge.

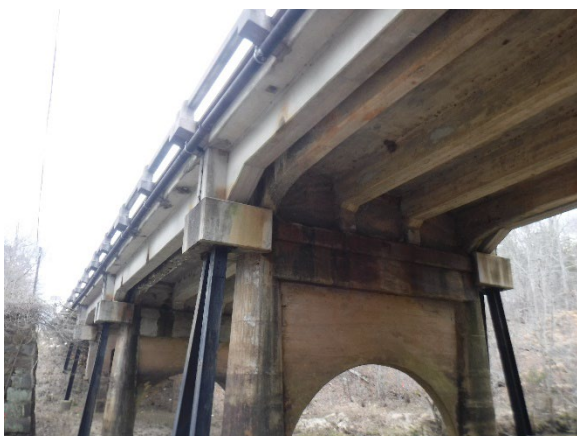
Photo 5. New Bridge Addition Underside View.

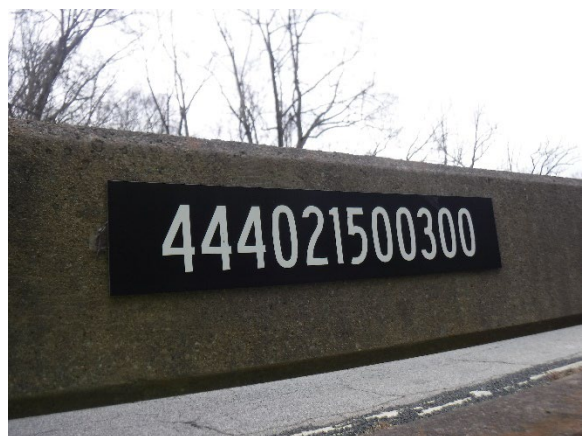
Photo 6. SCDOT Bridge Number Placard Attached to the Concrete Guardrail.
