LEAD-BASED PAINT INVESTIGATION REPORT

SC 114 (BOBBY FAUCETTE RD.) BRIDGE OVER
SANDY RUN CREEK
SCDOT BRIDGE #444011400100
UNION COUNTY, SOUTH CAROLINA

February 24, 2024

FME Project No.: G6658.005

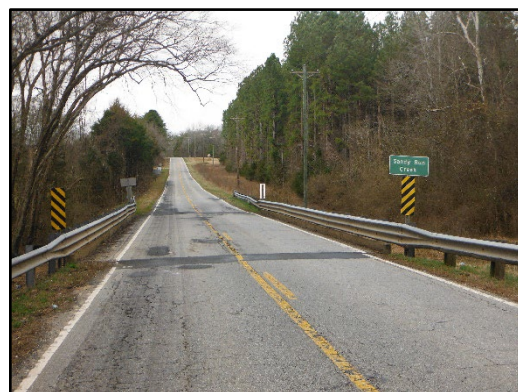
Photo 1: SC 114 (Bobby Faucette Rd.) Bridge over Sandy Run Creek in Union County, South Carolina.

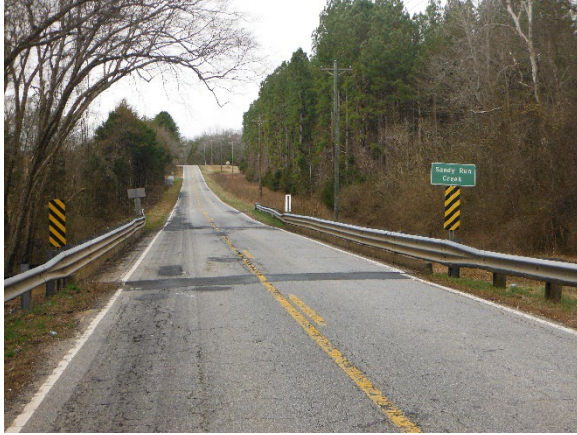
Photo 1. Top view of Bridge.

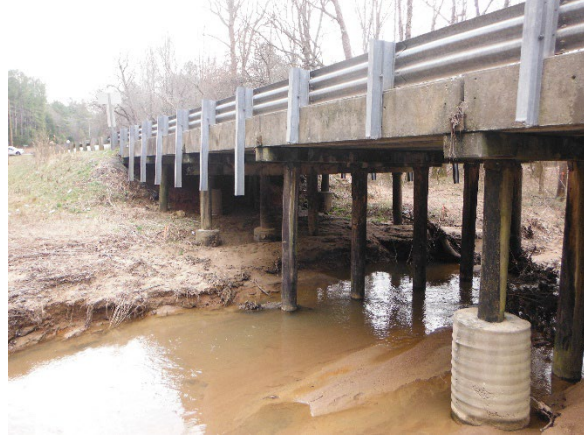
Photo 2. Northwest side view of Bridge

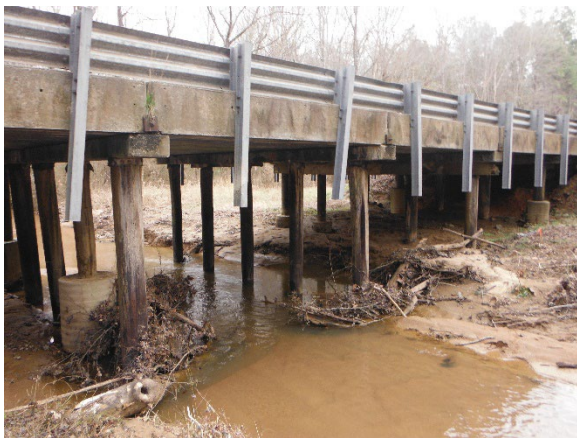
Photo 3. Southeast side view of Bridge.

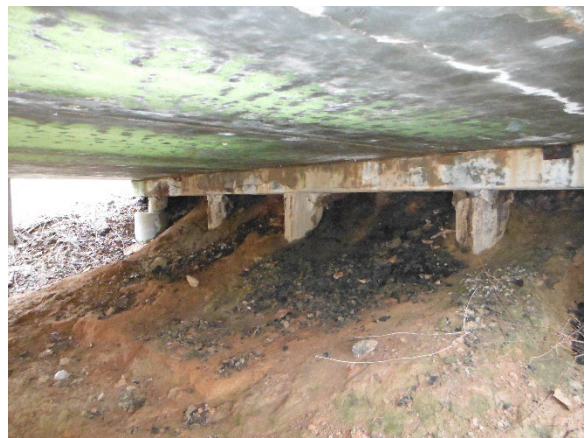
Photo 4. Underside View of Bridge.

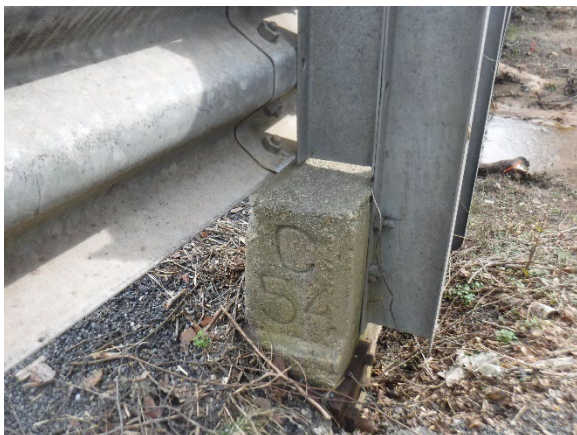
Photo 5. Apparent age of Bridge (1954) according to stamp on end of Bridge.

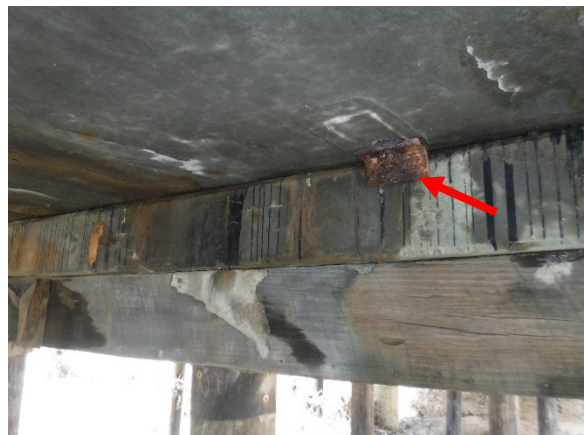
The results from the XRF quantitative testing of the Bridge components indicate that lead is present in paint and/or coatings in concentrations greater than or equal to (\geq) 0.7 mg/cm² in the following Bridge component:

- **Beam to Bent Cap Anchor Brackets**

Photo 6. Positive LBP on bridges deck to bent cap anchor bracket.

Therefore, OSHA regulations and procedures should be followed when impacting these components. If possible, they should be removed in whole and disposed of properly. Also, SCDHEC disposal requirements for lead containing materials should also be followed.
