LEAD-BASED PAINT INVESTIGATION REPORT

SC-49 (CROSS KEYS HWY.) RBO TYGER RIVER
SCDOT BRIDGE #444004900100
UNION COUNTY, SOUTH CAROLINA

February 22, 2023

FME Project No.: G6658.002

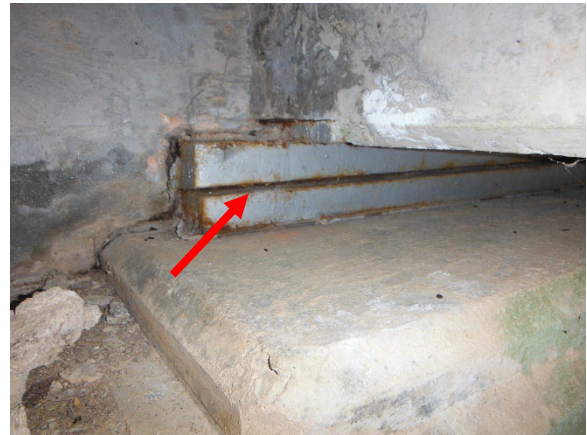
- **Beam Bearing Plates**
- **Tie-Rod Washers**

Photo 4. Steel Bearing Plates Positive for LBP.

Therefore, OSHA regulations and procedures should be followed when impacting these components. If possible, they should be removed in whole and disposed of properly. Also, SCDHEC disposal requirements for lead containing materials should also be followed.

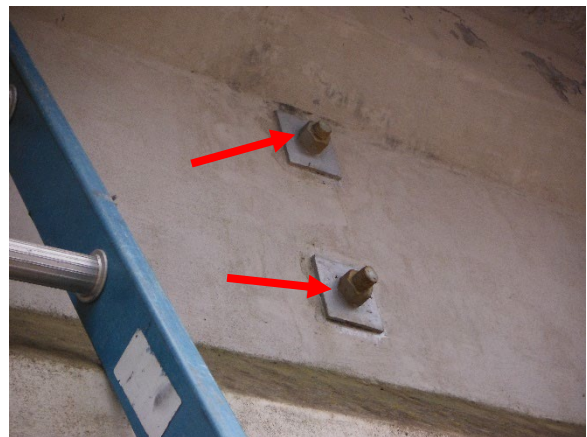
Photo 6. Bridge Tie-Rod Washers Positive for LBP.
