Asbestos & Lead Paint Inspection Report

S-39-32 Bridge over Crow Creek

December 20, 2023 | Report Number: 7323P180

Re: Asbestos & Lead Paint Inspection Report
SCDOT Bridge Package 19
S-39-32 over Crow Creek
Bridge Asset No. 03448
Pickens County, South Carolina
Terracon Project No. 7323P180
SCDOT Project No. P041168
Survey Conducted: November 9, 2023

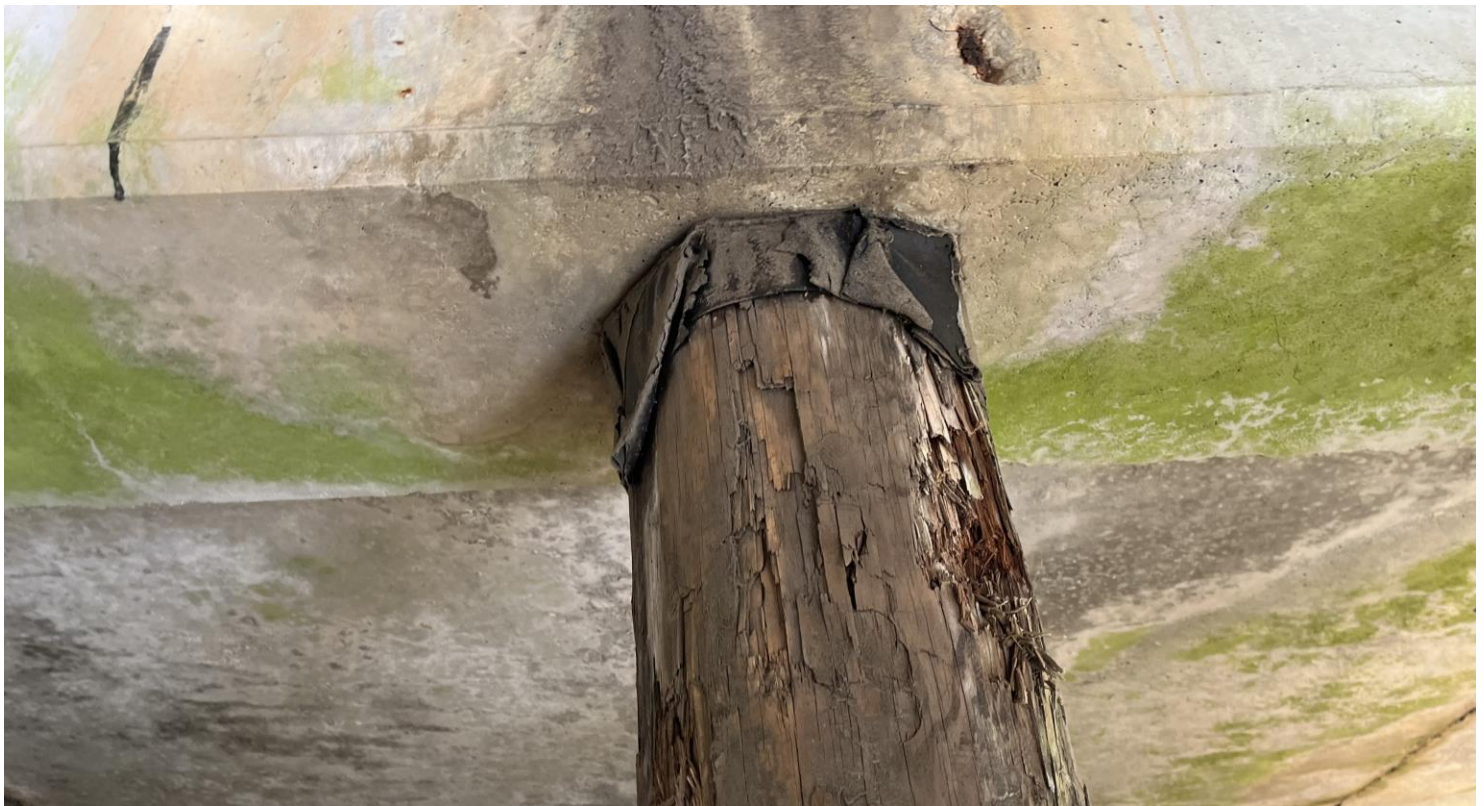
HA	Approx. Quantity* (ft ²)	Samples Collected	Description	Material Location	Lab Result	Category	Condition
1	400 LF	3	Thin felt vibration barrier	Between piers and pier caps	NAD	Misc.	F, Good
2	48 SF	3	Thick shingle vibration dampener	Between pier caps and decking	NAD	Misc.	NF, Good

PHOTO # 4 View of HA #1 thin felt vibration dampener.

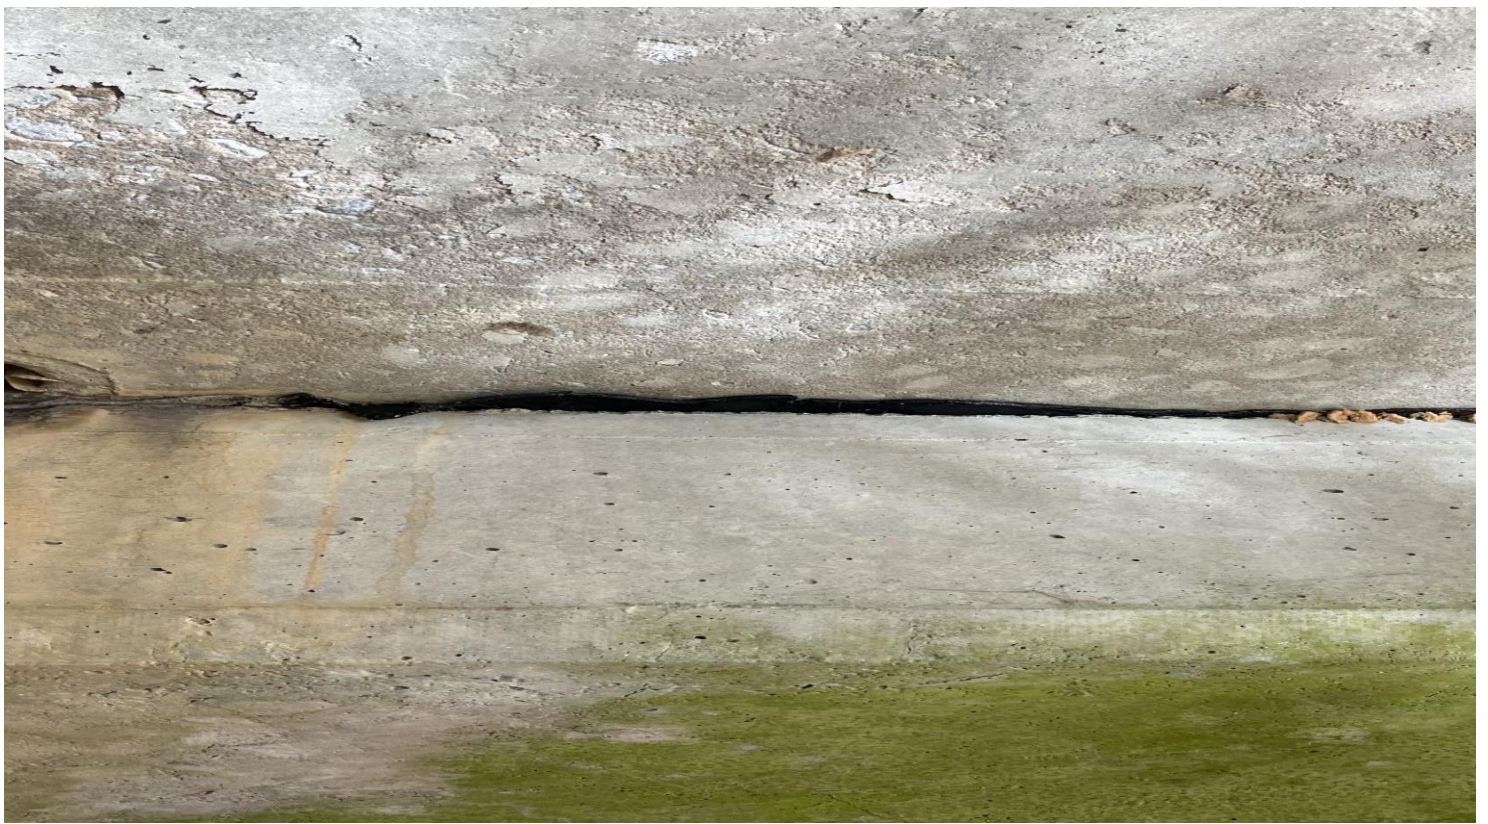
PHOTO # 5 View of HA #2 Thick shingle vibration dampener.

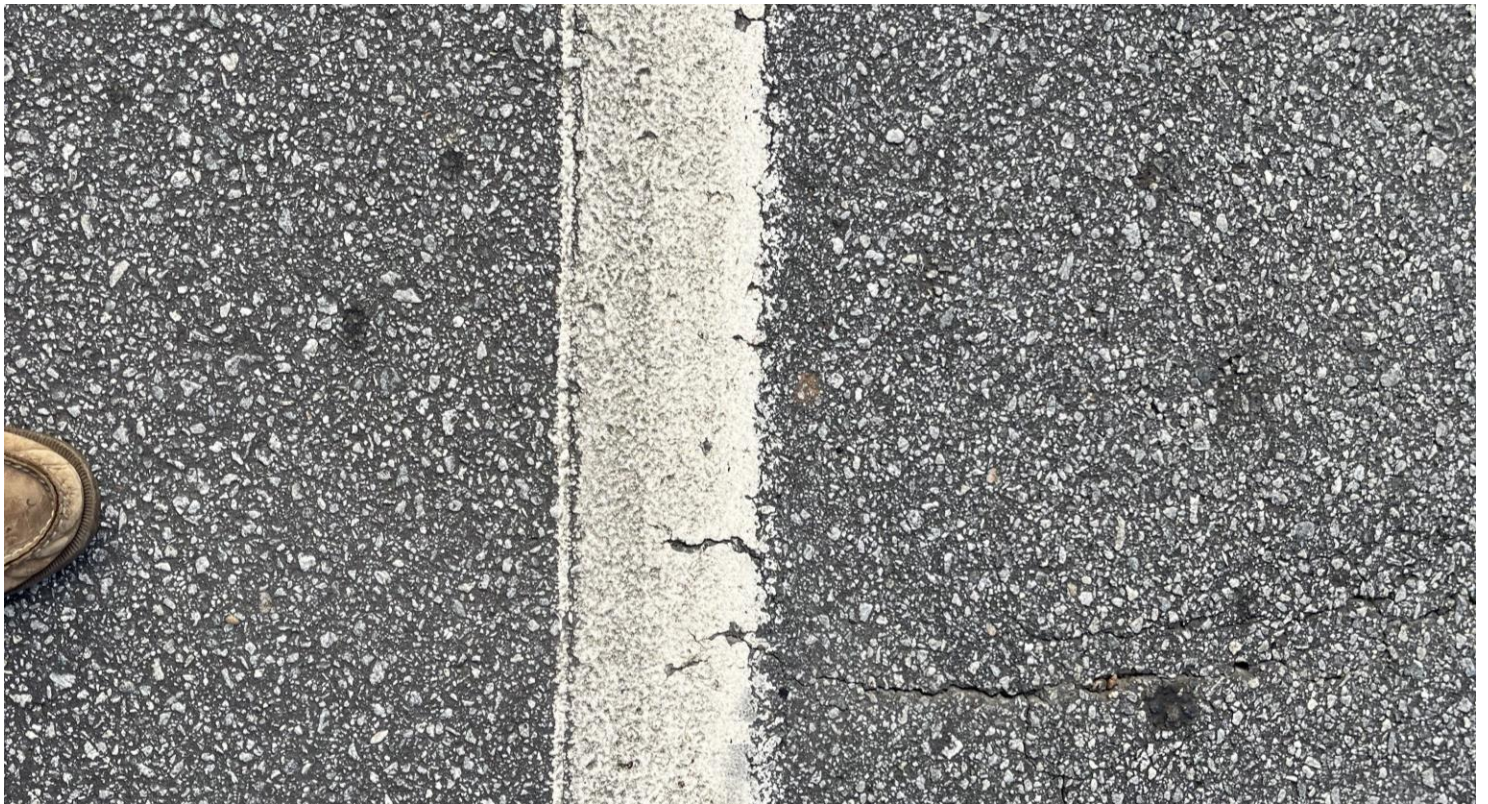
PHOTO # 6 View of LP-1 white stripe paint.

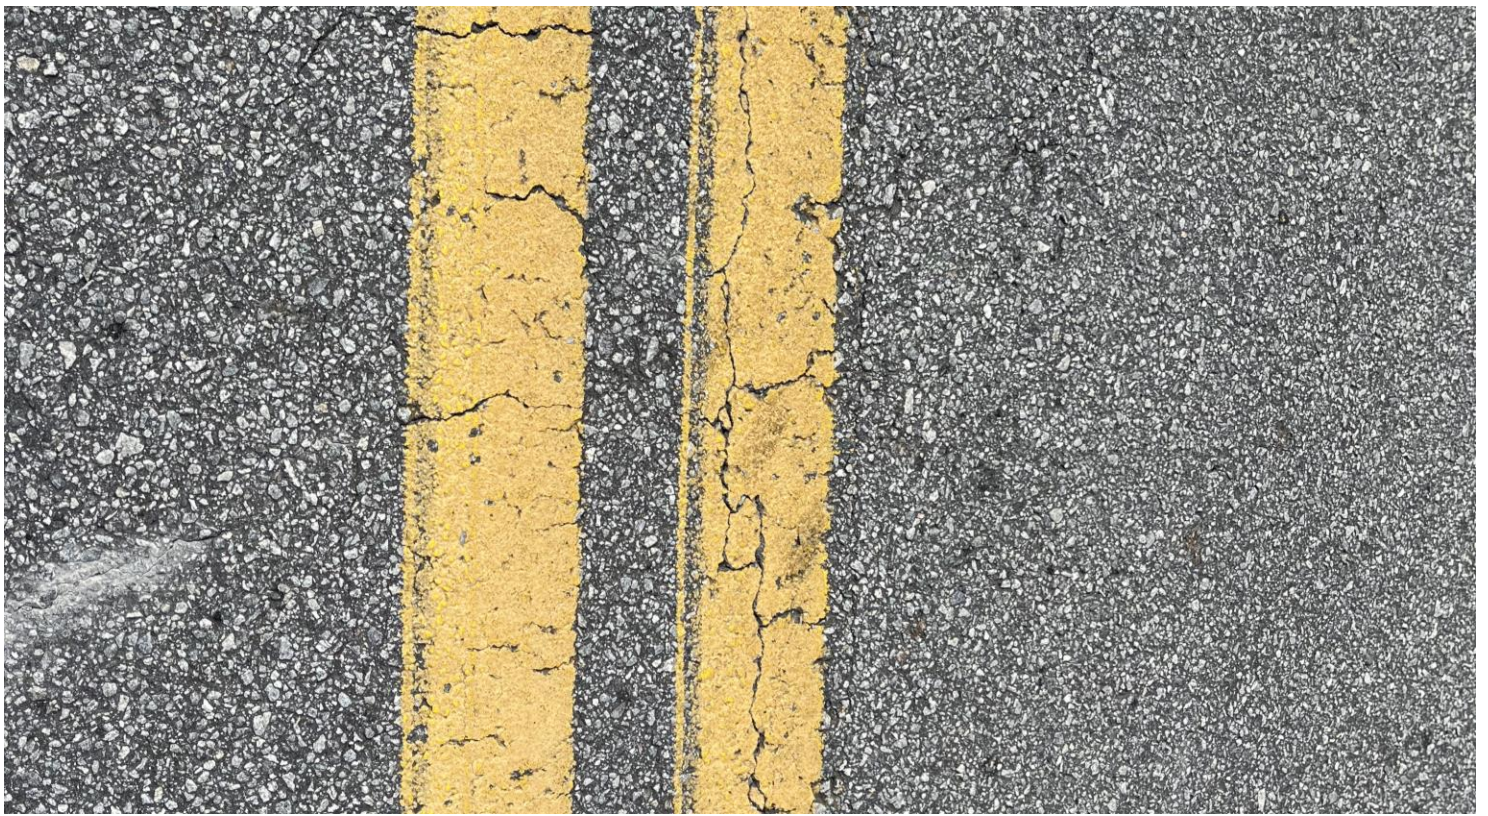
PHOTO # 7 View of LP-2 yellow stripe paint.

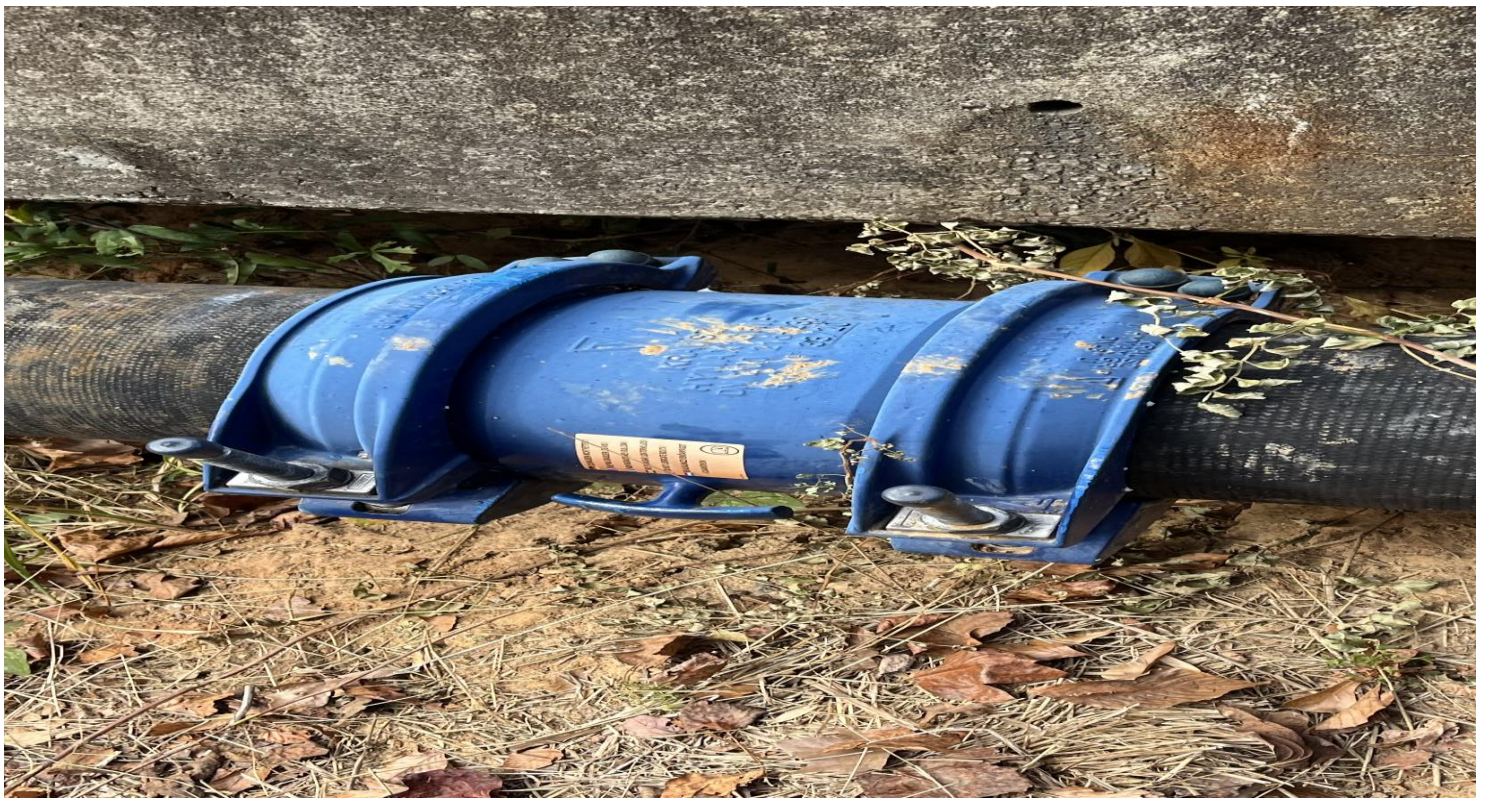
PHOTO # 8 View of LP-3 Blue union paint.

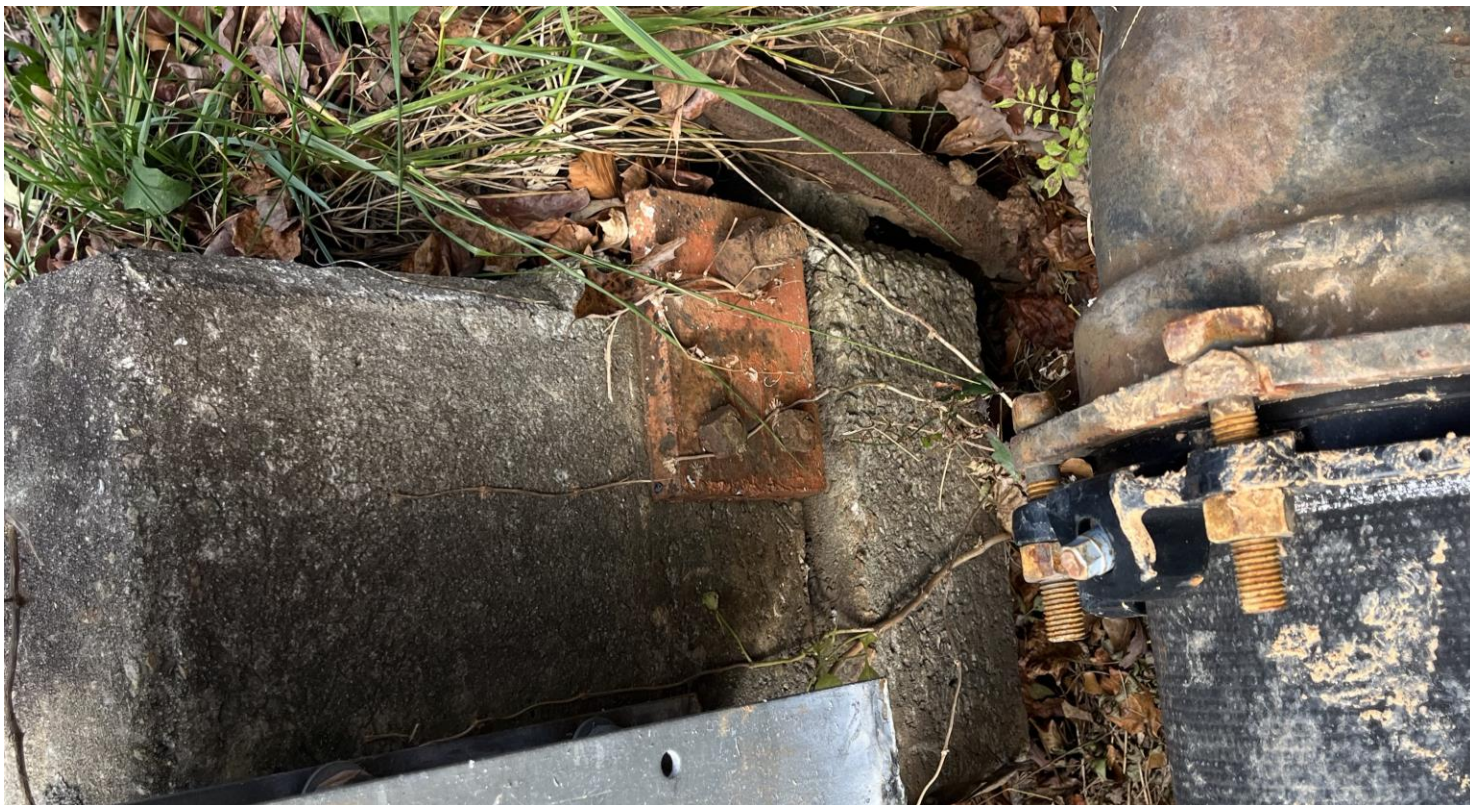
- Orange paint associated with metal brackets (33% by weight)

PHOTO # 9 View of LP-4 orange bracket paint.

- **Dispose of lead painted debris in a Class II Landfill.** - SCDHEC regulations require that lead-painted demolition debris be disposed in a permitted Class II landfill. Landfills should be contacted to determine their specific disposal requirements. Metal components painted with lead-based paint may be recycled however the recycler should be contacted to determine their specific requirements.

- **Inform contractors and workers of presence of lead in paints** - Occupational Safety and Health Administration Lead Regulations apply to actions initiated on lead containing materials. This regulation applies to lead concentrations greater than the analytical limit of detection. This regulation provides exposure levels on airborne lead and does not reference the concentration of lead in paint or other lead-containing materials. Workers performing work on surfaces which have any lead concentration should be notified to comply with OSHA requirements. The full OSHA lead standard should be referenced for compliance.
