Asbestos & Lead Paint Inspection Report

S-42-197 Bridge over South Tyger River

December 20, 2023 | Report Number: 7323P180

Re: Asbestos & Lead Paint Inspection Report
SCDOT Bridge Package 19
S-42-197 over South Tyger River
Bridge Asset No. 05624
Spartanburg County, South Carolina
Terracon Project No. 7323P180
SCDOT Project ID. P041164
Survey Conducted: November 2, 2023

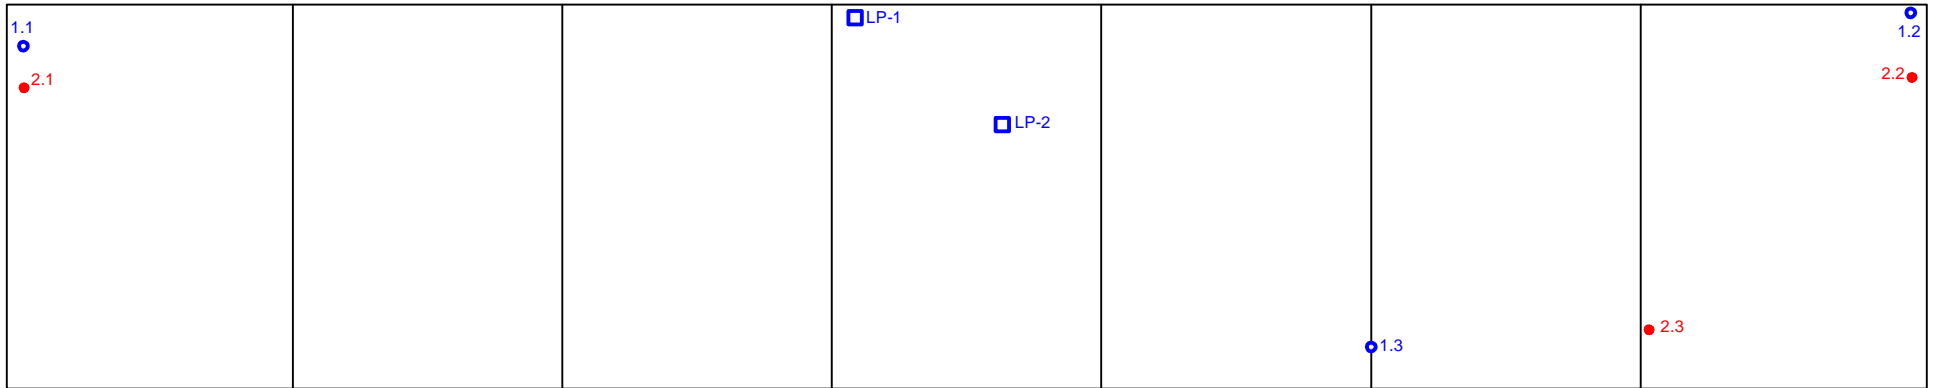
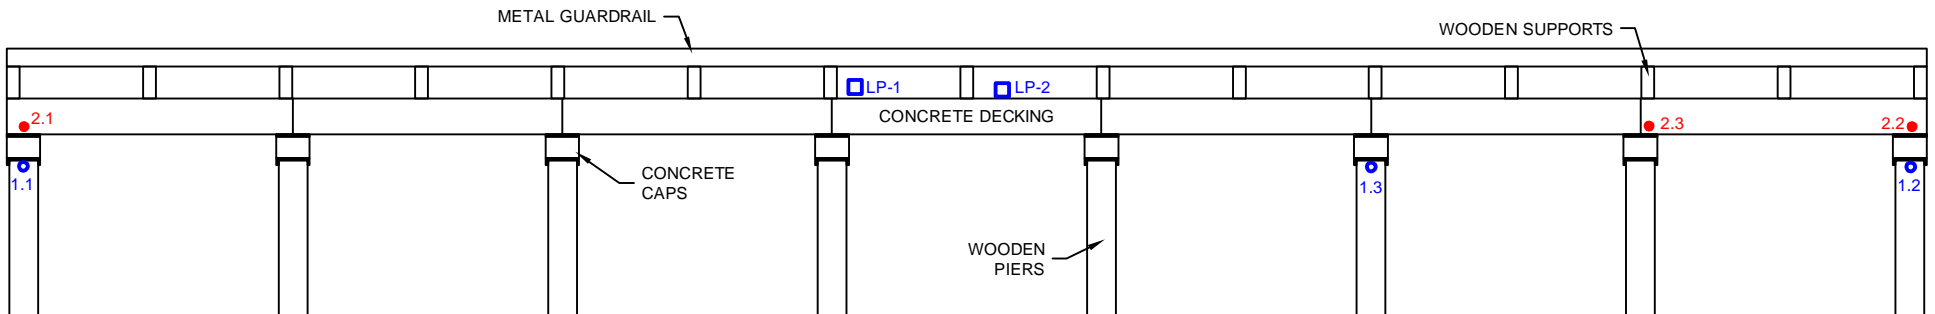
SAMPLE LOCATION PLAN
S-42-197 OVER SOUTH TYGER RIVER
OLD SPARTANBURG HIGHWAY
SPARTANBURG COUNTY, SOUTH CAROLINA
BRIDGE #05624

See Exhibit 2 for sample locations

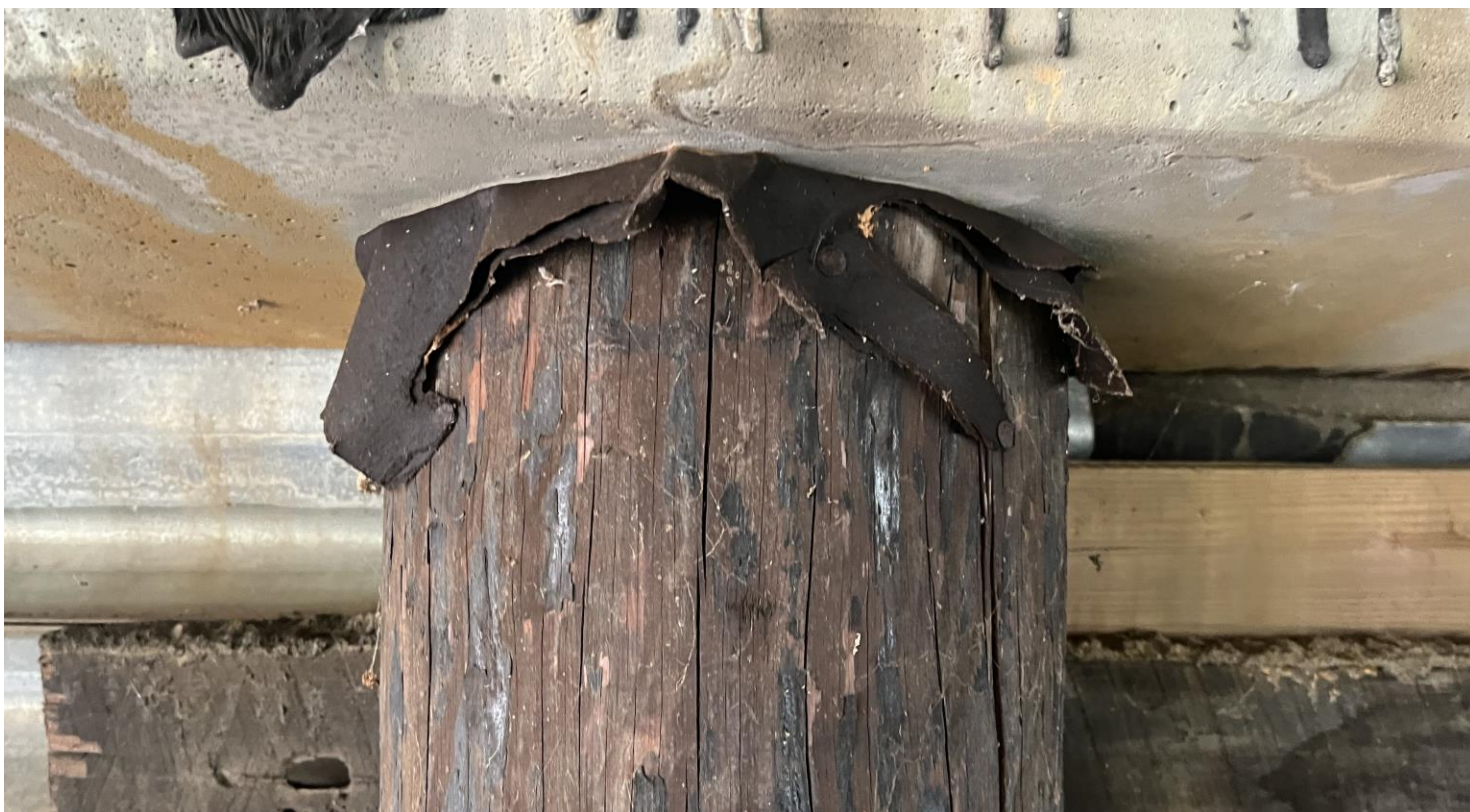
HA	Approx. Quantity* (ft ²)	Samples Collected	Description	Material Location	Lab Result	Category	Condition
1	44 SF	3	Thin felt vibration dampener	Between piers and pier caps	NAD	Misc	NF, Good
2	385 LF	3	Thick tar and shingle vibration dampener	Between pier caps and decking	4% Chry	Cat I	NF, Good

PHOTO # 3 View of HA #1 Thin felt vibration dampener between the piers and pier caps.

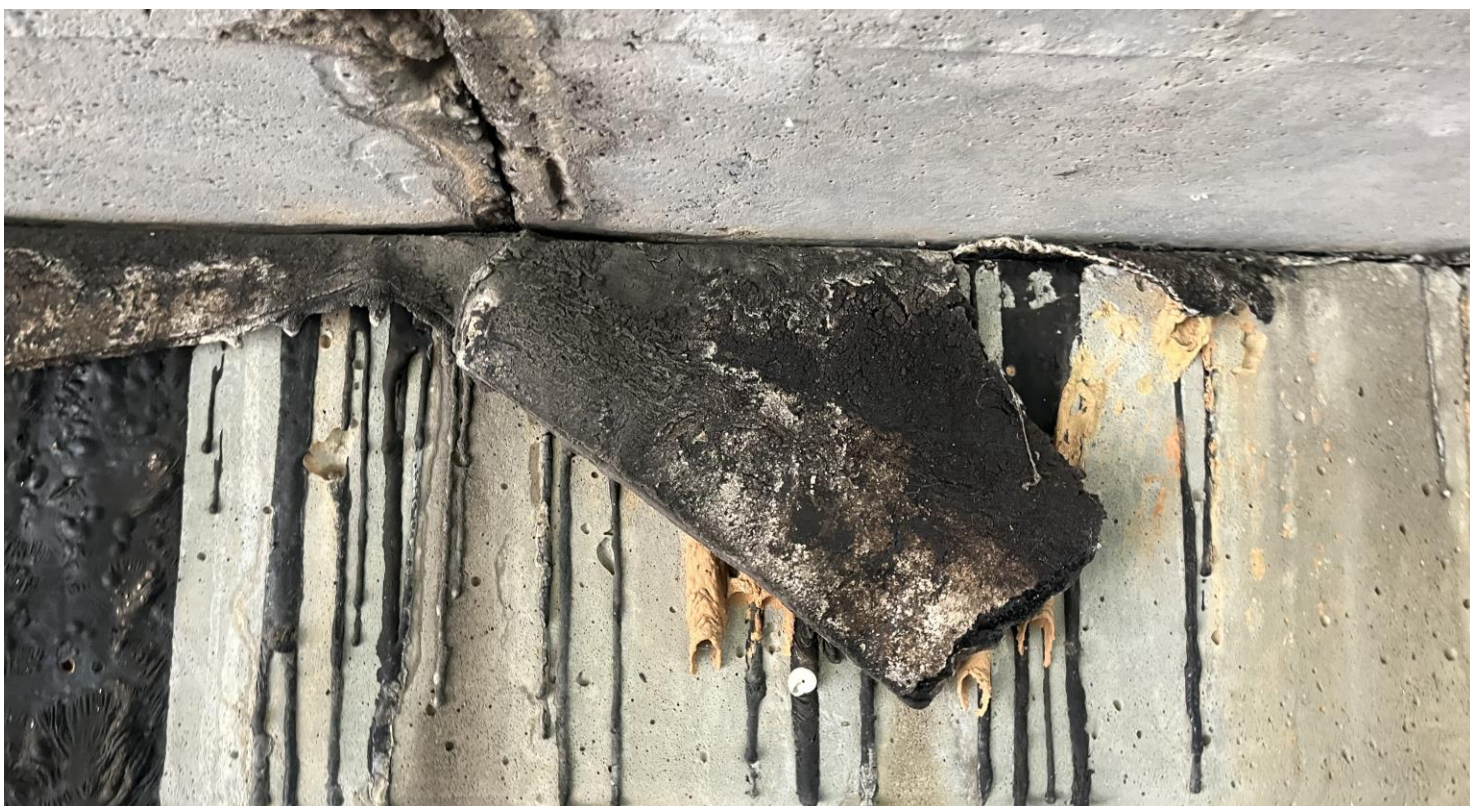
- Thick tar and shingle vibration dampener (4% Chrysotile) between pier caps and decking.

PHOTO # 4 View of HA #2 Thick tar and shingle vibration dampener.

- All asbestos-containing materials should be removed by a South Carolina licensed asbestos abatement contractor prior to demolition of the structure.

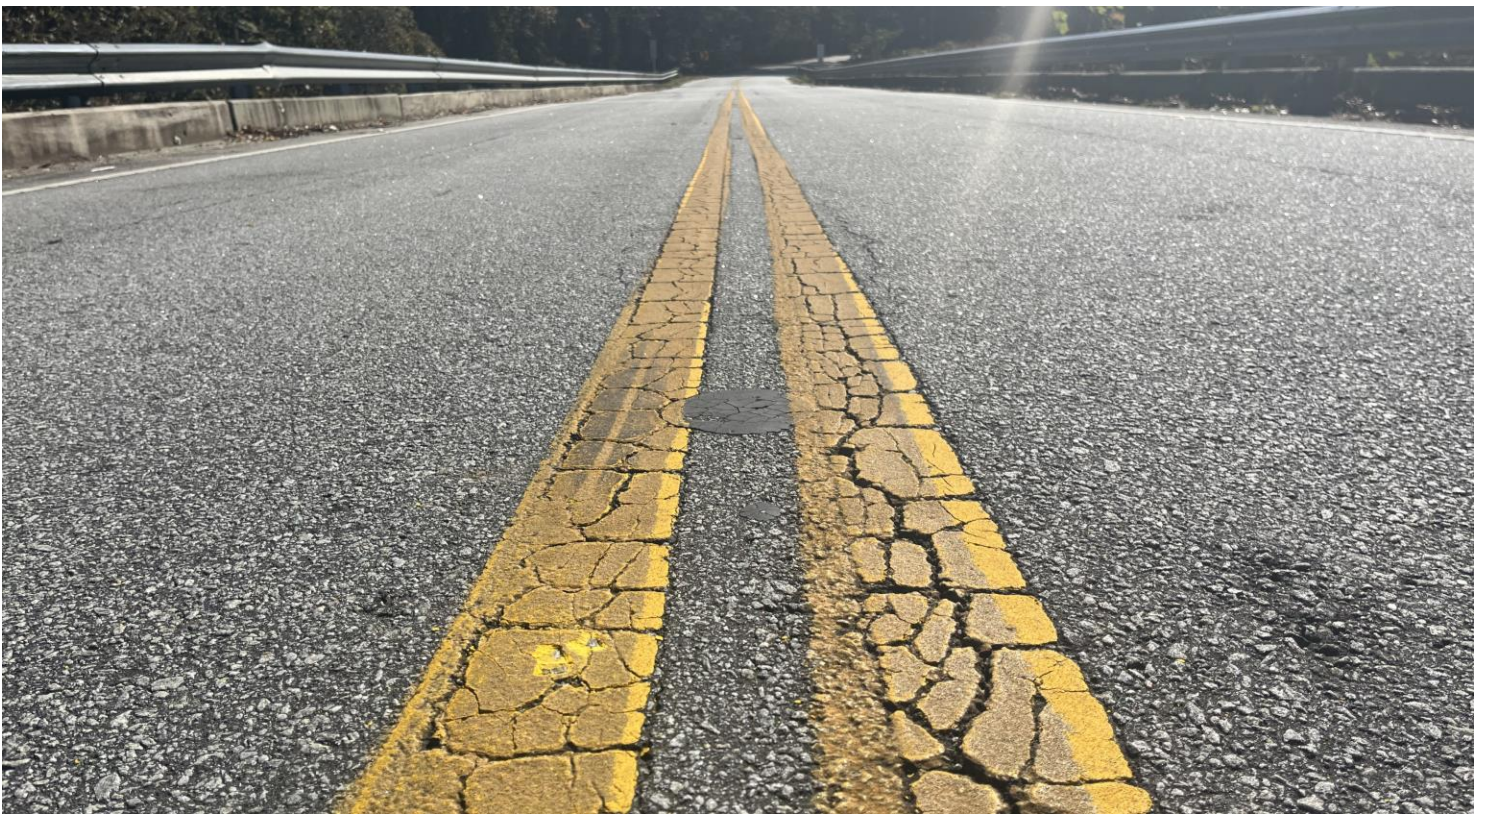
Lead was not detected above the detection limits in any of the paint chip samples collected. A summary of the lead paint laboratory results is presented in Table 2. The analytical report is included in Appendix B.

PHOTO # 5 View of LP-1 (Yellow Paint).

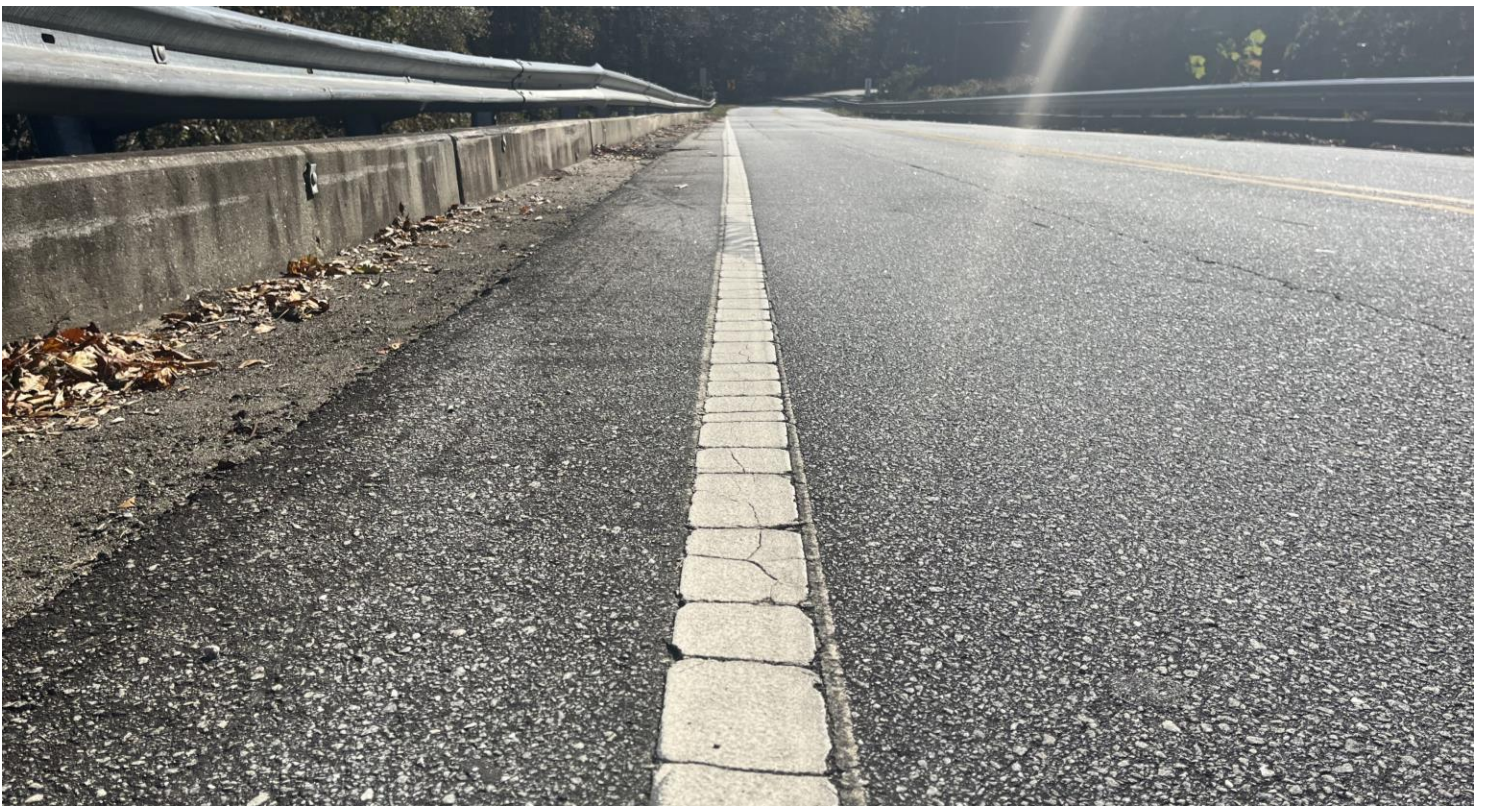
PHOTO # 6 View of LP-2 (White Paint).
