ASBESTOS CONTAINING MATERIAL INVESTIGATION REPORT

US 278 OVER BEAVERDAM BRANCH
BRIDGE ASSETS #01190 AND #01191
JASPER COUNTY, SOUTH CAROLINA

October 18, 2024

F&ME Project No.: G7100.006

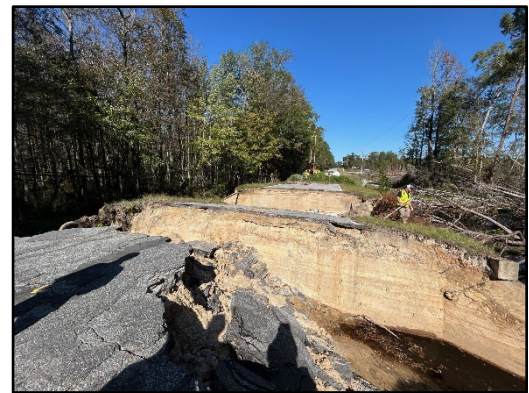
Photo 1: US 278 over Beaverdam Branch in Jasper County, South Carolina

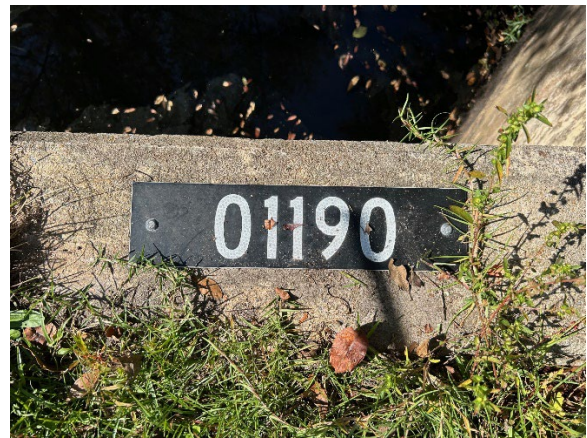
Photo 4. Bridge Asset Number Attached to Concrete Culvert.

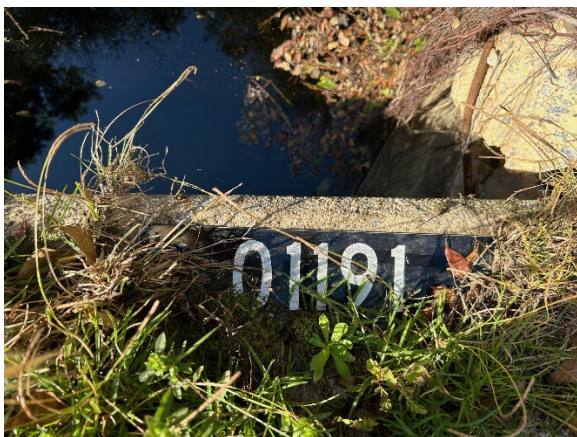
Photo 5. Bridge Asset Number Attached to Concrete Culvert.
