## LEAD-BASED PAINT INVESTIGATION REPORT

US 76 (LONG CREEK HWY.) RBO CHAUGA RIVER  
OCONEE COUNTY, SOUTH CAROLINA  
PROJECT ID P043969

**November 1, 2024**

FME Project No.: G7100.005

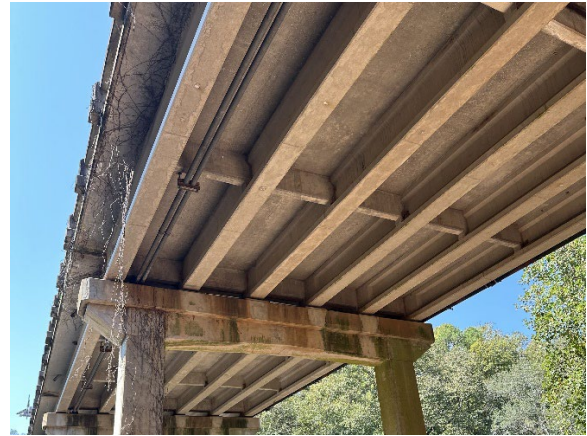
**Photo 4.** Underside View of Bridge.

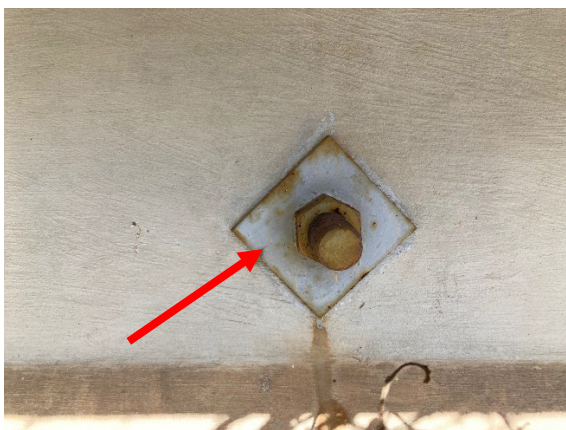
Scan No.	Pbc (mg/cm <sup>2</sup> )	Component	Substrate	Side	Condition	Color
1	0.98	Calibrate				
2	0.94	Calibrate				
3	0.97	Calibrate				
4	0.87	Tie-Rod Washer	Metal	C	Poor	Silver
5	1.67	Utility Bracket	Metal	C	Poor	Silver
6	<LOD	Bearing Plate	Metal	D	Poor	Black
7	<LOD	Bearing Plate	Metal	Center	Poor	Black
8	<LOD	Bearing Plate	Metal	Center	Poor	Black
9	<LOD	Utility Bracket	Metal	A	Intact	Silver
10	<LOD	Utility Bracket	Metal	A	Intact	Silver
11	<LOD	Utility Bracket	Metal	A	Intact	Silver
12	0.96	Calibrate				
13	0.98	Calibrate				
14	0.99	Calibrate

**Photo 5.** LBP on Silver Tie-Rod Washer.

Therefore, OSHA regulations and procedures should be followed when impacting these components. If possible, they should be removed in whole and disposed of properly. Also, SCDES disposal requirements for lead containing materials should also be followed.

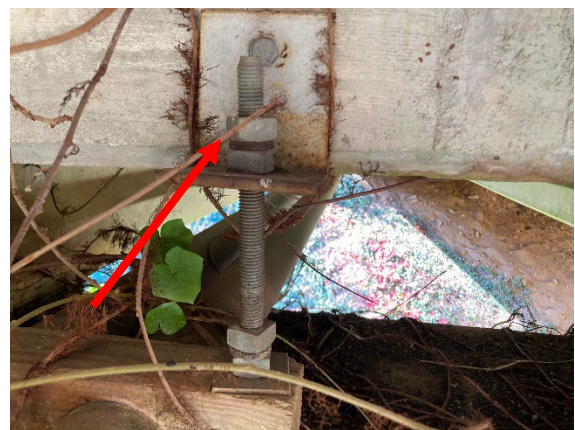
**Photo 6** LBP on Utility Bracket attached to the Underside of the Bridge on the South Side.
