Asbestos & Lead Paint Survey Report

S-46-1086 Bridge over Beaverdam Creek
York, South Carolina
Bridge Asset No. 03560

June 28, 2023
Terracon Project No. 7323P100_5

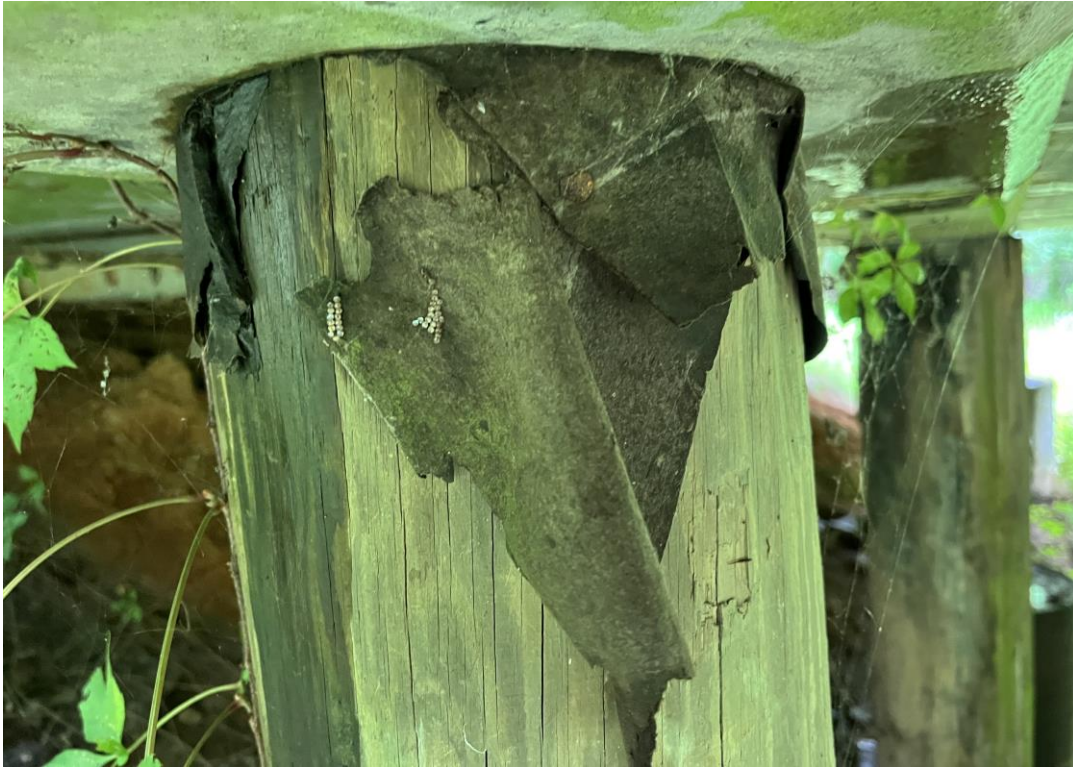
HA	Approx. Quantity (ft ²)	Samples Collected	Description	Sample Location	Lab Result	Category	Condition
1	50	3	Thin Friction Barrier	Between piers and pier caps	NAD	Misc	NF, Good
2	125	3	Thick Friction Barrier	Between pier caps and decking	NAD	Misc	NF, Good

Photo 3 View of thin friction barrier between pier and pier cap.

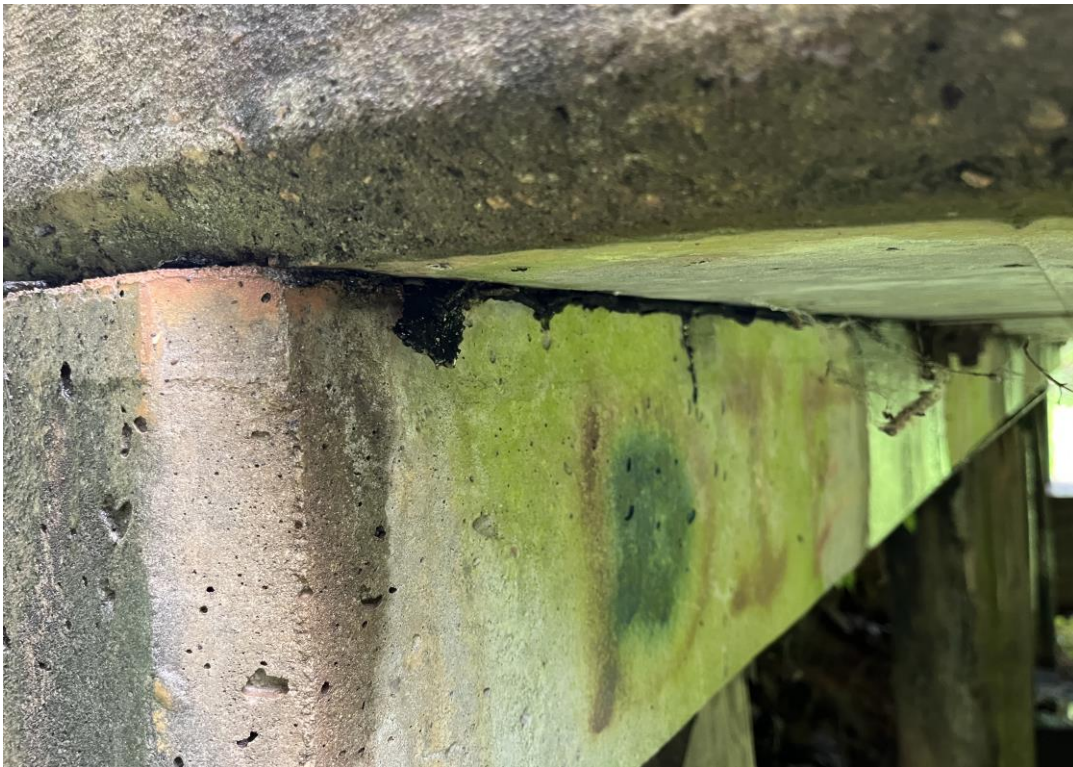
Photo 4 View of thick friction barrier between pier cap and decking

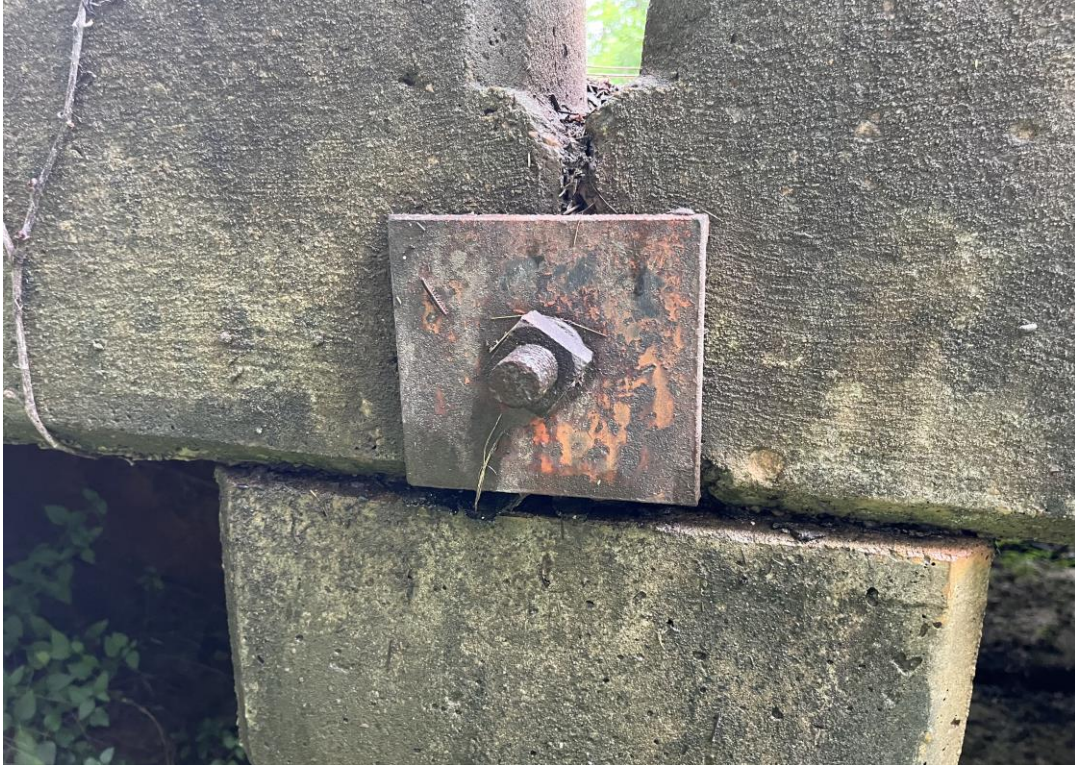
- Orange Metal Bracket – 0.05 mg/cm²

Sample Number	Description	Location	XRF Result
LP-1	Orange on Metal Bracket	Between Decking Joints	0.05 mg/cm ²

Photo 5 View of corroded orange metal bracket.
