Asbestos & Lead Paint Survey Report

S-20-20 Bridge over Hogfork Branch
Fairfield County, South Carolina
Bridge Asset No. 03647

June 28, 2023

Terracon Project No. 7323P100

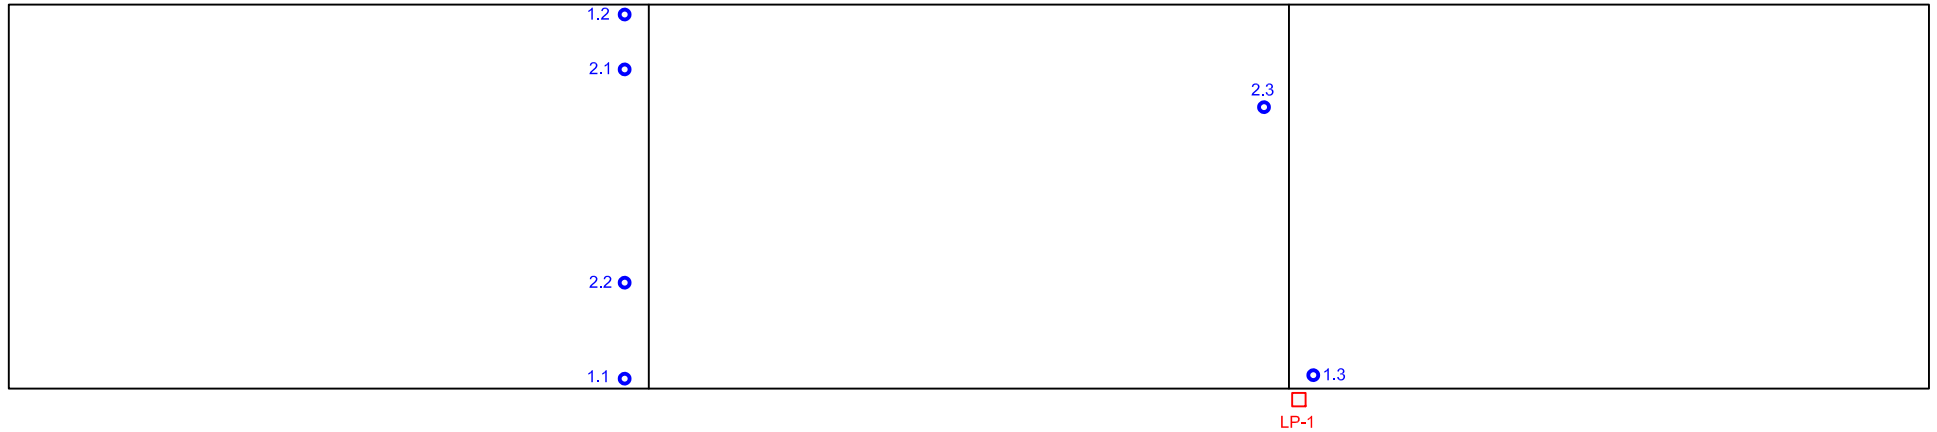
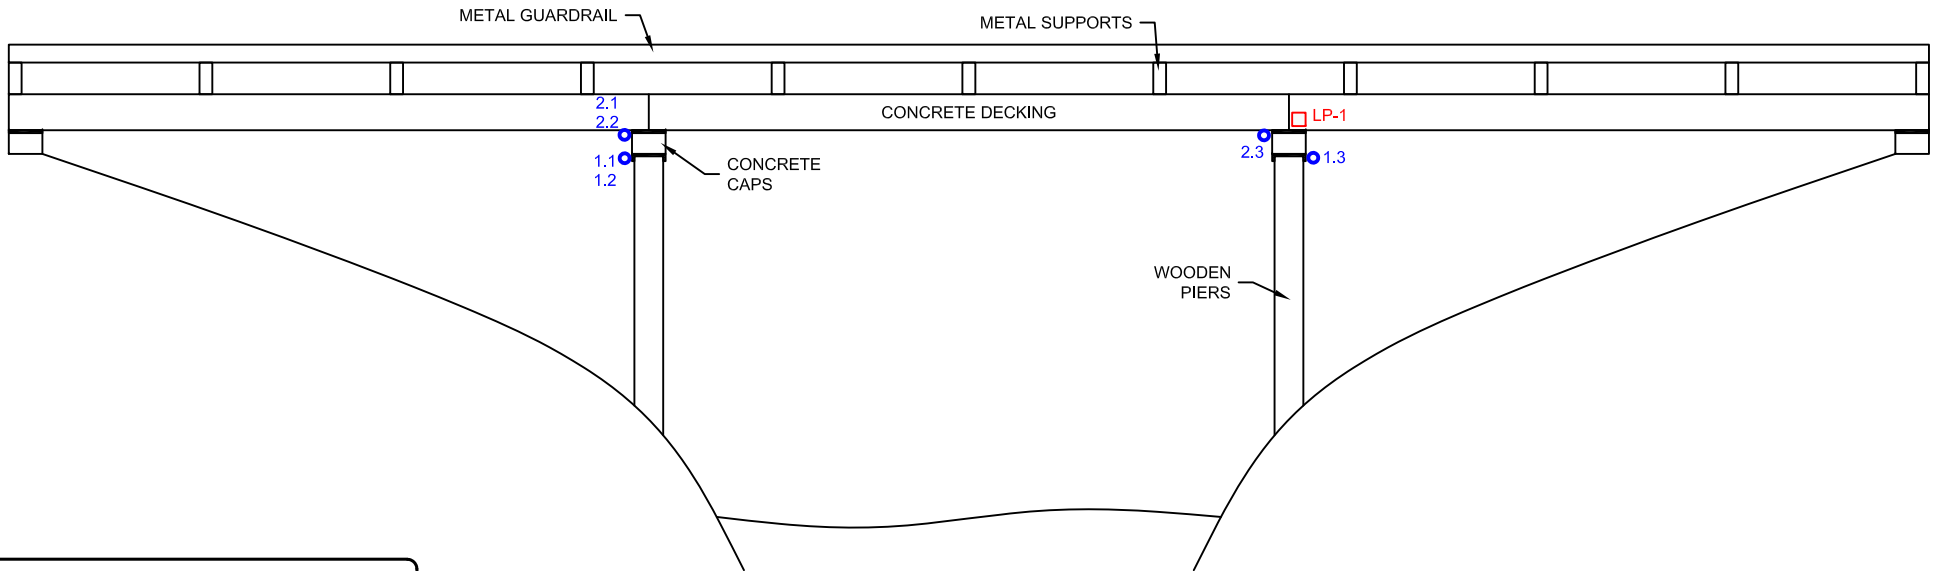
SAMPLE LOCATION PLAN
S-20-20 OVER HOGFORK BRANCH
CAMP WELFARE ROAD
FAIRFIELD COUNTY, SOUTH CAROLINA
BRIDGE #03647

- Orange Metal Bracket – 4.83 mg/cm²

It should be noted that on this bridge all metal brackets have rusted and decayed over time leaving behind little to no lead paint.

XRF analysis detected lead concentrations greater than 0.7 mg/cm². SCDHEC regulations require that lead painted demolition debris be disposed in a permitted Class II landfill. Landfills should be contacted to determine their specific disposal requirements. Metal components painted with lead-based paint may be recycled however the recycler should be contacted to determine their specific requirements. Additionally, the provisions in the OSHA Standard for Lead (29 CFR 1926.62) should be followed by contractor personnel conducting work activity during the demolition. A summary of the lead paint laboratory results is presented in Table 2 in Appendix A.

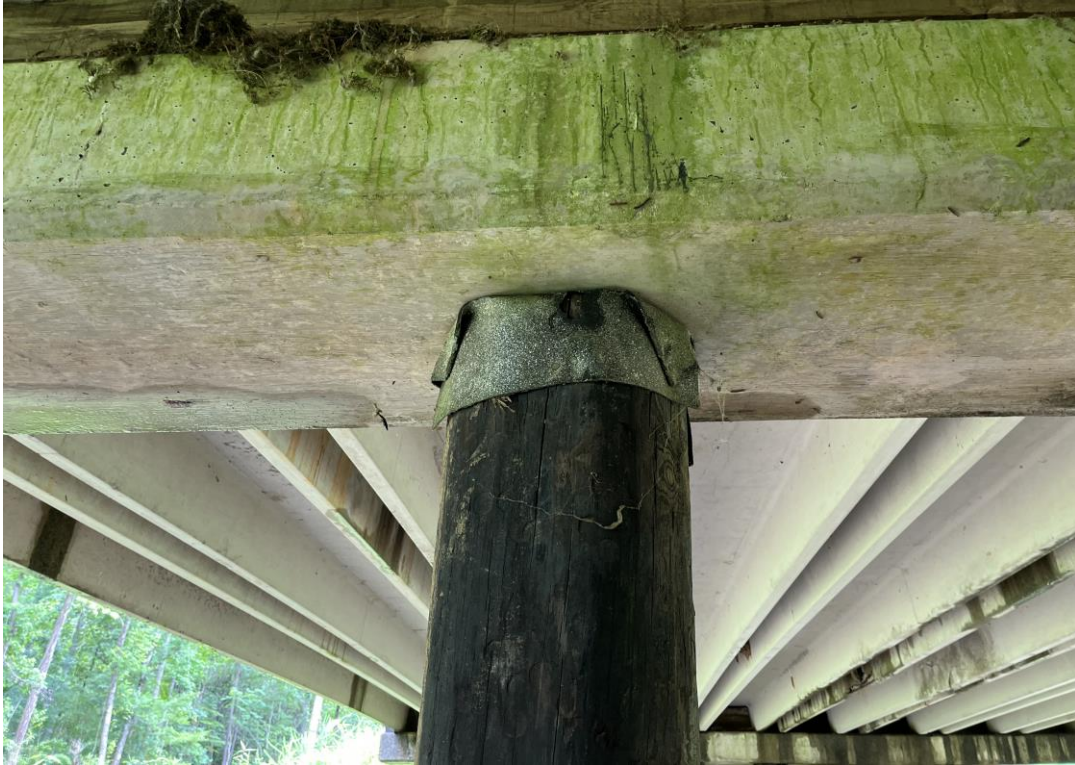
HA	Approx. Quantity (ft ²)	Samples Collected	Description	Sample Location	Lab Result	Category	Condition
1	16	3	Thin Friction Barrier	Between piers and pier caps	NAD	Misc	NF, Good
2	100	3	Thick Friction Barrier	Between pier caps and decking	NAD	Misc	NF, Good

Photo 3 View of thin friction barrier between pier and pier cap.

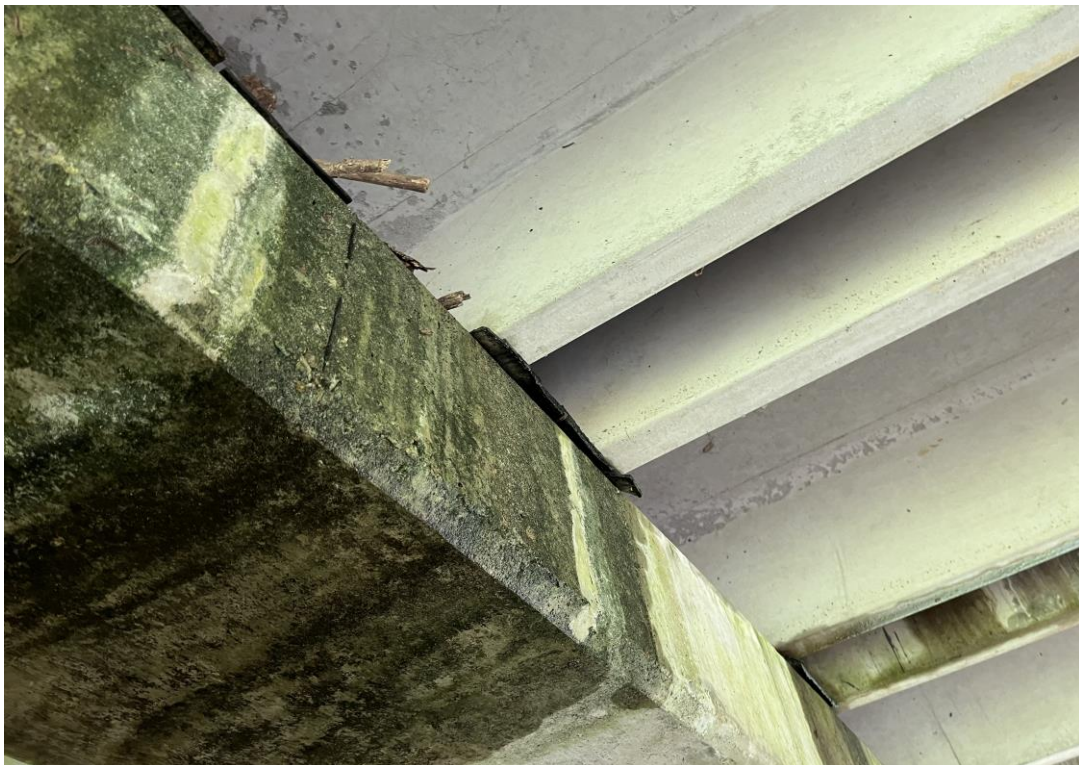
Photo 4 View of thick friction barrier between pier cap and decking.
