Asbestos & Lead Paint Survey Report

S-46-998 Bridge over Wildcat Creek
York, South Carolina
Bridge Asset No. 05643

June 28, 2023

Terracon Project No. 7323P100_3

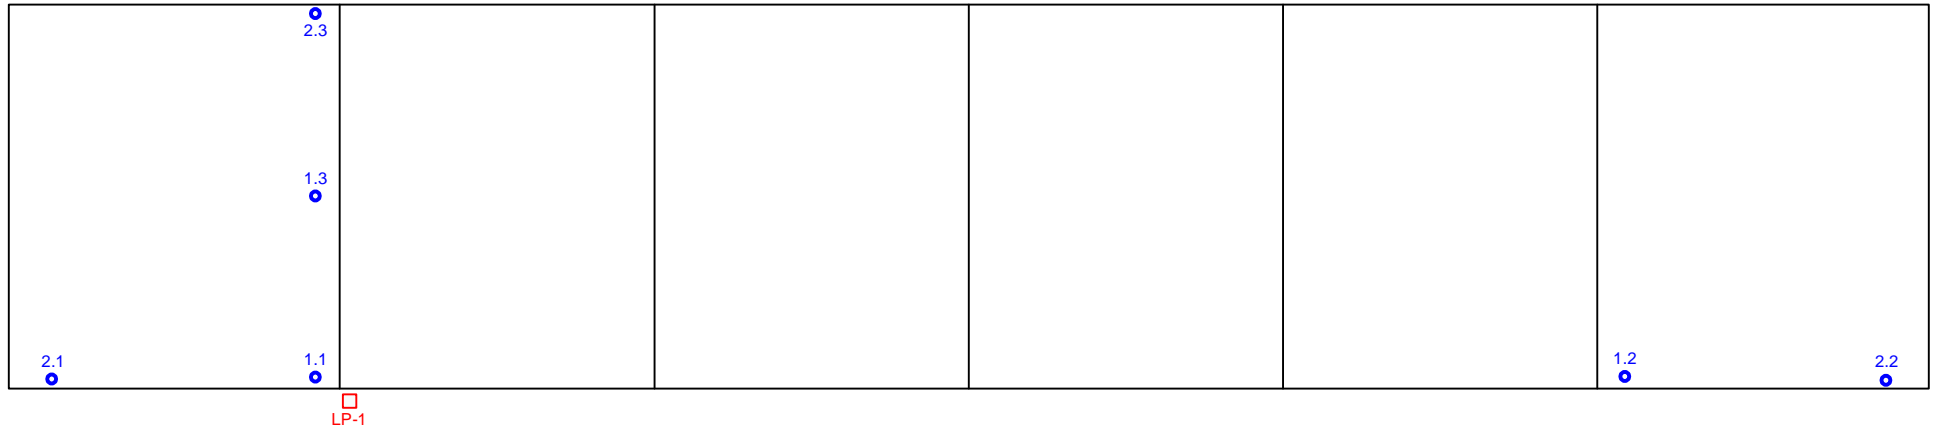
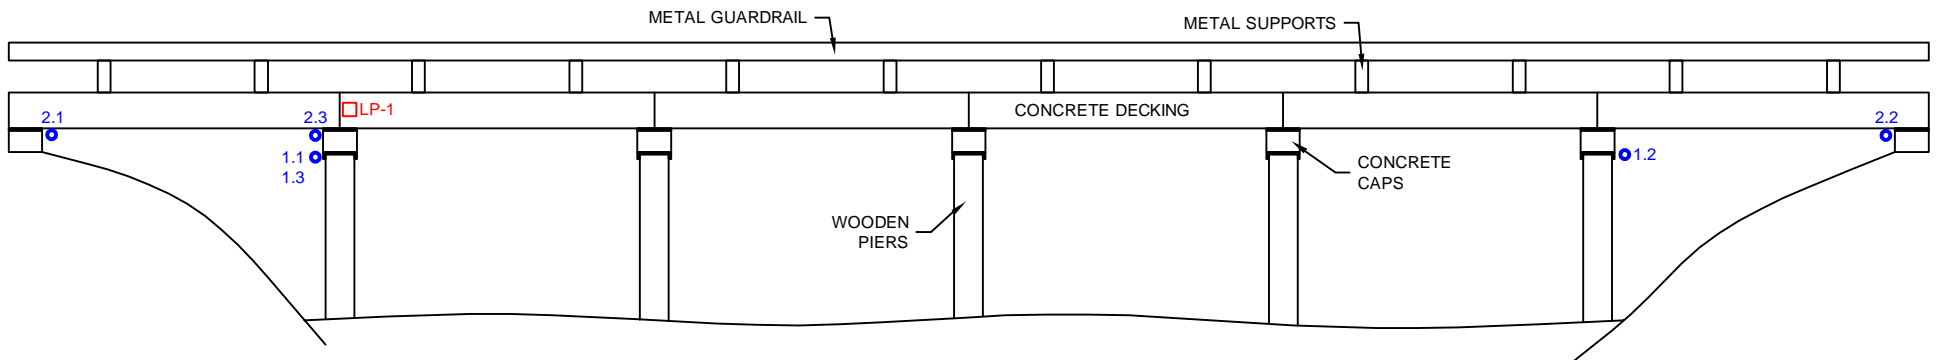
SAMPLE LOCATION PLAN
S-46-998 OVER WILDCAT CREEK
ROBERTSON ROAD
YORK COUNTY, SOUTH CAROLINA
BRIDGE #05643

Sample Number	Description	Location	XRF Result
LP-1	Orange Metal Bracket	Between Decking Joints	2.78 mg/cm ²

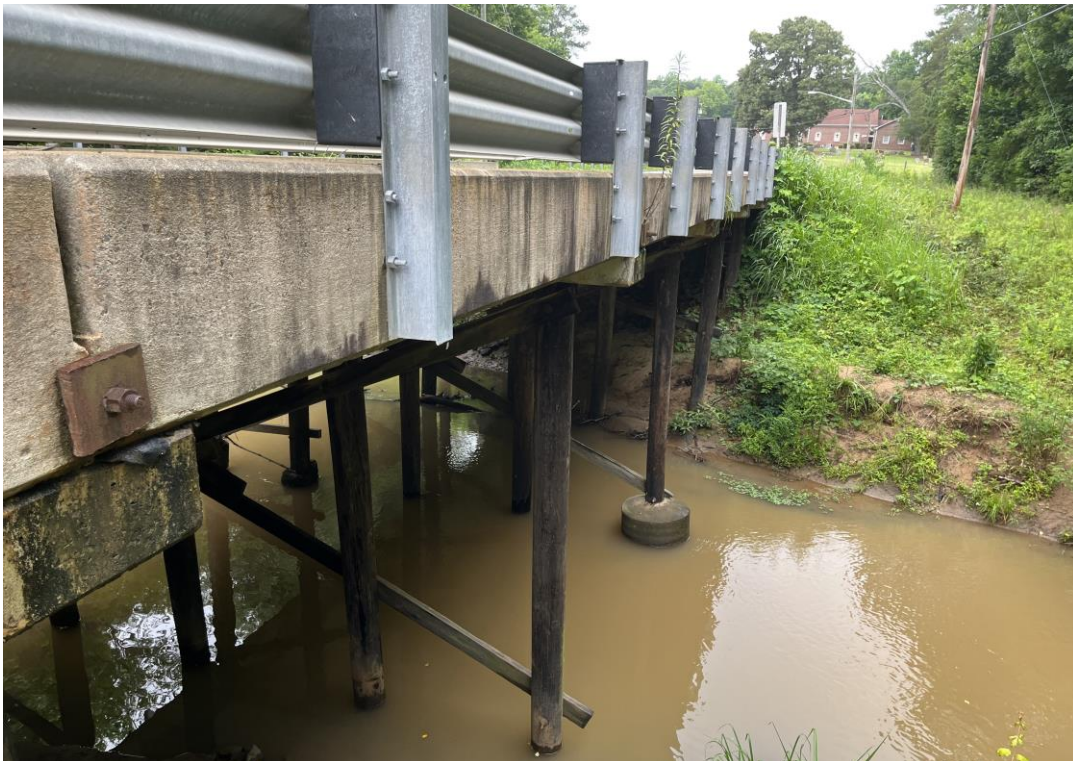
- Orange Metal Bracket – 2.78 mg/cm²;

It should be noted that on this bridge all metal brackets have rusted and decayed over time leaving behind little to no lead paint.

Photo 4 View of the side of the bridge to the west with the metal brackets on the side.

XRF analysis detected lead concentrations greater than 0.7 mg/cm². SCDHEC regulations require that lead painted demolition debris be disposed in a permitted Class II landfill. Landfills should be contacted to determine their specific disposal requirements. Metal components painted with lead-based paint may be recycled however the recycler should be contacted to determine their specific requirements. Additionally, the provisions in the OSHA Standard for Lead (29 CFR 1926.62) should be followed by contractor personnel conducting work activity during the demolition. A summary of the lead paint laboratory results is presented in Table 2 in Appendix A.

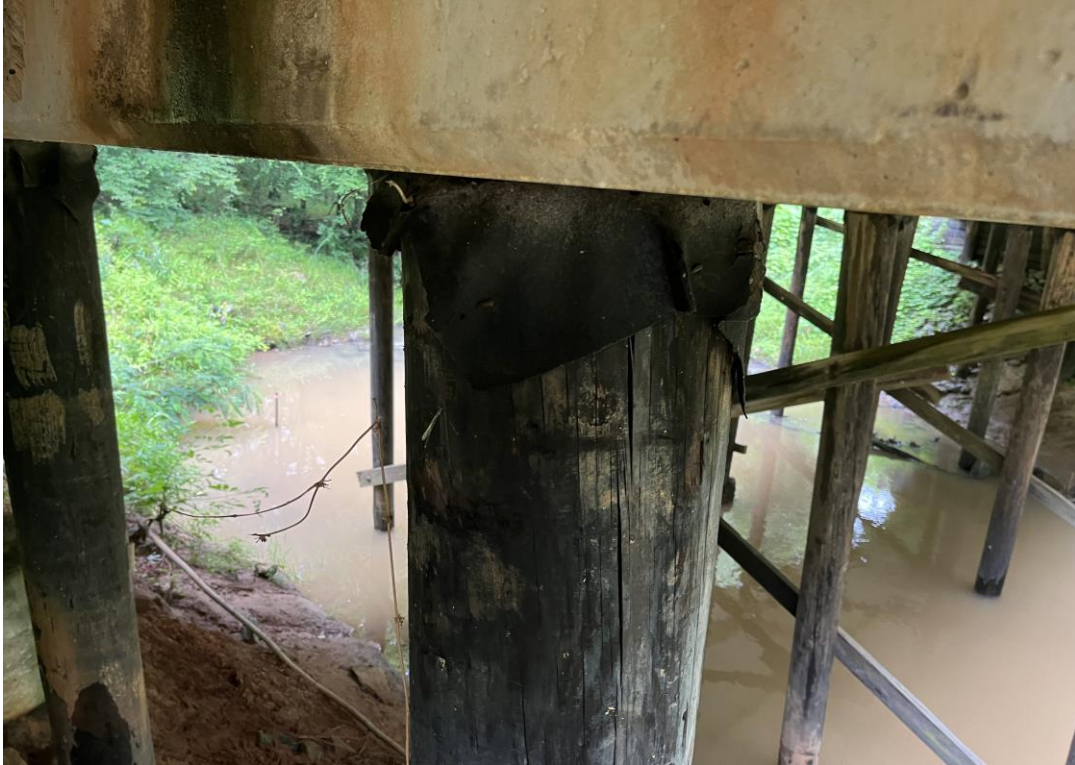
Based on the results of laboratory analyses, **asbestos was not detected** in the friction barrier samples collected from the bridge. These results were confirmed by TEM analysis. Asbestos laboratory analytical reports are included in Appendix B.

Photo 5 View of thin friction barrier between pier and pier cap.

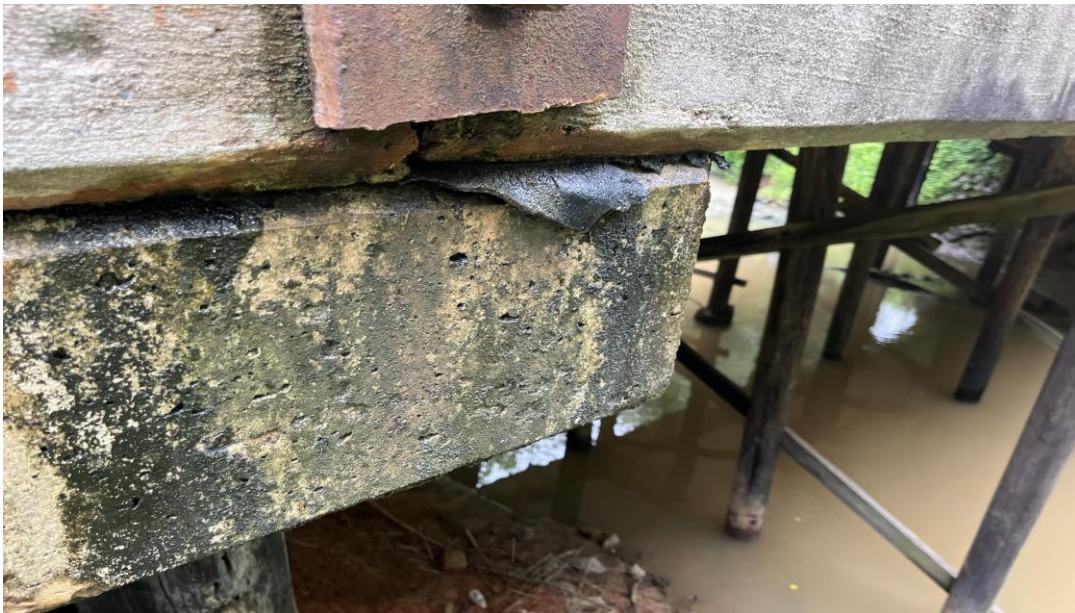
Photo 6 View of thick friction barrier between pier and pier cap
