## ASBESTOS CONTAINING MATERIAL INVESTIGATION REPORT

S-17-58 (GADDY'S MILL RD.) BRIDGE OVER  
BEAVERDAM CREEK  
DILLON COUNTY, SOUTH CAROLINA  
PROJECT ID P043715

**March 3, 2025**

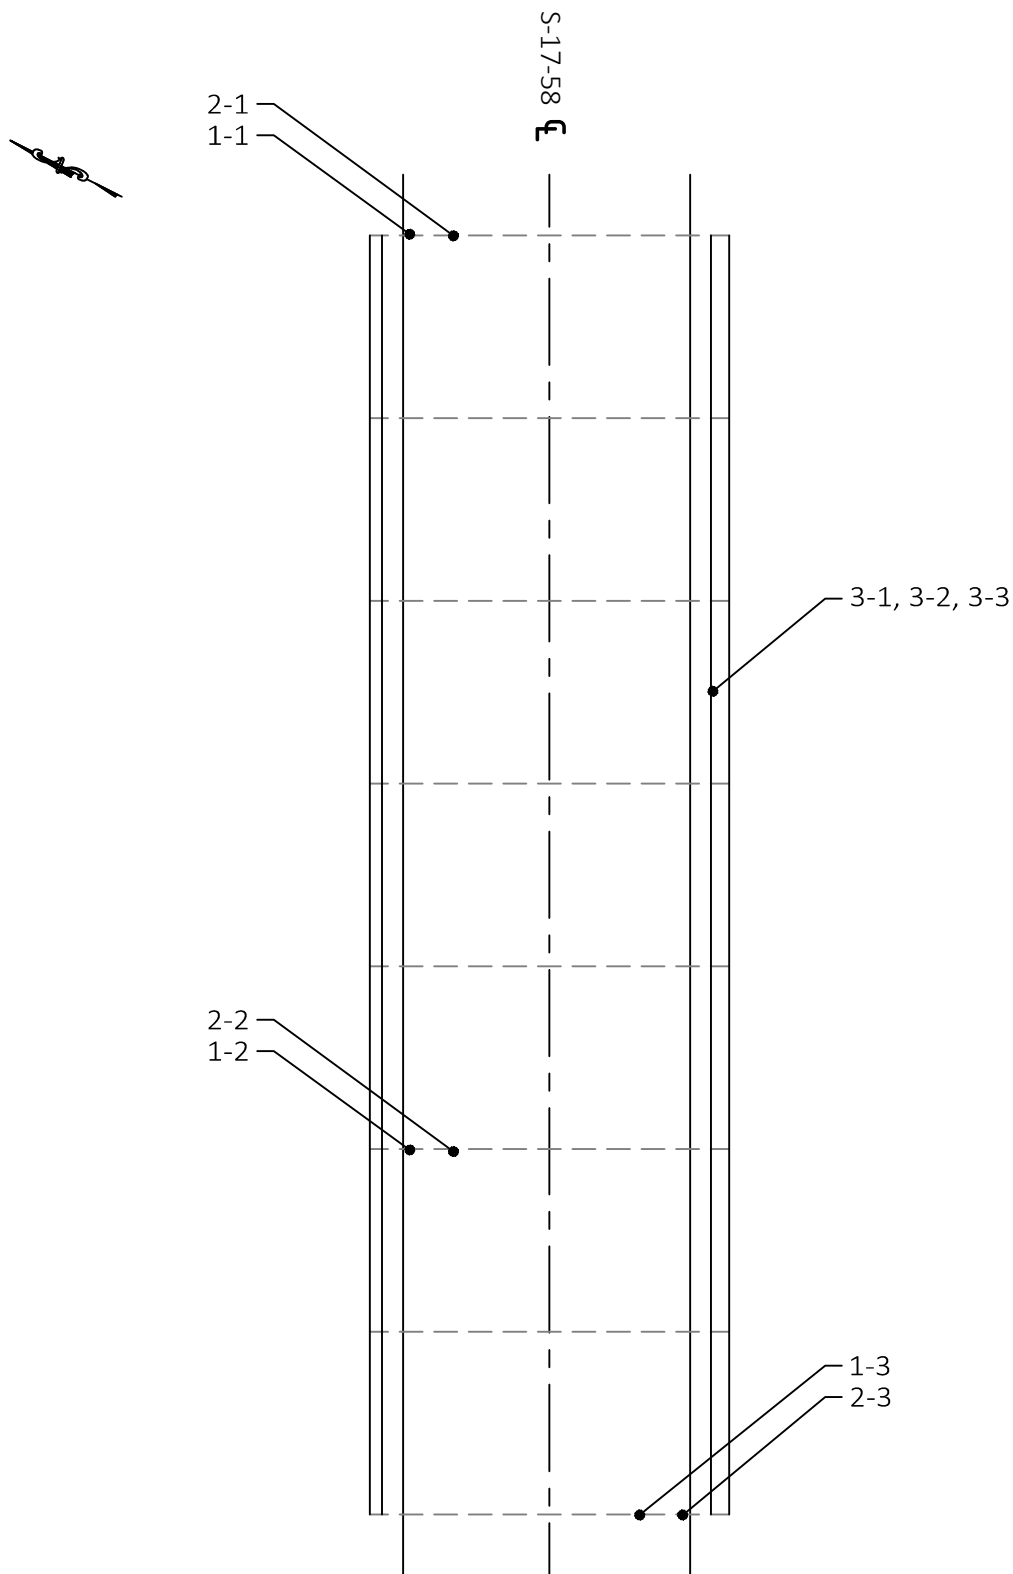
2

During the investigation, accessible bridge components (i.e., bent caps, timber piles, scuppers, expansion joints, etc.) were visually inspected for suspect ACM. Examples of possible suspect materials include bond break bearing pads, expansion joint material, and drainage scuppers. Three (3) suspect materials were observed/visible on the Bridge. The suspect materials noted on the Bridge were timber pile cap felt, black bearing pads, and textured concrete curbing. Samples of these materials were taken from random locations on the Bridge. Refer to Appendix B, Sample Location Plan, for detailed sample locations. Also, refer to Appendix G, Site Photographs, for more details.

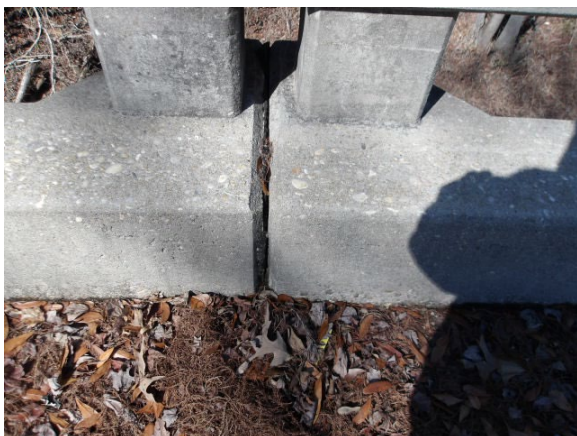
**Photo 5.** Non-ACM Expansion Joint Material.
