LEAD-BASED PAINT INVESTIGATION REPORT

S-17-58 (GADDY'S MILL RD.) BRIDGE OVER
BEAVERDAM CREEK
DILLON COUNTY, SOUTH CAROLINA
PROJECT ID P043715

March 3, 2025

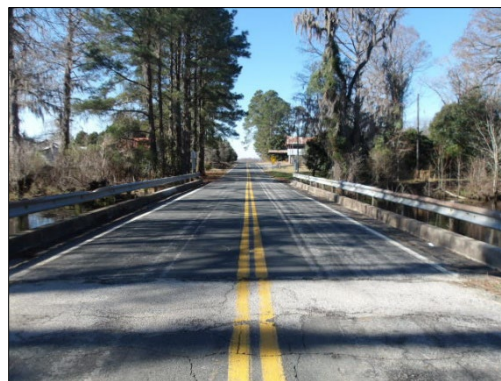
Photo 1 – S-17-58 (Gaddy’s Mill Rd.) Bridge over Beaverdam Creek, Dillon County, SC.

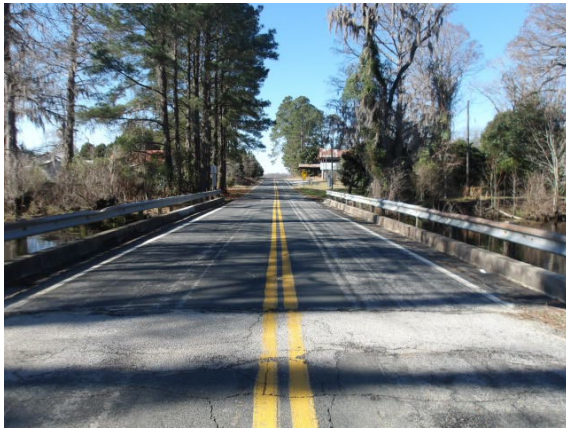
Photo 1. Top View of Bridge.

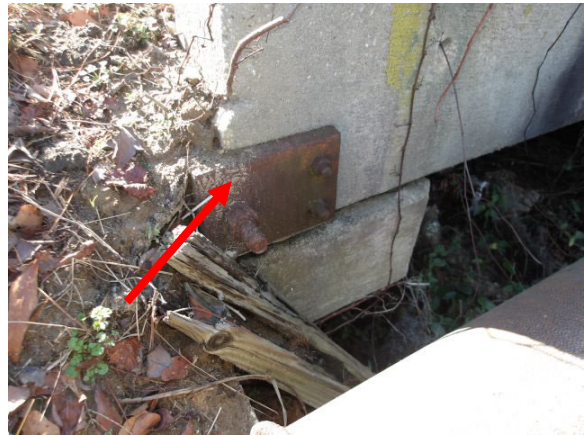
- **Rust Tie Rod Washers.**
- **L Brackets**

Photo 2. LBP on Tie-Rod Washer on Both Sides of the Bridge.

Therefore, OSHA regulations and procedures should be followed when impacting these components. If possible, they should be removed in whole and disposed of properly. Also, SCDES disposal requirements for lead-containing materials should also be followed.

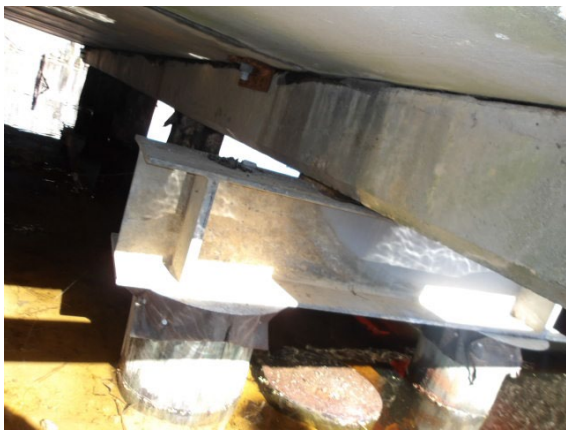
Photo 3. Underside View of Bridge.

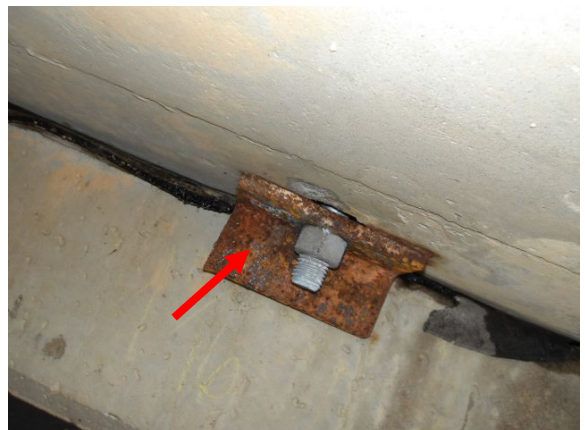
Photo 4. LBP on L-Brackets on Underside of Bridge.

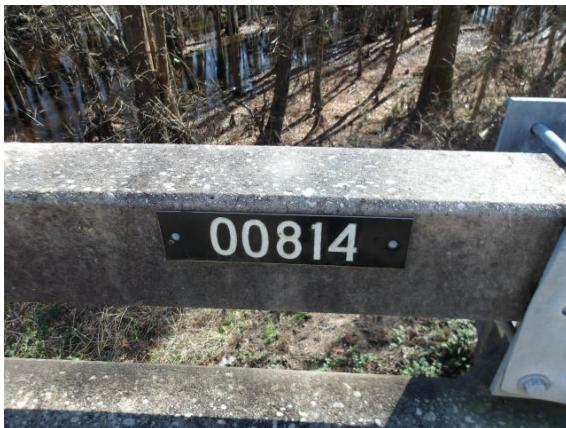
Photo 5. SCDOT Bridge Asset # Attached on Concrete Guardrail.
