## Appendix I: Field Investigation Notes

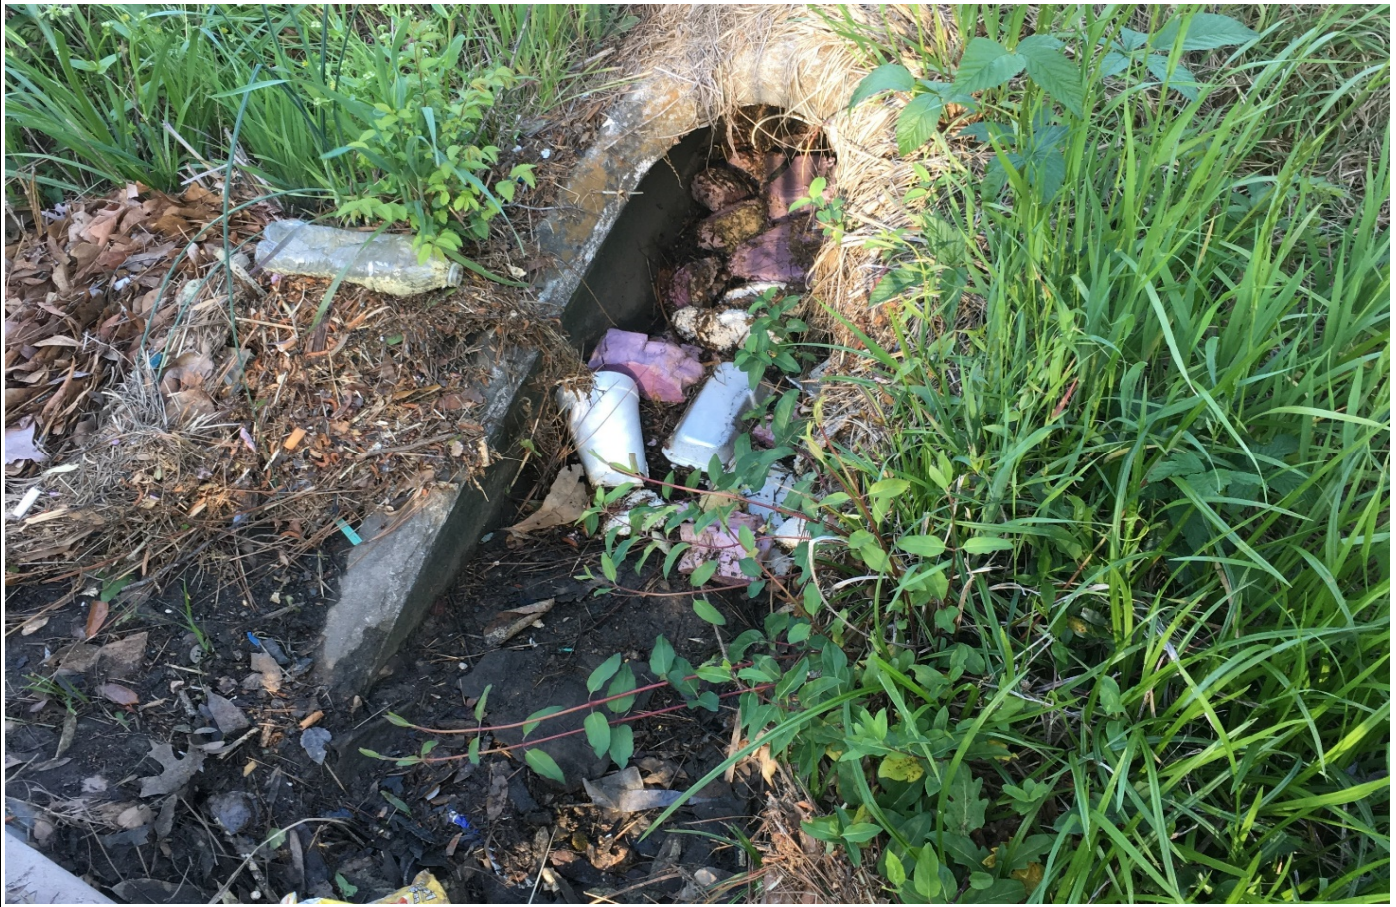
<b>Carolina Crossroads Field Investigation</b>		<b>Site ID:</b>	<b>3401</b>
		<b>Type:</b>	<b>Outfall</b>
Alignment:	I20000X	Date:	4/17/2018
Approx. Station:	68+75	Weather:	Sunny
Side:	RT	Reviewer:	Tom Miller / Cole Pierce
<b><i>Downstream Channel Information</i></b>			
Channel Width:	1 ft	Approx. Side Slopes:	3:1
Channel Alignment:	Straight	Vegetation On Banks?	Yes
Channel Bottom Material:	Vegetation / Debris	Approx. Water Depth:	N/A
High Water Mark Visible?	No	Water Present?	Dry
Erosion Present?	No	Overbank Areas Description: Undeveloped.	
Notes: Channel is approximately 1.5 feet-deep. Approximately 100 ft downstream, the channel size increases, some erosion is observed, and there is about 6 in of standing water. The channel width is 3 ft wide with very flat banks about 1 ft-deep.			
<b><i>Pipe Structure Information</i></b>			
Shape:	Circular	Size:	18 in
Material:	R.C.	End Type:	Beveled End
Rip Rap Present?	No	Scour Present?	No

Other Notes: The last section of pipe is separated. This area is to be reconstructed per RPA geometry.

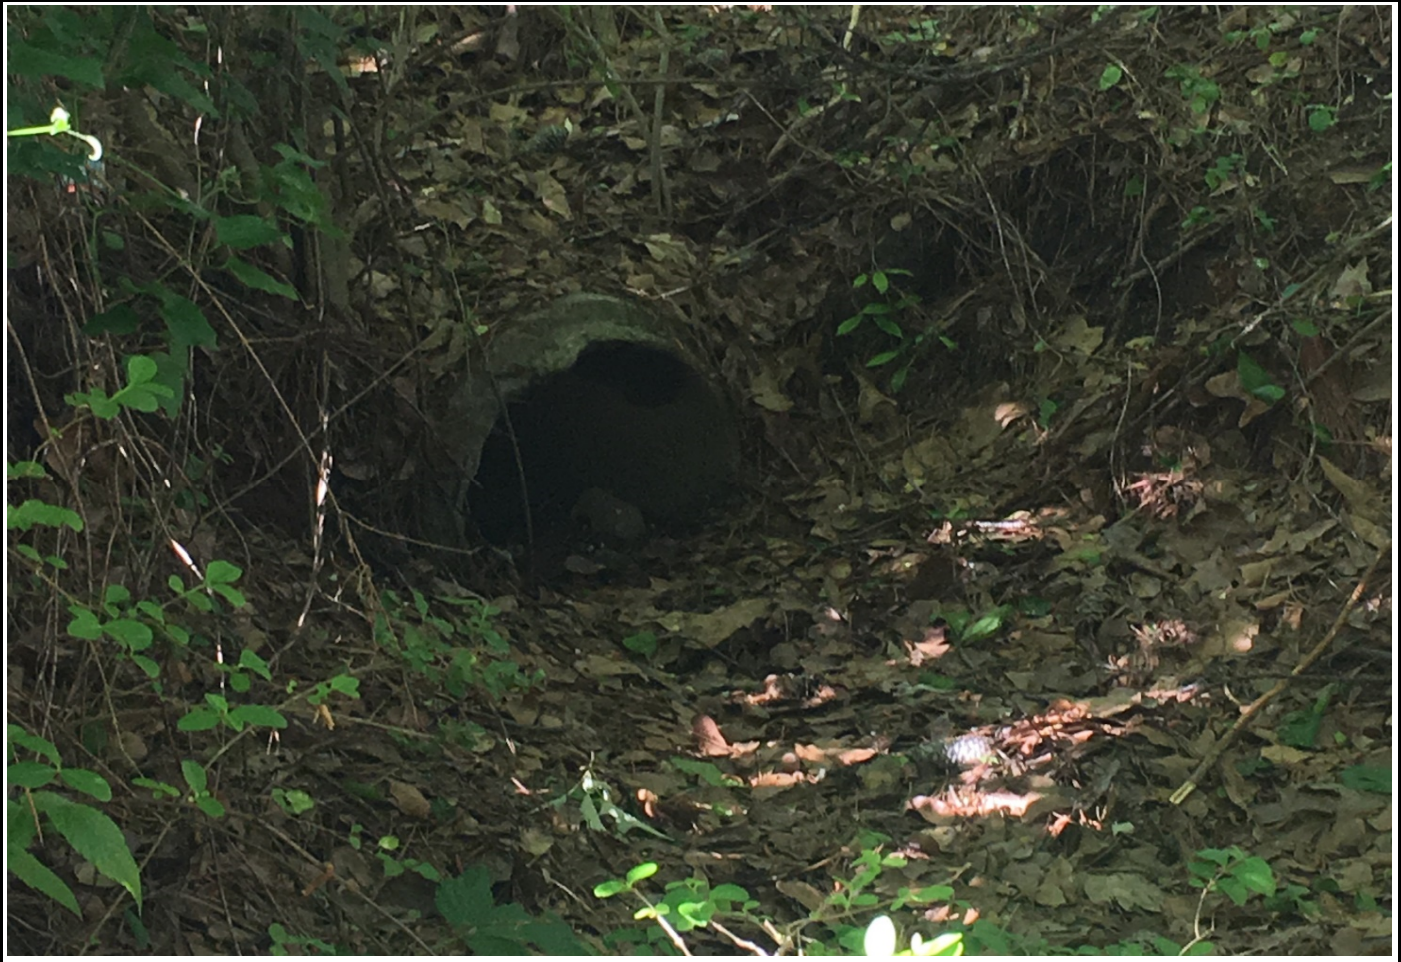
<b>Carolina Crossroads Field Investigation</b>		<b>Site ID:</b>	<b>3501</b>
		<b>Type:</b>	<b>Outfall</b>
Alignment:	I20000X	Date:	4/17/2018
Approx. Station:	82+75	Weather:	Sunny
Side:	LT	Reviewer:	Tom Miller / Cole Pierce
<b><i>Downstream Channel Information</i></b>			
Channel Width:	2 ft to 3 ft	Approx. Side Slopes:	1:1
Channel Alignment:	Straight	Vegetation On Banks?	Yes
Channel Bottom Material:	Soil / Leaf Debris	Approx. Water Depth:	N/A
High Water Mark Visible?	N/A	Water Present?	Dry
Erosion Present?	No	Notes: Channel is approximately 2 feet-deep	
Overbank Areas Description: Heavily vegetated overbanks			
<b><i>Pipe Structure Information</i></b>			
Shape:	Circular	Size:	15 in
Material:	R.C.	End Type:	Pipe End Projecting
Rip Rap Present?	No	Scour Present?	No
Other Notes: No apparent flow except during rainfall events. Some buldings within 200 ft of bank. No indication of past overtopping. The outfall is located within the proposed interstate fill slope.

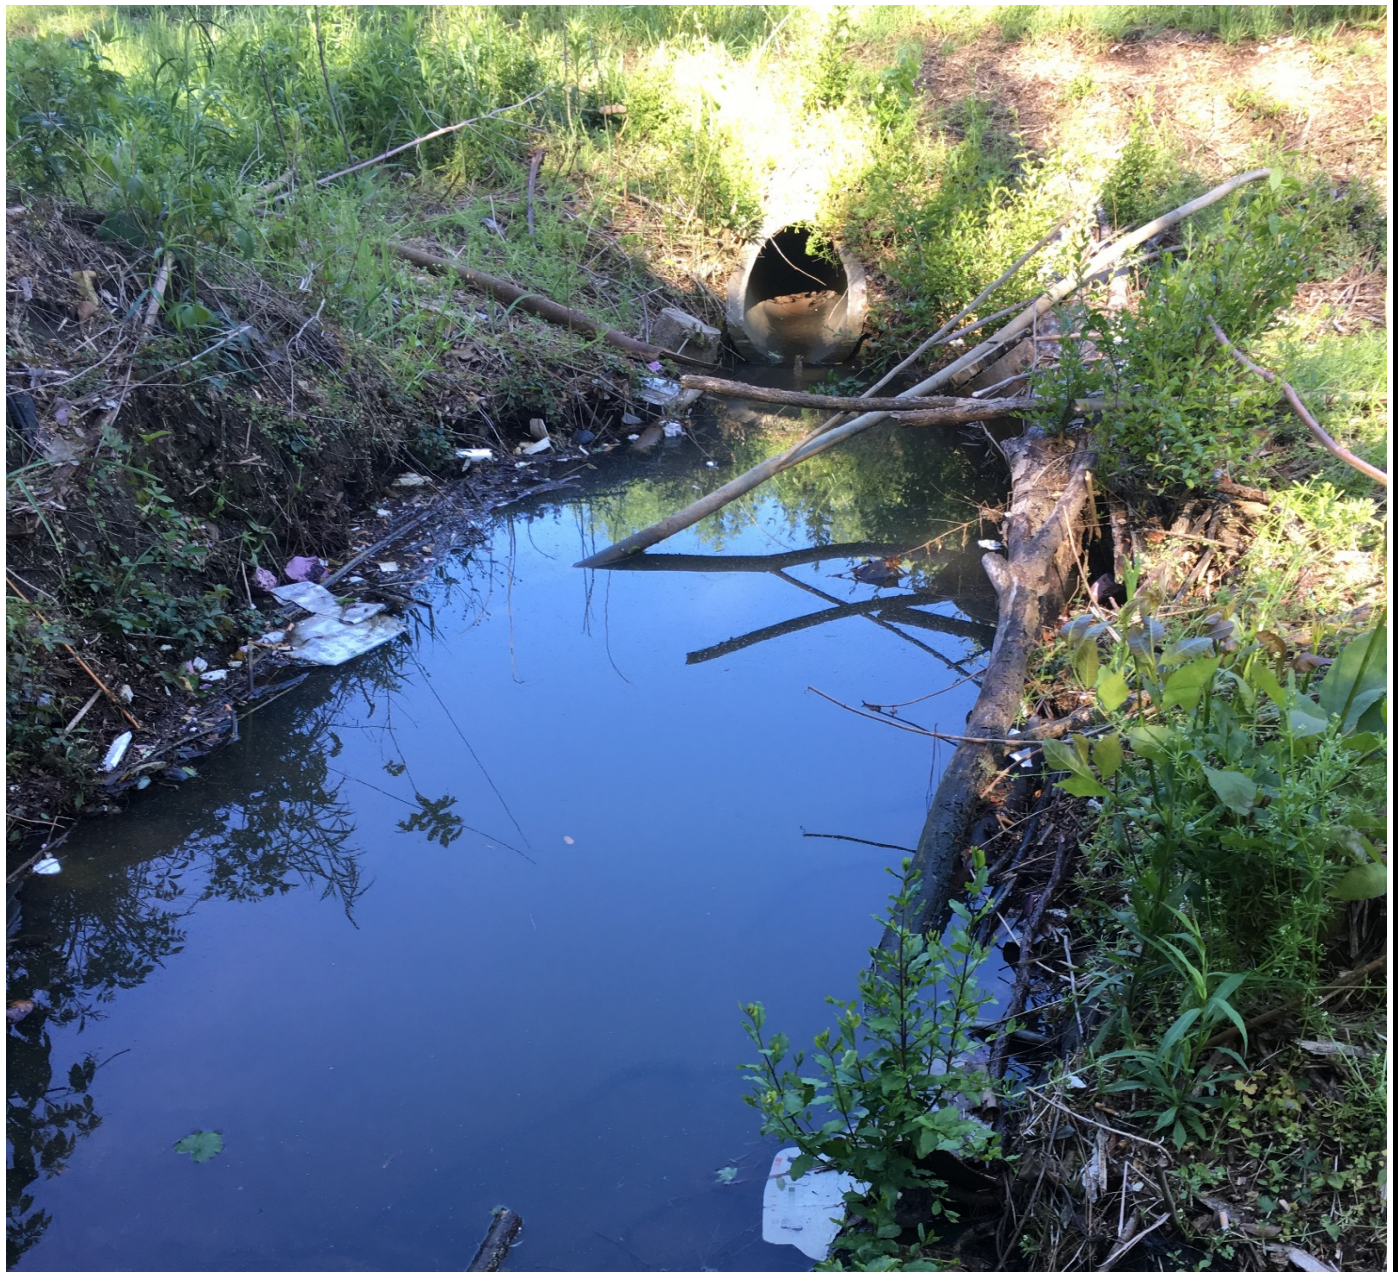
Carolina Crossroads Field Investigation		Site ID:	3502
		Type:	Outfall
Alignment:	I20000X	Date:	4/17/2018
Approx. Station:	86+30	Weather:	Sunny
Side:	RT	Reviewer:	Tom Miller / Cole Pierce
<b>Downstream Channel Information:</b>		No real defined channel	
Additional Description: Toe of fill outlet with no defined channel.			
<b>Pipe Structure Information</b>			
Shape:	Circular	Size:	15 in
Material:	R.C.	End Type:	Beveled End
Rip Rap Present?	No	Scour Present?	Yes
Other Notes: Long scour hole. This area is to be reconstructed per RPA geometry.

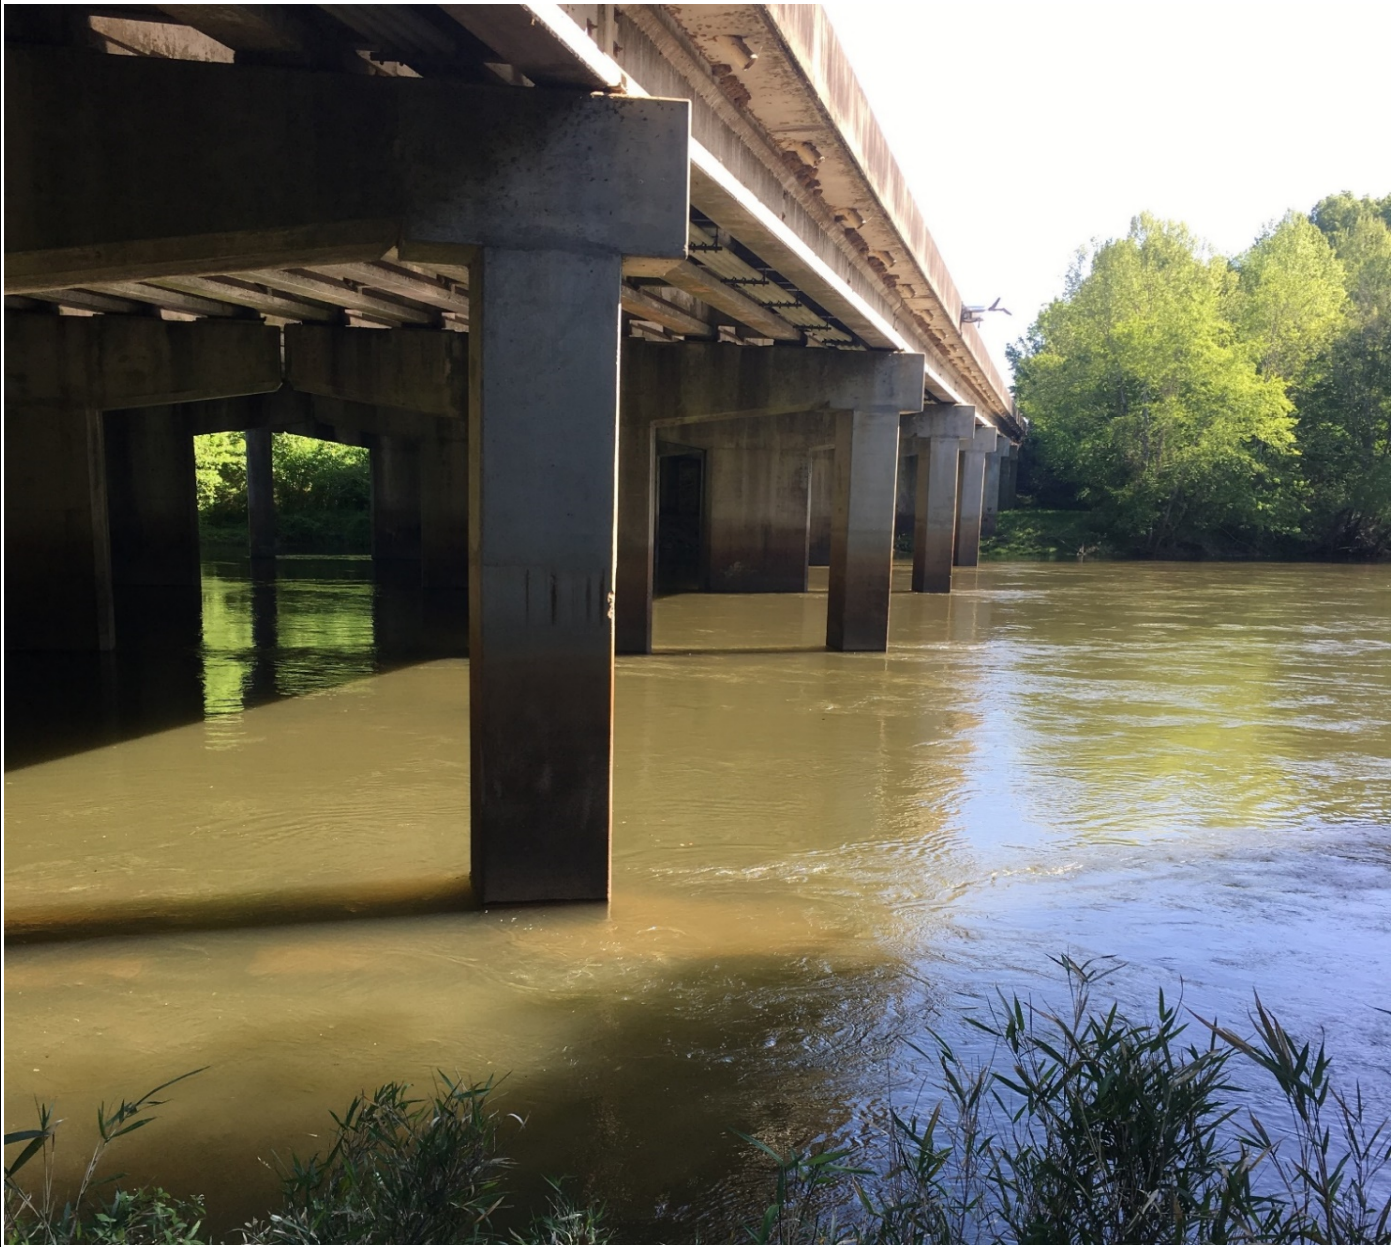
Carolina Crossroads Field Investigation			Site ID:	3503
			Type:	Bridge
Alignment:	I20000X	Date:	4/17/2018	
Approx. Station:	89+60	Weather:	Sunny	
Side:	RT	Reviewer:	Dustin Hughey	
Bridge Information				
Water Body:	Saluda River			
Road Name:	Interstate 20			
Rip Rap Present?	Yes	Scour Present?	No	
High Water Mark Visible?	Yes	Banks Description: Vegetation & rip rap		
Other Notes: Discoloration along the pier indicates a recent high-water mark of approximately 6 ft below the cap.

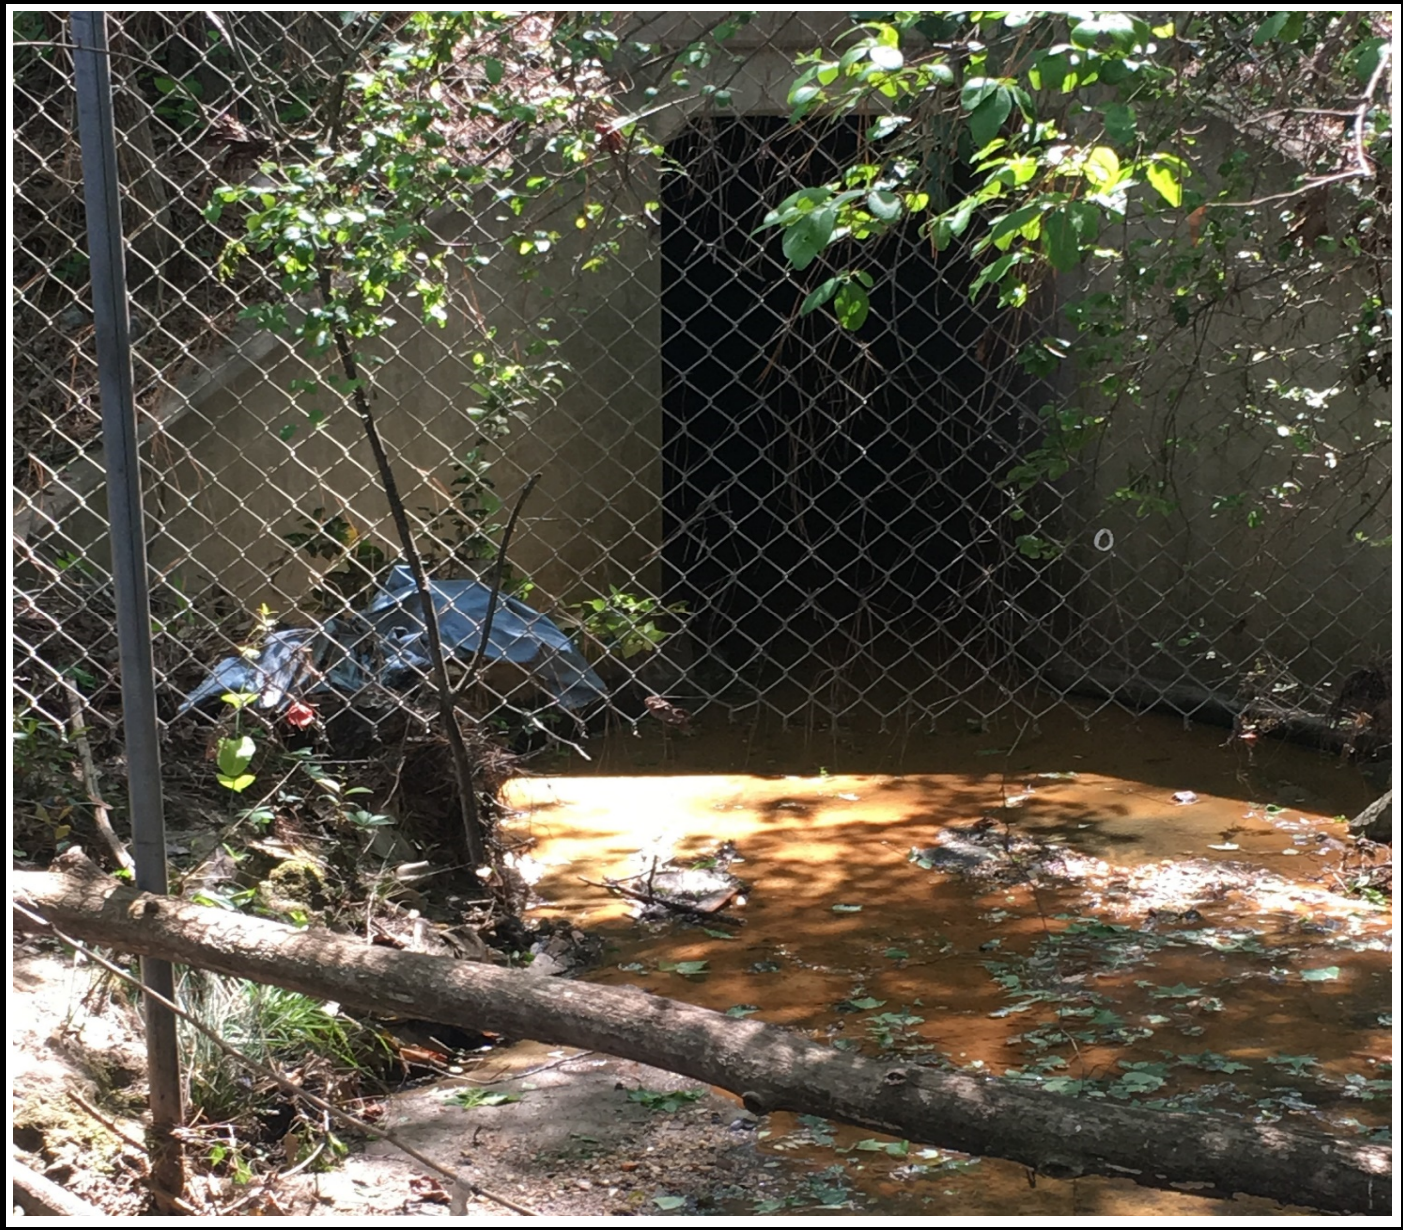
<b>Carolina Crossroads Field Investigation</b>		<b>Site ID:</b>	<b>3701</b>
		<b>Type:</b>	<b>Inlet</b>
Alignment:	BSHRFOP	Date:	4/18/2018
Approx. Station:	4119+05	Weather:	Sunny
Side:	LT	Reviewer:	Tom Miller / Cole Pierce
<b><i>Upstream Channel Information</i></b>			
High Water Mark Visible?	No	Water Present?	Perennial
Erosion Present?	No	Notes: Heavily vegetated overbanks	
<b><i>Pipe Structure Information</i></b>			
Shape:	Box	Size:	4 ft (w) X 6 ft (h)
Material:	R.C.	End Type:	Headwall
Rip Rap Present?	No	Scour Present?	No

Other Notes: Headwall with 30 to 45 degree wingwalls. This area may need reconstruction per RPA geometry.

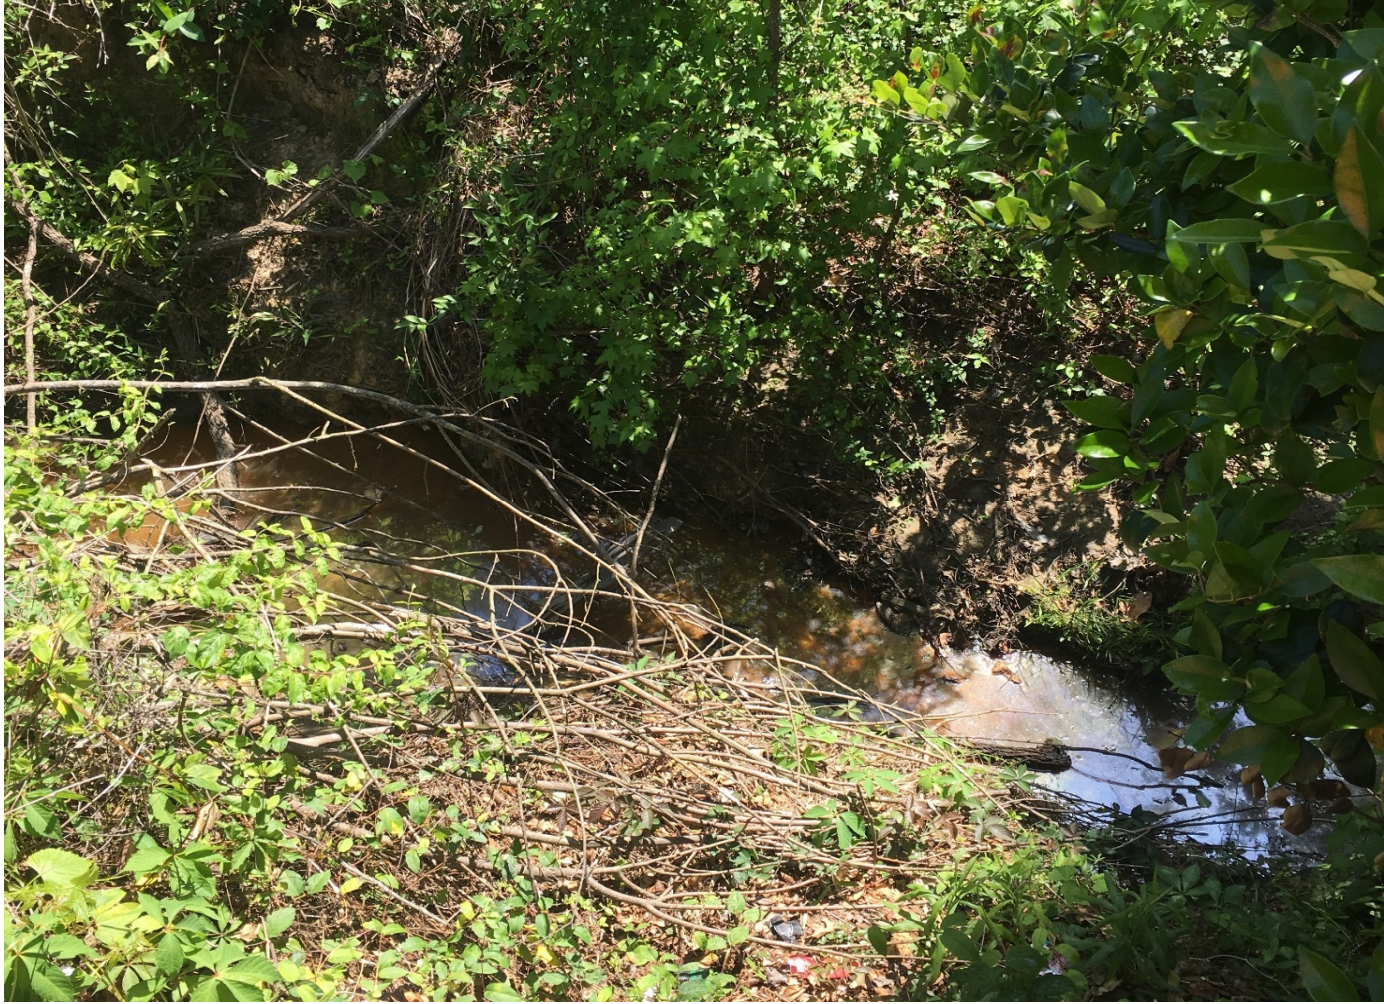
Carolina Crossroads Field Investigation			Site ID:	3702
			Type:	Channel
Alignment:	BSHRF1P	Date:	4/18/2018	
Approx. Station:	4124+90	Weather:	Sunny	
Side:	LT	Reviewer:	Tom Miller / Cole Pierce	
<b>Channel Information</b>				
Channel Width:	2 ft	Approx. Side Slopes:	Vertical	
Channel Alignment:	Meandering	Vegetation On Banks?	Yes	
Channel Bottom Material:	Sandy	Approx. Water Depth:	1 in to 2 in	
High Water Mark Visible?	No	Water Present?	Intermittent	
Erosion Present?	No			
Additional Channel Description: Approximately 1 foot deep. Rip rap protection over entire length of channel.				
Overbank Areas Description: Bush River Road is located to the north of the ditch and a Cracker Barrel is located to the south. The overbanks are vegetated between the ditch and road / business.				
Upstream Pipe Structure Information: See Site			3703	
Other Notes: The channel will need some realignment according to RPA geometry.

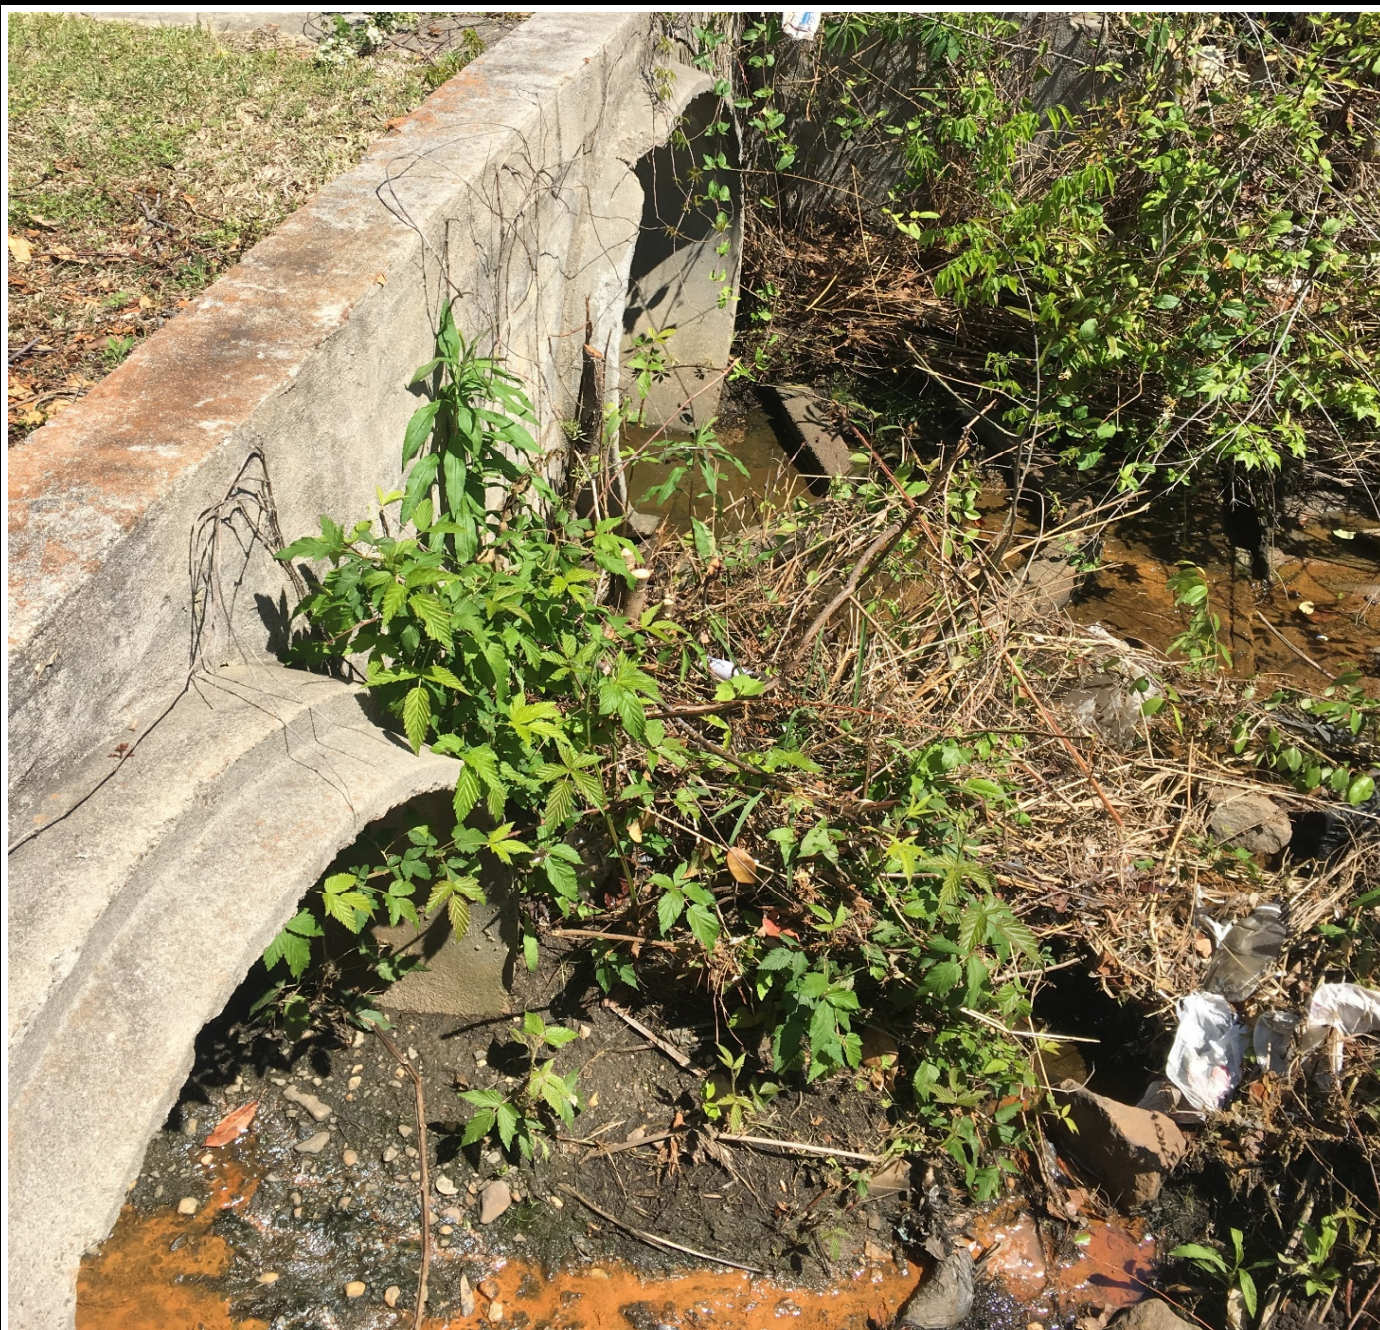
<b>Carolina Crossroads Field Investigation</b>		<b>Site ID:</b>	<b>3703</b>
		<b>Type:</b>	<b>Outfall</b>
Alignment:	BSH001P	Date:	4/18/2018
Approx. Station:	23+25	Weather:	Sunny
Side:	RT	Reviewer:	Tom Miller / Cole Pierce
<b>Downstream Channel Information: See Site</b>			<b>3702</b>
<b>Pipe Structure Information</b>			
Shape:	Circular	Size:	Double 42 in
Material:	R.C.	End Type:	Headwall
Rip Rap Present?	Yes	Scour Present?	No
Other Notes: Energy dissipaters downstream of the northern pipe. Area to be reconstructed per RPA geometry.

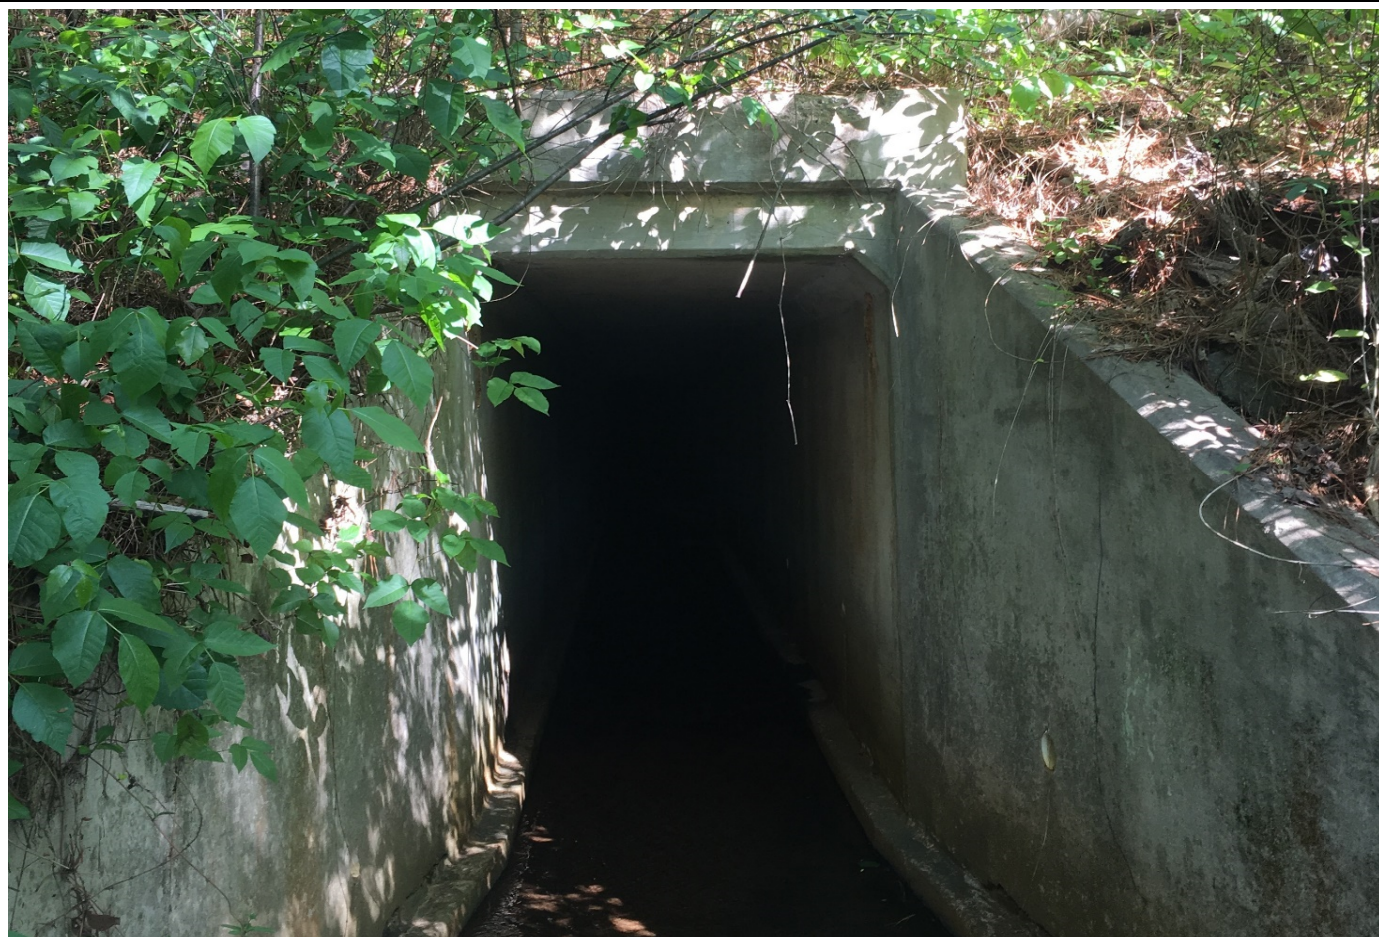
<b>Carolina Crossroads Field Investigation</b>		<b>Site ID:</b>	<b>3721</b>
		<b>Type:</b>	<b>Outfall</b>
Alignment:	BSHRG0P	Date:	4/17/2018
Approx. Station:	5120+50	Weather:	Sunny
Side:	RT	Reviewer:	Tom Miller / Cole Pierce
<b><i>Downstream Channel Information</i></b>			
Channel Width:	6 ft	Approx. Side Slopes:	3:1
Channel Alignment:	Straight	Vegetation On Banks?	Yes
Channel Bottom Material:	Concrete	Approx. Water Depth:	1 in
High Water Mark Visible?	No	Water Present?	Perennial
Erosion Present?	No	Notes: Paved channel, approximately 3 feet-deep.	
Overbank Areas Description: Heavily developed immediately downstream.			
<b><i>Pipe Structure Information</i></b>			
Shape:	Box	Size:	4 ft (w) X 6 ft (h)
Material:	R.C.	End Type:	Wingwalls
Rip Rap Present?	No	Scour Present?	No
Other Notes: 75 degree wingwalls downstream. Stable banks. Constant 0.5 in flow through concrete ditch to 60 in pipe, grooved end projected.

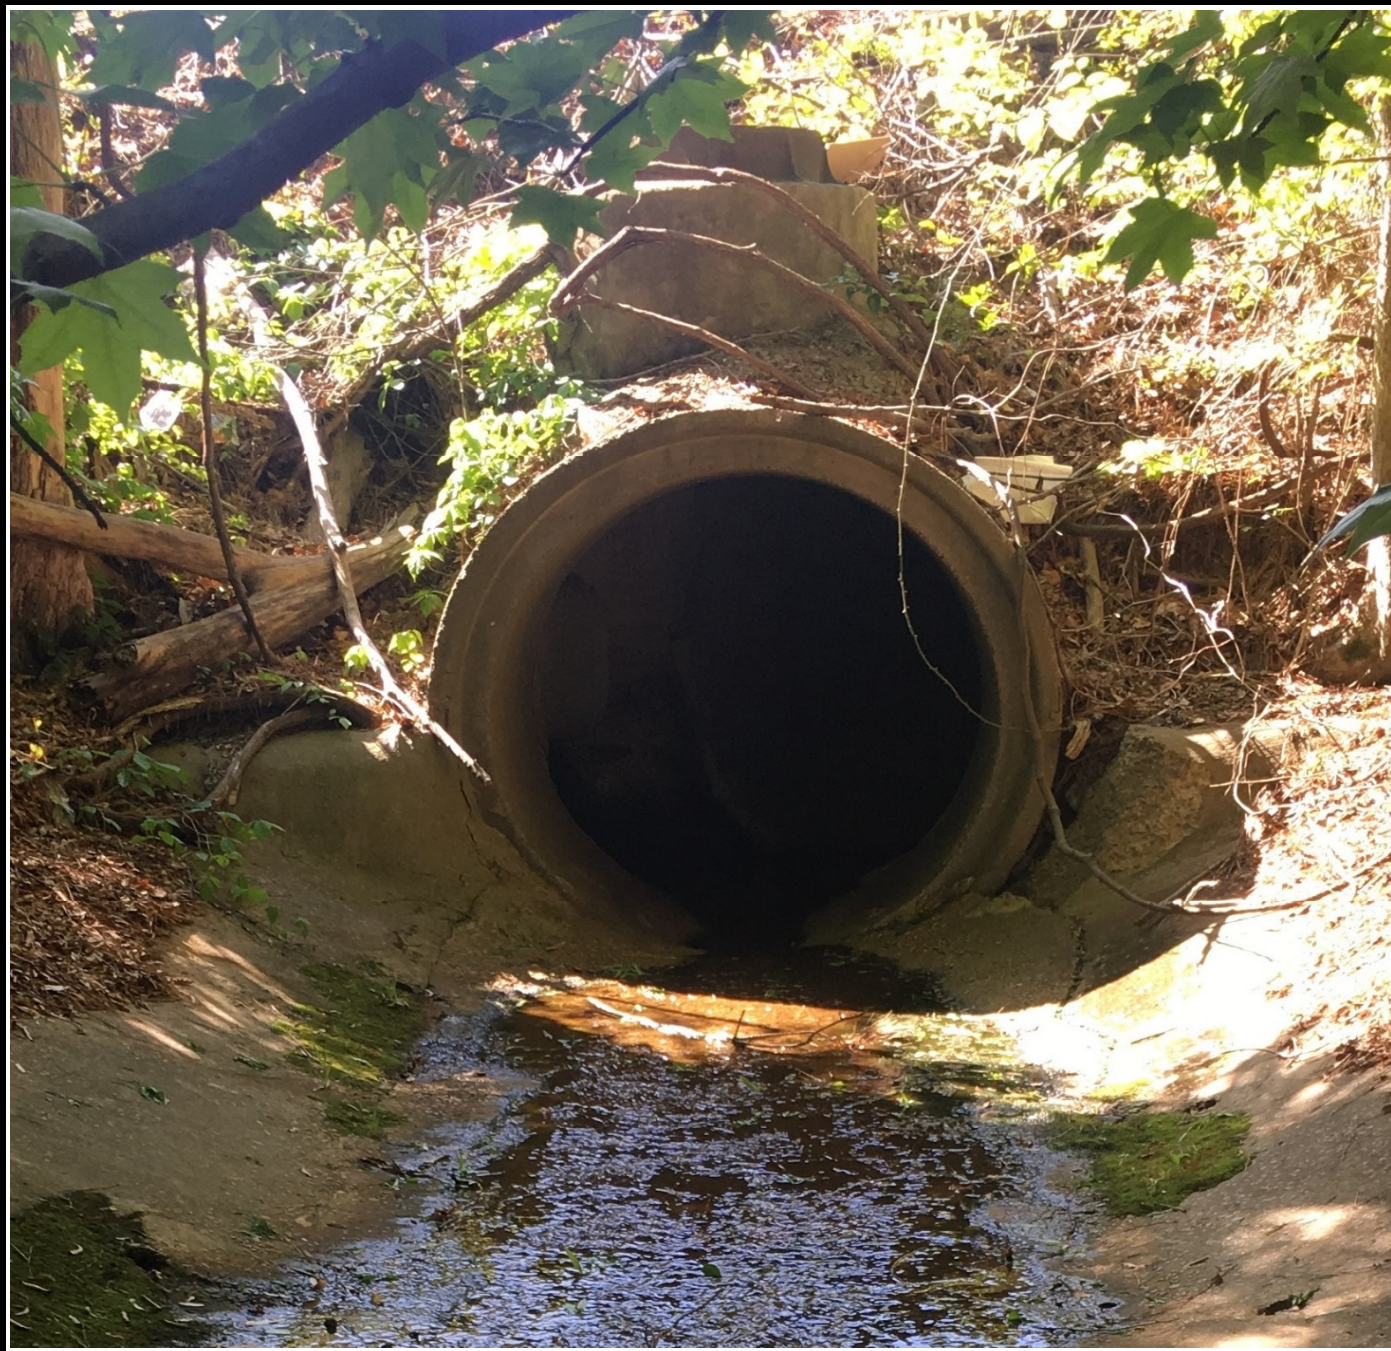
Carolina Crossroads Field Investigation			Site ID:	3722
			Type:	Inlet
Alignment:	BSHRG0P	Date:	4/17/2018	
Approx. Station:	5120+40	Weather:	Sunny	
Side:	RT	Reviewer:	Tom Miller / Cole Pierce	
Upstream Channel Information: See Site				3721
Pipe Structure Information				
Shape:	Circular	Size:	60 in	
Material:	R.C.	End Type:	Pipe End Projecting	
Rip Rap Present?	No	Scour Present?	No
