## LEAD BASED PAINT INVESTIGATION REPORT

COMMERCIAL STRUCTURE  
411 LAWAND DRIVE  
COLUMBIA, SOUTH CAROLINA

**February 7, 2020**

FME Project No.: G5662.00

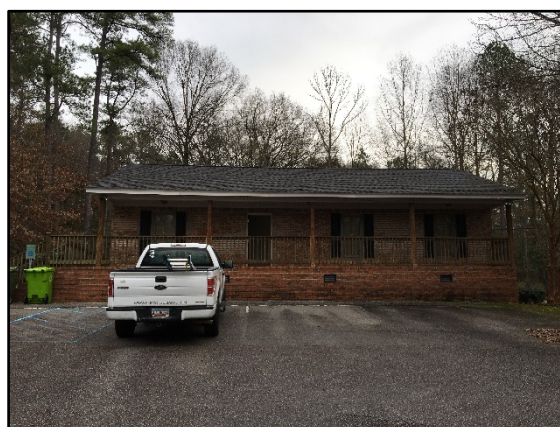
Photo 1 – 411 Lawand Drive, Columbia, SC

It is FME’s understanding that the objective of this investigation was to identify lead painted or coated building components associated with the interior and exterior of the subject structure in advance of demolition activities. The field investigation was performed on February 5, 2020. The 1400 ft<sup>2</sup> subject structure was constructed in 1985, according to the Richland County Tax Assessor’s office, and is located at 411 Lawand Dr., in Columbia, South Carolina. It is a single-story, raised foundation brick and mortar structure with a pitched shingled roof, and an eight (8)

foot overhang on the front porch of the structure. The finishes within the interior of the structure are drywall walls and ceilings with spray applied texture on the ceilings, and wood floors with various floor finishes throughout. See Appendix A – Site Vicinity Map, for the location of the structure. See Appendix B –General Building Plans, for a layout of the building.

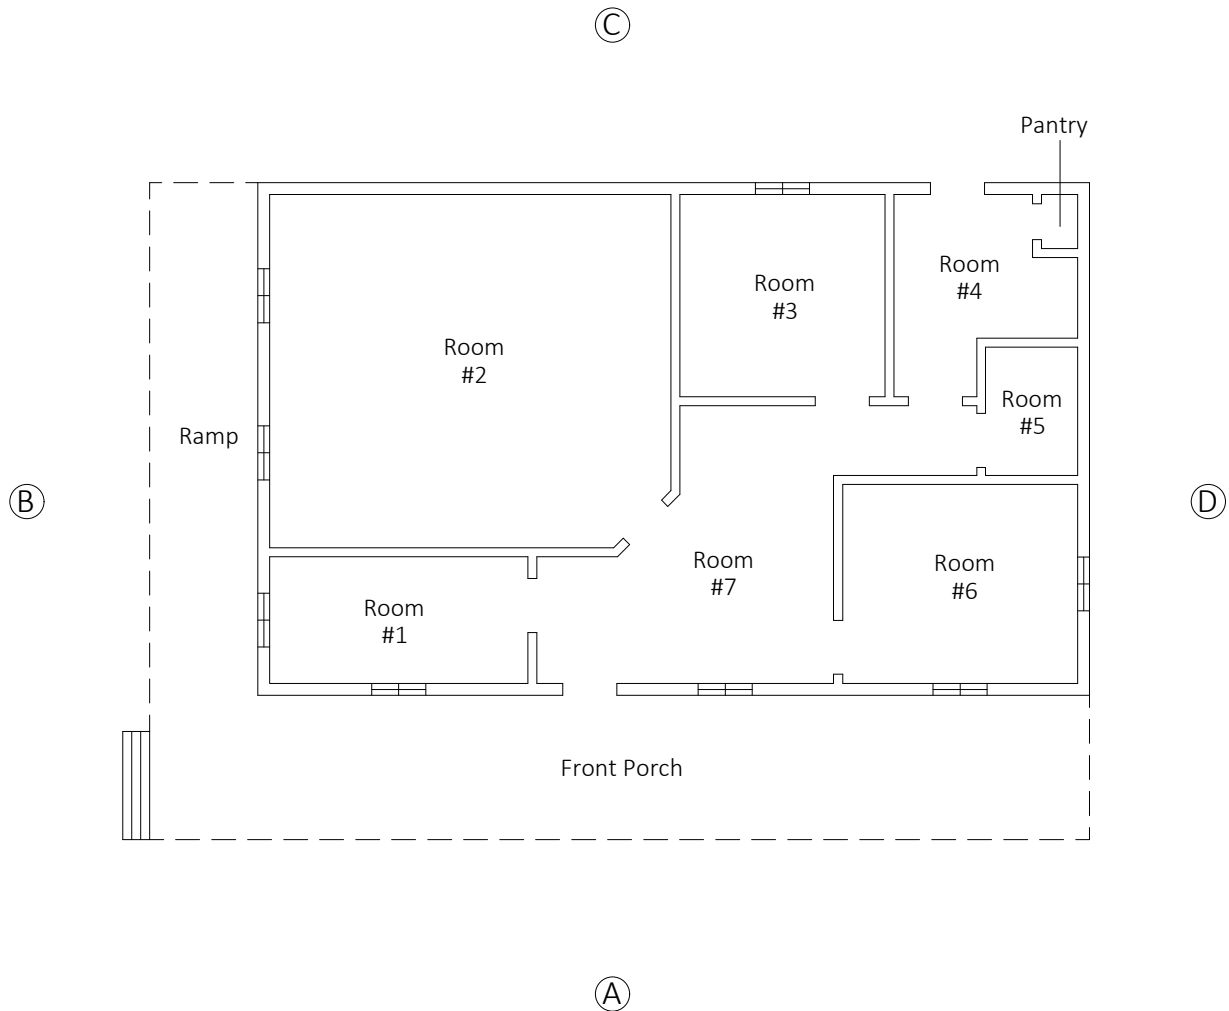
2

The results from the XRF quantitative testing of the building components indicate that lead is present in paint and/or coatings in concentrations greater than or equal to ( $\geq$ ) 0.7 mg/cm<sup>2</sup> on the porcelain sink in the bathroom. No other lead-containing or LBP coated building materials were identified during the investigation. See Appendix B – General Building Plans, for the lay-out of the building.

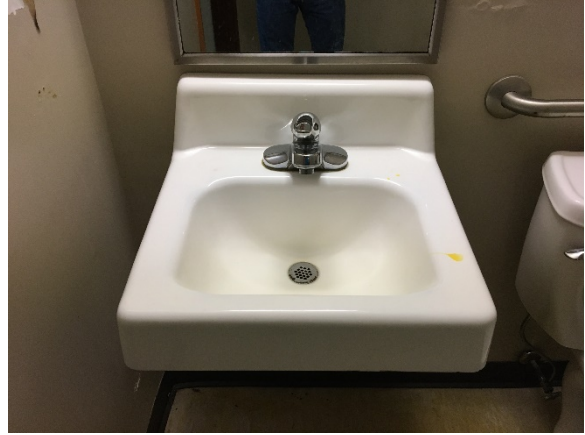
The following building component tested positive for lead in concentrations greater than or equal to ( $\geq$ ) 0.7 mg/cm<sup>2</sup>: The white porcelain sink in the restroom For more information regarding the specific descriptions and locations of the items that were scanned, refer to the Appendix C – Summary of XRF Data. On the XRF Data Table, items highlighted in Red are positive and contain lead in concentrations greater than or equal to ( $\geq$ ) 0.7 mg/cm<sup>2</sup>. Items in Blue and Red text contain lead in concentrations that must be considered a potential for worker exposure by OSHA. See Appendix E – Site Photos for locations and pictures of the materials with concentrations greater than or equal to ( $\geq$ ) 0.7 mg/cm<sup>2</sup>. Appendix D includes the inspector's EPA lead-based paint inspector certification.

The results from the XRF quantitative testing of the interior building components scanned indicate that lead is present in paint and/or coatings in concentrations greater than or equal to ( $\geq$ ) 0.7 mg/cm<sup>2</sup> on the white porcelain sink in the restroom. There are no specific recommendations for this building unless salvaging is anticipated where the sink may be removed. Otherwise, the sink can remain in the building during demolition activities. As stated previously, OSHA regulates any measurable level of lead, as it may pose a substantial exposure hazard to workers. Therefore, in these situations, OSHA regulations and safety procedures should be followed. These regulations also list the proper personal protective equipment to be used by the workers disturbing the LBP items

**Photo 2.** Porcelain Sink in Restroom

SCDHEC regulates the proper disposal of LBP and associated debris. SCDHEC defines two types of LBP debris. The first is LBP *waste*, which is defined as material such as wood, brick and metal that is painted with LBP. The other is LBP *residue* which is defined as residue that is generated from the removal (e.g., scraped, chipped, sandblasted, or chemical) of LBP from a structure. LBP *waste* that comes from a commercial or residential facility may be disposed of in either a class 2 or 3 landfill, while LBP *residue* from a commercial facility must have a toxicity characteristic leaching procedure (TCLP) analysis to determine the lead content. TCLP analysis is used to determine whether or not a waste is a characteristic hazardous waste due to leachability under the South Carolina Hazardous Waste Management Regulations. LBP *residue* with a TCLP analysis result greater than or equal to five milligrams per liter ( $\geq 5\text{ mg/l}$ ) lead must be disposed of in a Subtitle C landfill (Hazardous Waste). However, LBP *residue* from a commercial facility with a TCLP analysis result less than five milligrams per liter ( $< 5\text{ mg/l}$ ) lead is required to be disposed of in a Class 3 landfill.
