## ASBESTOS CONTAINING MATERIAL INVESTIGATION REPORT

COMMERCIAL STRUCTURE  
TRACT #402 – 500 LAWAND DRIVE  
COLUMBIA, SOUTH CAROLINA 29210  
TMS # R07302-05-01

November 17, 2020

FME Project No.: G5662.020

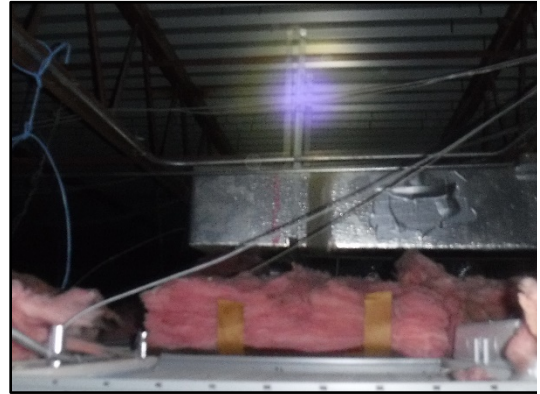
**HA-1 – Grey Duct Mastic on Fiberglass Duct Board (1,000 LF).** Asbestos-containing grey duct mastic on fiberglass duct board was noted above the suspended ceilings throughout both floors of the Building. This material was in an intact non-friable condition with no evidence of damage being noted. This material must be removed, handled, and disposed of as ACM by a licensed abatement contractor prior to the start of demolition activities.

Asbestos-containing grey duct mastic on fiberglass duct board was noted above the suspended ceilings throughout both floors of the Building. This material was in an intact non-friable condition with no evidence of damage being noted. This material must be removed, handled, and disposed of as ACM by a licensed abatement contractor prior to the start of demolition activities.

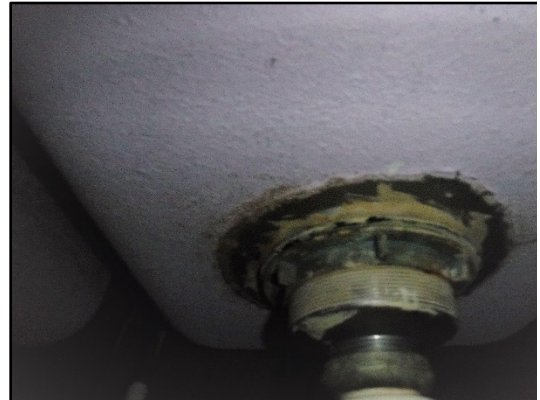
**HA-2 – Pink Sink Undercoating (8 SF).** Asbestos-containing pink sink undercoating was noted in the break room on the first floor. This material was in an intact non-friable condition with no evidence of damage being noted. This material must be removed, handled, and disposed of as ACM by a licensed abatement contractor prior to the start of demolition activities.

Asbestos-containing pink sink undercoating was noted in the break room on the first floor. This material was in an intact non-friable condition with no evidence of damage being noted. This material must be removed, handled, and disposed of as ACM by a licensed abatement contractor prior to the start of demolition activities.

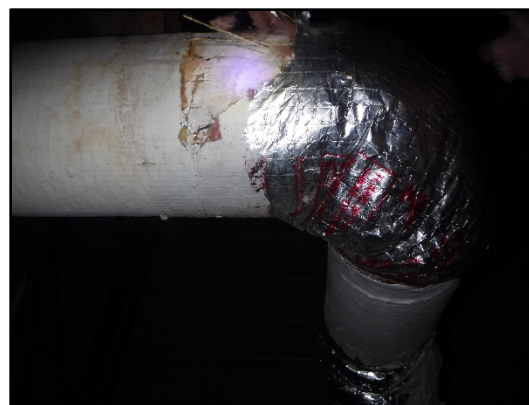
#### HA-3 – White Roof Drainpipe Mastic (20 LF).

Asbestos-containing white roof drain mastic was identified associated with one of the roof drains located above the suspended ceilings on the 2<sup>nd</sup> floor. This mastic was not found at other roof drains. This material was found in an intact non-friable condition with no evidence of damage being noted. This material must be removed, handled, and disposed of as ACM by a licensed abatement contractor prior to the start of demolition activities.

Asbestos-containing white roof drainpipe mastic was identified associated with one of the roof drains located above the suspended ceilings on the 2<sup>nd</sup> floor. This mastic was not found at other roof drains. This material was found in an intact non-friable condition with no evidence of damage being noted. This material must be removed, handled, and disposed of as ACM by a licensed abatement contractor prior to the start of demolition activities.

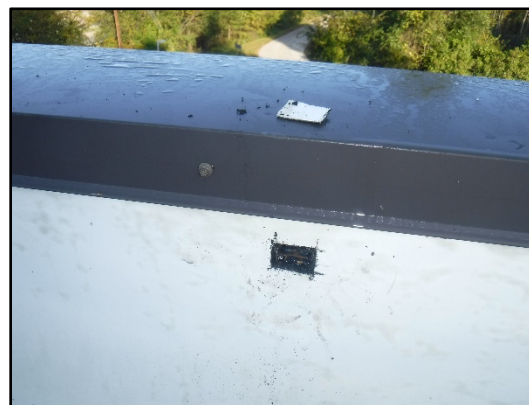
HA-4 – Roof Flashing (800 SF). Asbestos-containing roof flashing was noted around the perimeter of the roof and on flashing associated with curbing that supports roof mounted mechanical systems for the Building. This material was found under a white non-ACM roof membrane. This material was in an intact non-friable condition with no evidence of damage being noted. This material must be removed, handled, and disposed of as ACM by a licensed abatement contractor prior to the start of demolition activities.

Asbestos-containing roof flashing was noted on around the perimeter of the roof and on flashing associated with curbing that supports roof mounted mechanical systems for the Building. This material was found under a white non-ACM roof membrane. This material was in an intact non-friable condition with no evidence of damage being noted. This material must be removed, handled, and disposed of as ACM by a licensed abatement contractor prior to the start of demolition activities.
