# Underwater Inspection Report

South Carolina Department of Transportation

**Bridge No. 3210002600400**

**I-26 over Saluda River**

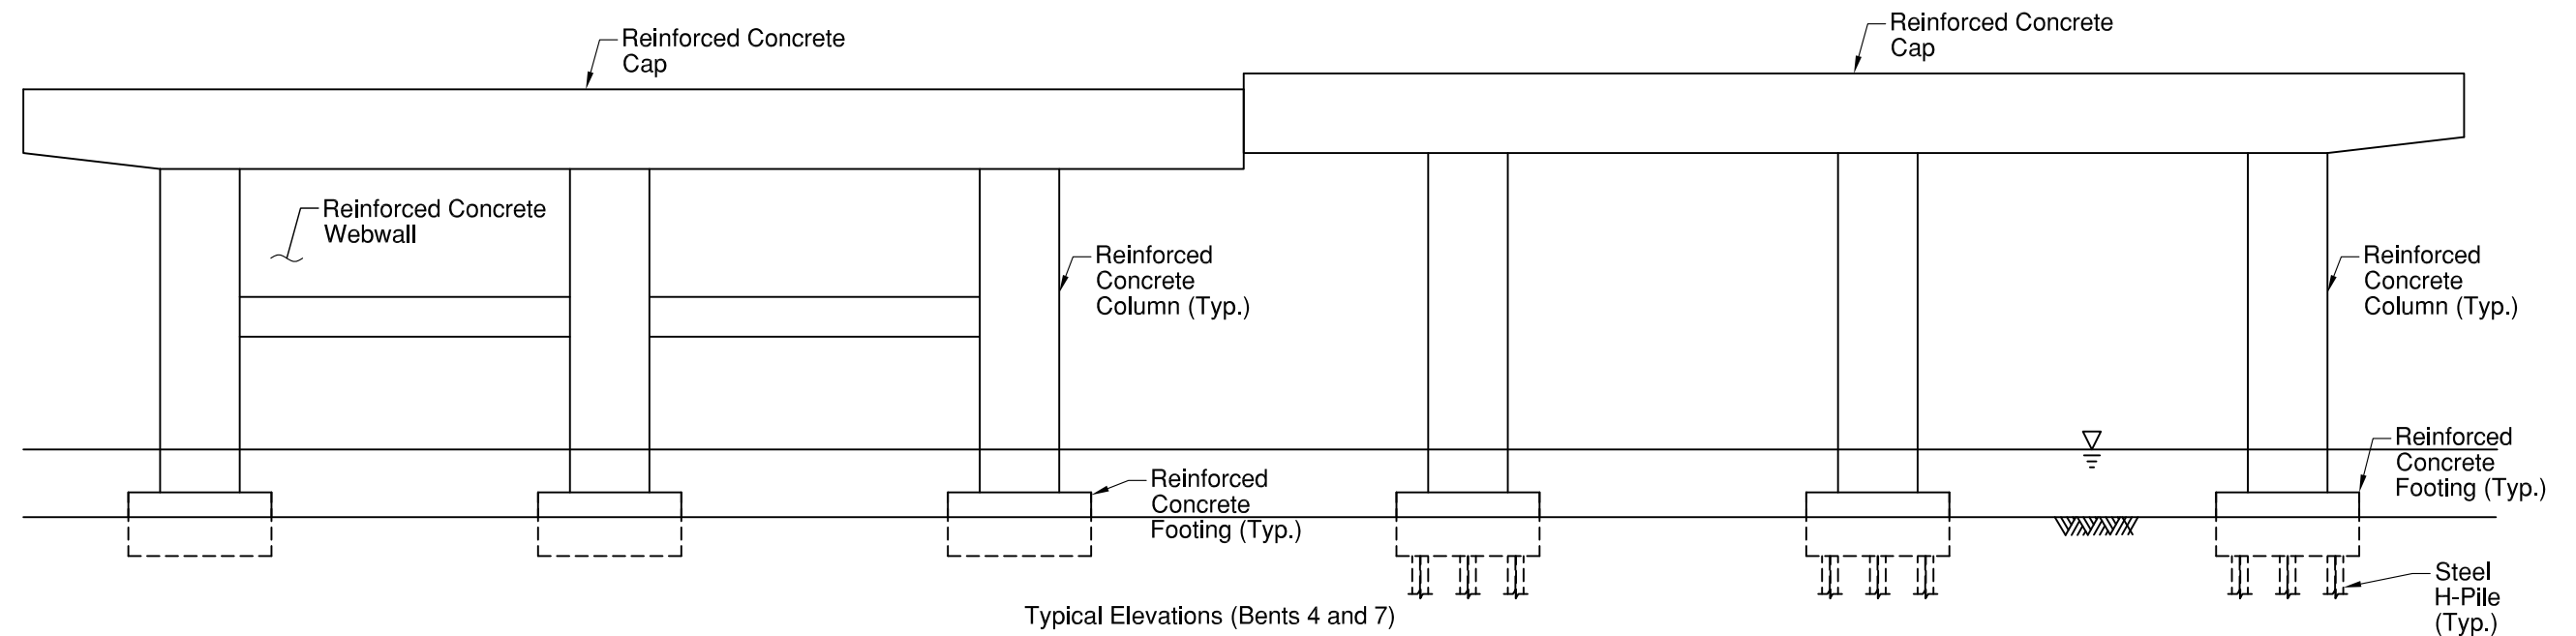
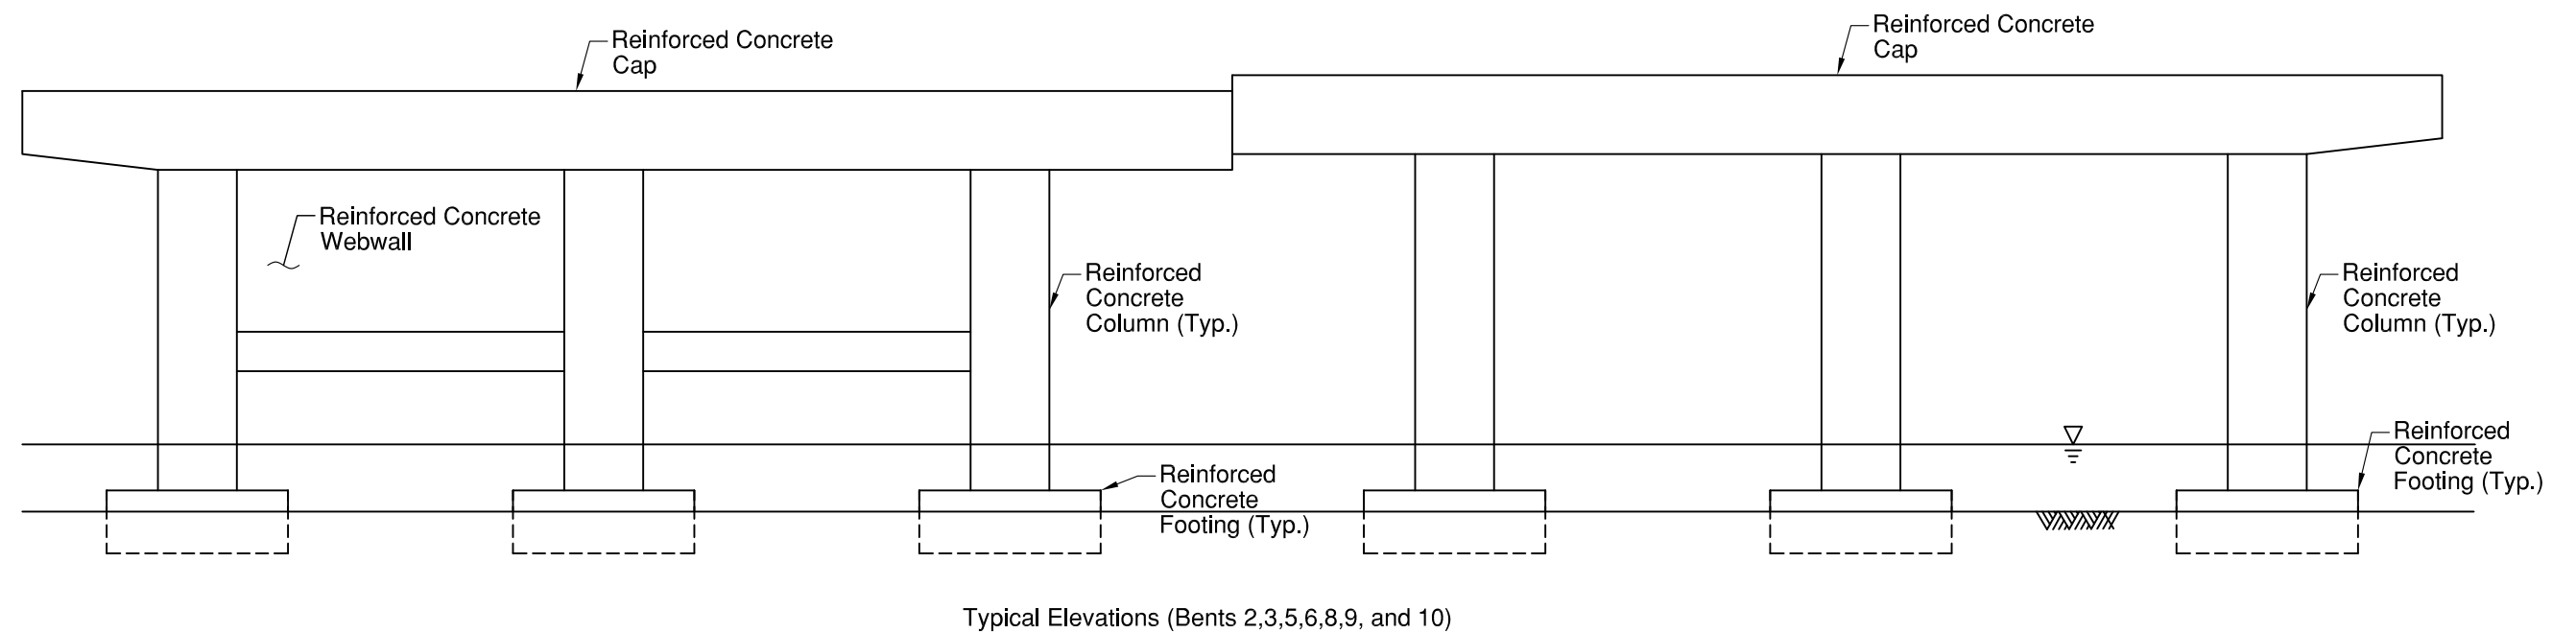
The SSUs located in water at the time of inspection included Bents 4 through 9. All of the inspected SSUs have 1/8-in. penetration scaling from the channel bottom to 4 ft. above the waterline. There is timber debris throughout the channel. Many of the inspected columns have footing exposure, up to 60 in. high. Refer to Table 2 in Appendix A for detailed footing exposure and remaining embedment measurements. Refer to Figure 1 in Appendix A for detailed inspection notes and a plan view showing the existing conditions at each of the inspected bents.

Overall, the submerged components of the bridge SSUs are in **good** condition. The light scaling observed is typical of in-service concrete of this age and does not affect the bridge. Based on a comparison with the original channel bottom profile, there has been up to 10 ft of general scour since construction. The widespread footing exposure is a result of the general scour. Plans call for the footings to be keyed into rock or founded on piles; no undermining was found during the inspection. The footing exposure does not affect the bridge.

It is recommended that the channel bottom be closely monitored for additional scour. In accordance with NBIS recommendations, the next routine underwater inspection for this bridge should be conducted on an interval not to exceed 60 months. In addition, bridge soundings should be taken as part of biennial above-water inspections, as well as following significant flooding events.

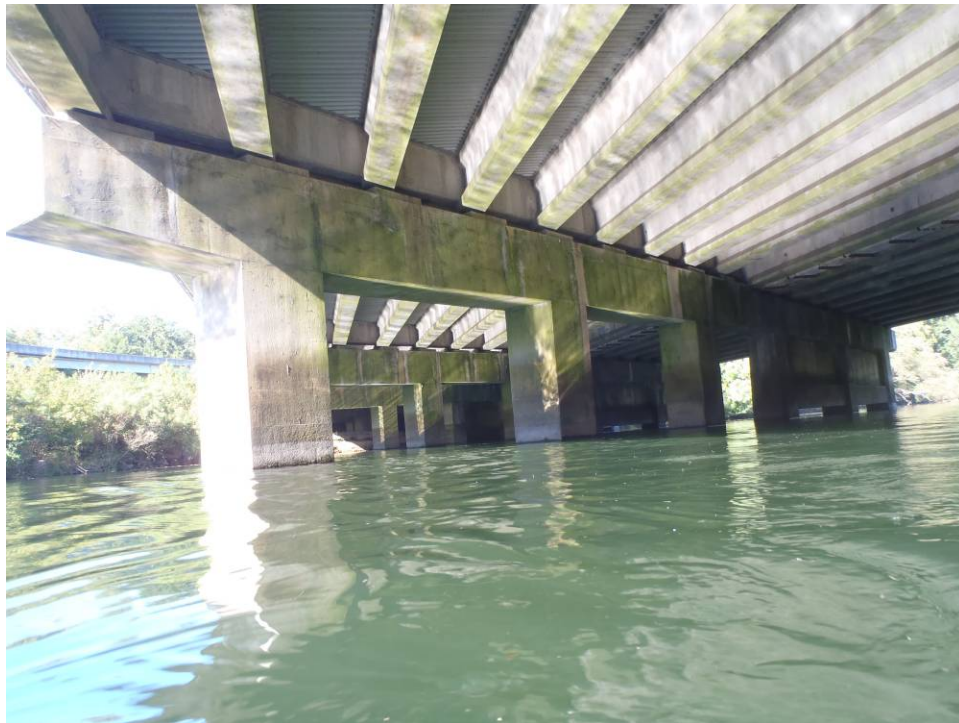
**Photograph 2. View of Bent 6, Typical of Bents 4 through 9.**

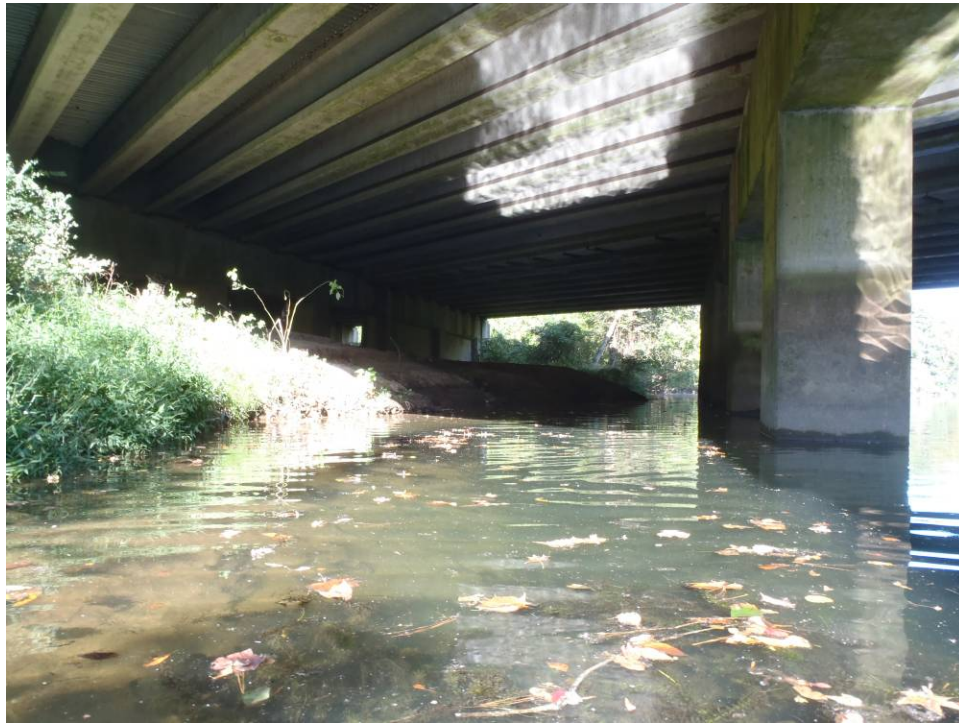
The banks along the Saluda River in the bridge vicinity are in stable condition. Embankment protection in the form of riprap is present on the north and south banks. The banks are gently sloping and there is no sign of active erosion. Refer to Photographs 3 and 4 in Appendix B for a view of the north and south embankments, respectively. The channel bottom in the bridge vicinity primarily consists of mud and rock.

**Photograph 3. North Embankment.**

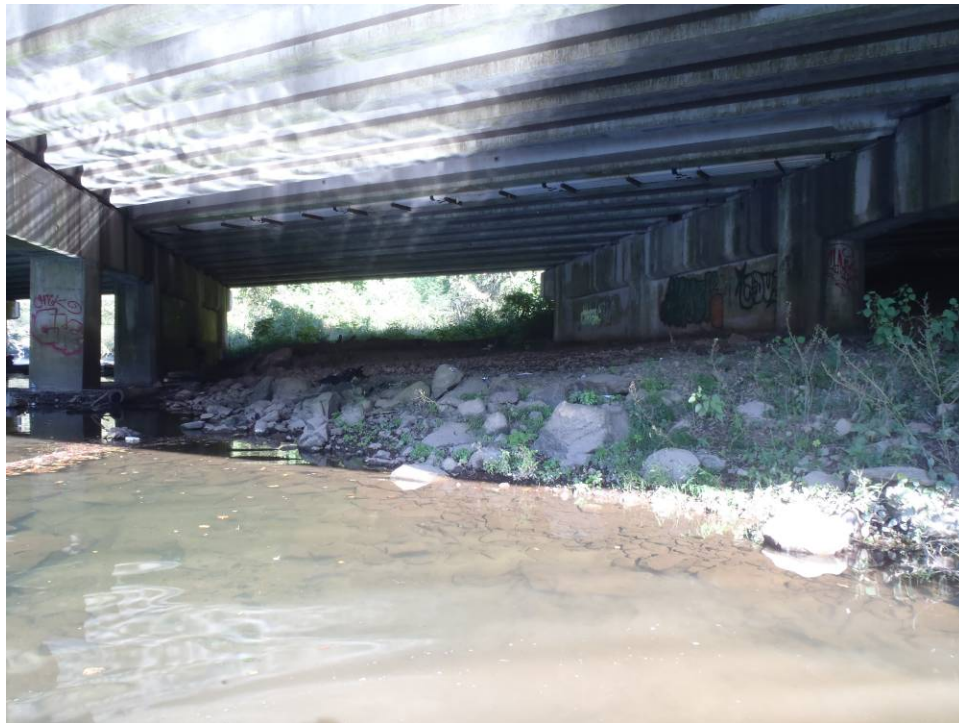
**Photograph 4. South Embankment.**
