(008) BRIDGE ID: 4010012620071
(005) ROUTE: RICHLAND I- 126 RMP
(006) CROSSING: I-126 I-26 SALUDA RIV RR

Bridge Element Group Textual Data

Bridge ID: 40-1-00126-2-00-71

14 Dec-2016

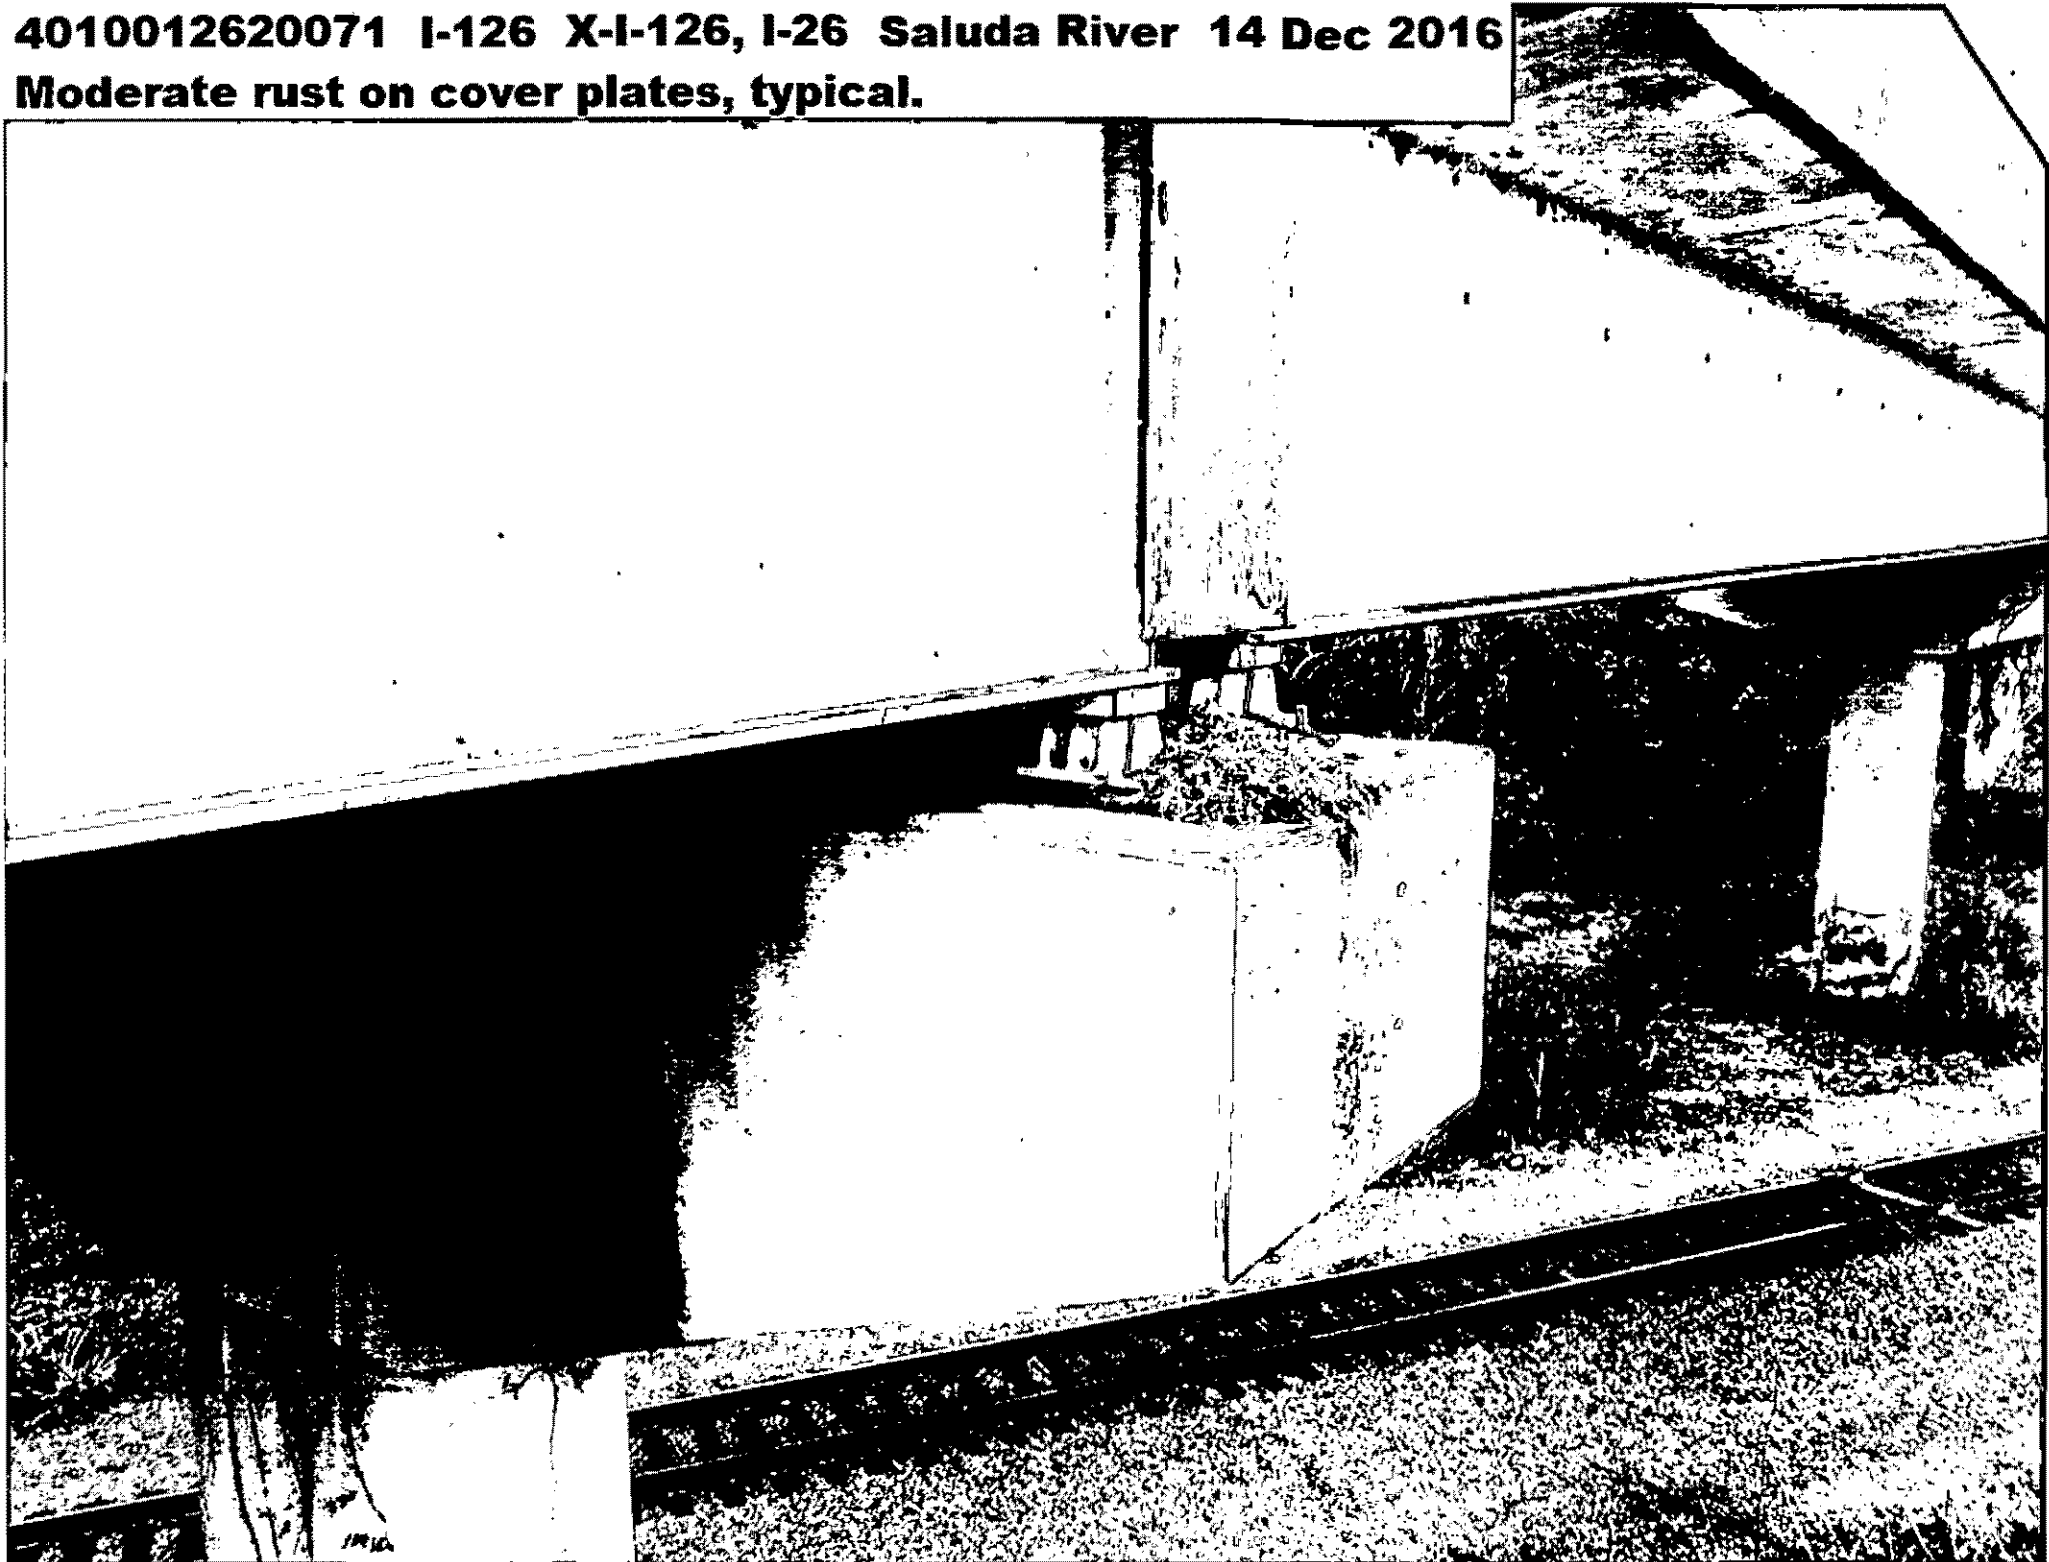
Moderate rust on cover plates, typical.

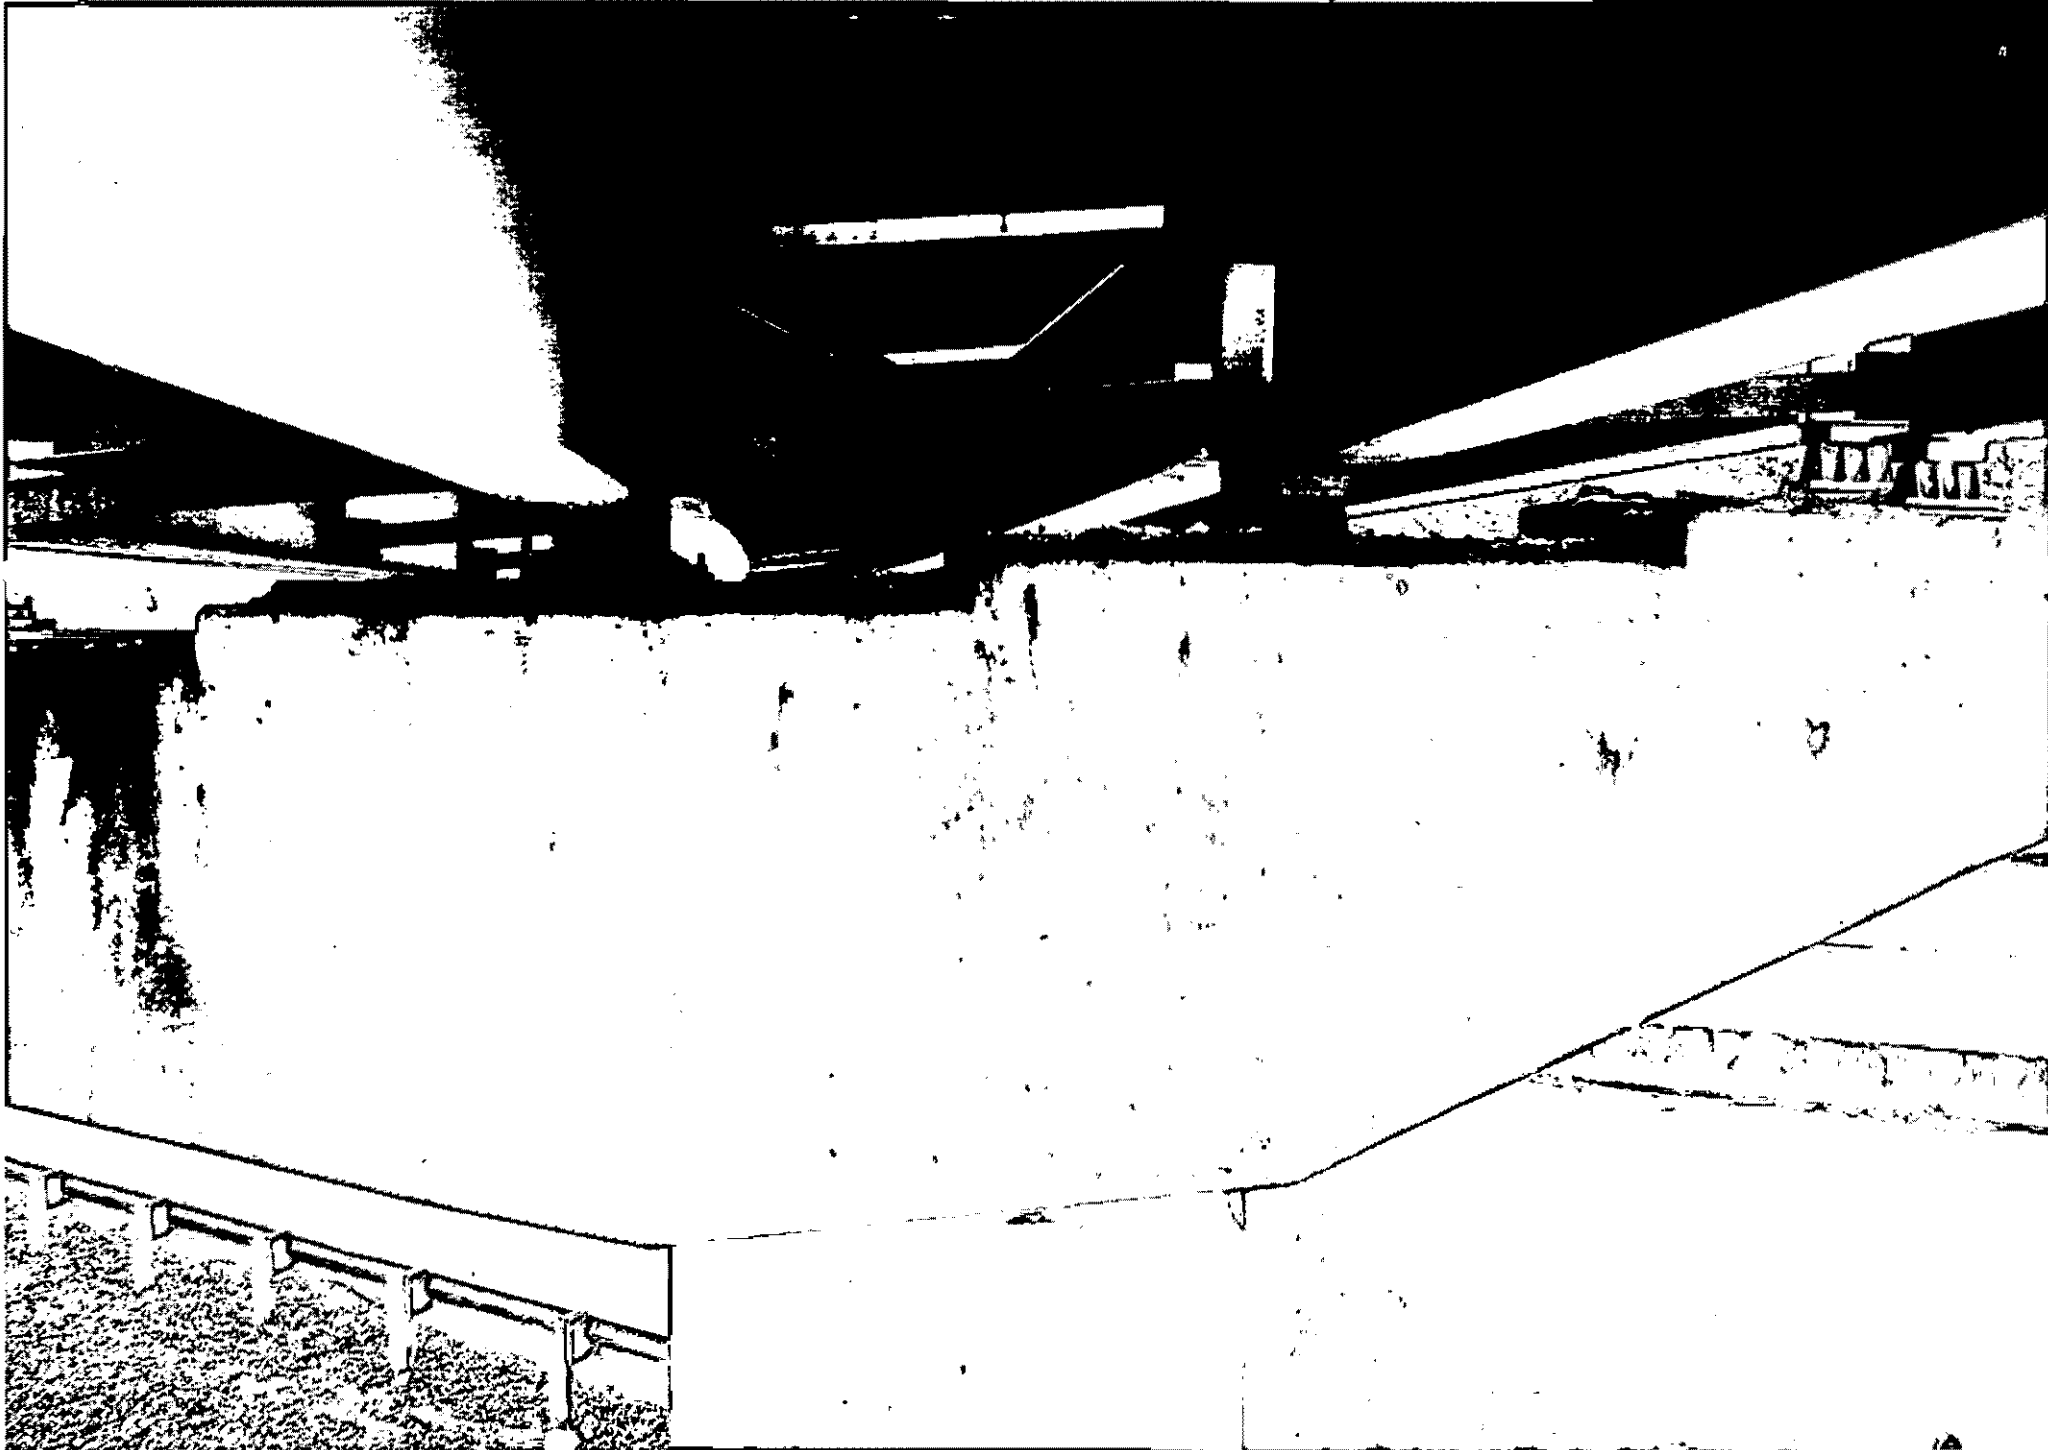
Cap bent 11 has a:

4ea 1' vert. h/l crack w/rust between bms 2 & 3, East side.

2ea minor spalls w/rust between bms 1 & 2, East side.

2' vert. h/l crack w/rust between bms 2 & 3, East side.

H/l map cracking between bms 3 & 4 East side.

4010012620071 I-126 X-I-126, I-26 Saluda River 14 Dec 2016
Cap bent 11 has minor spalls w/rust and hairline cracks, East side.

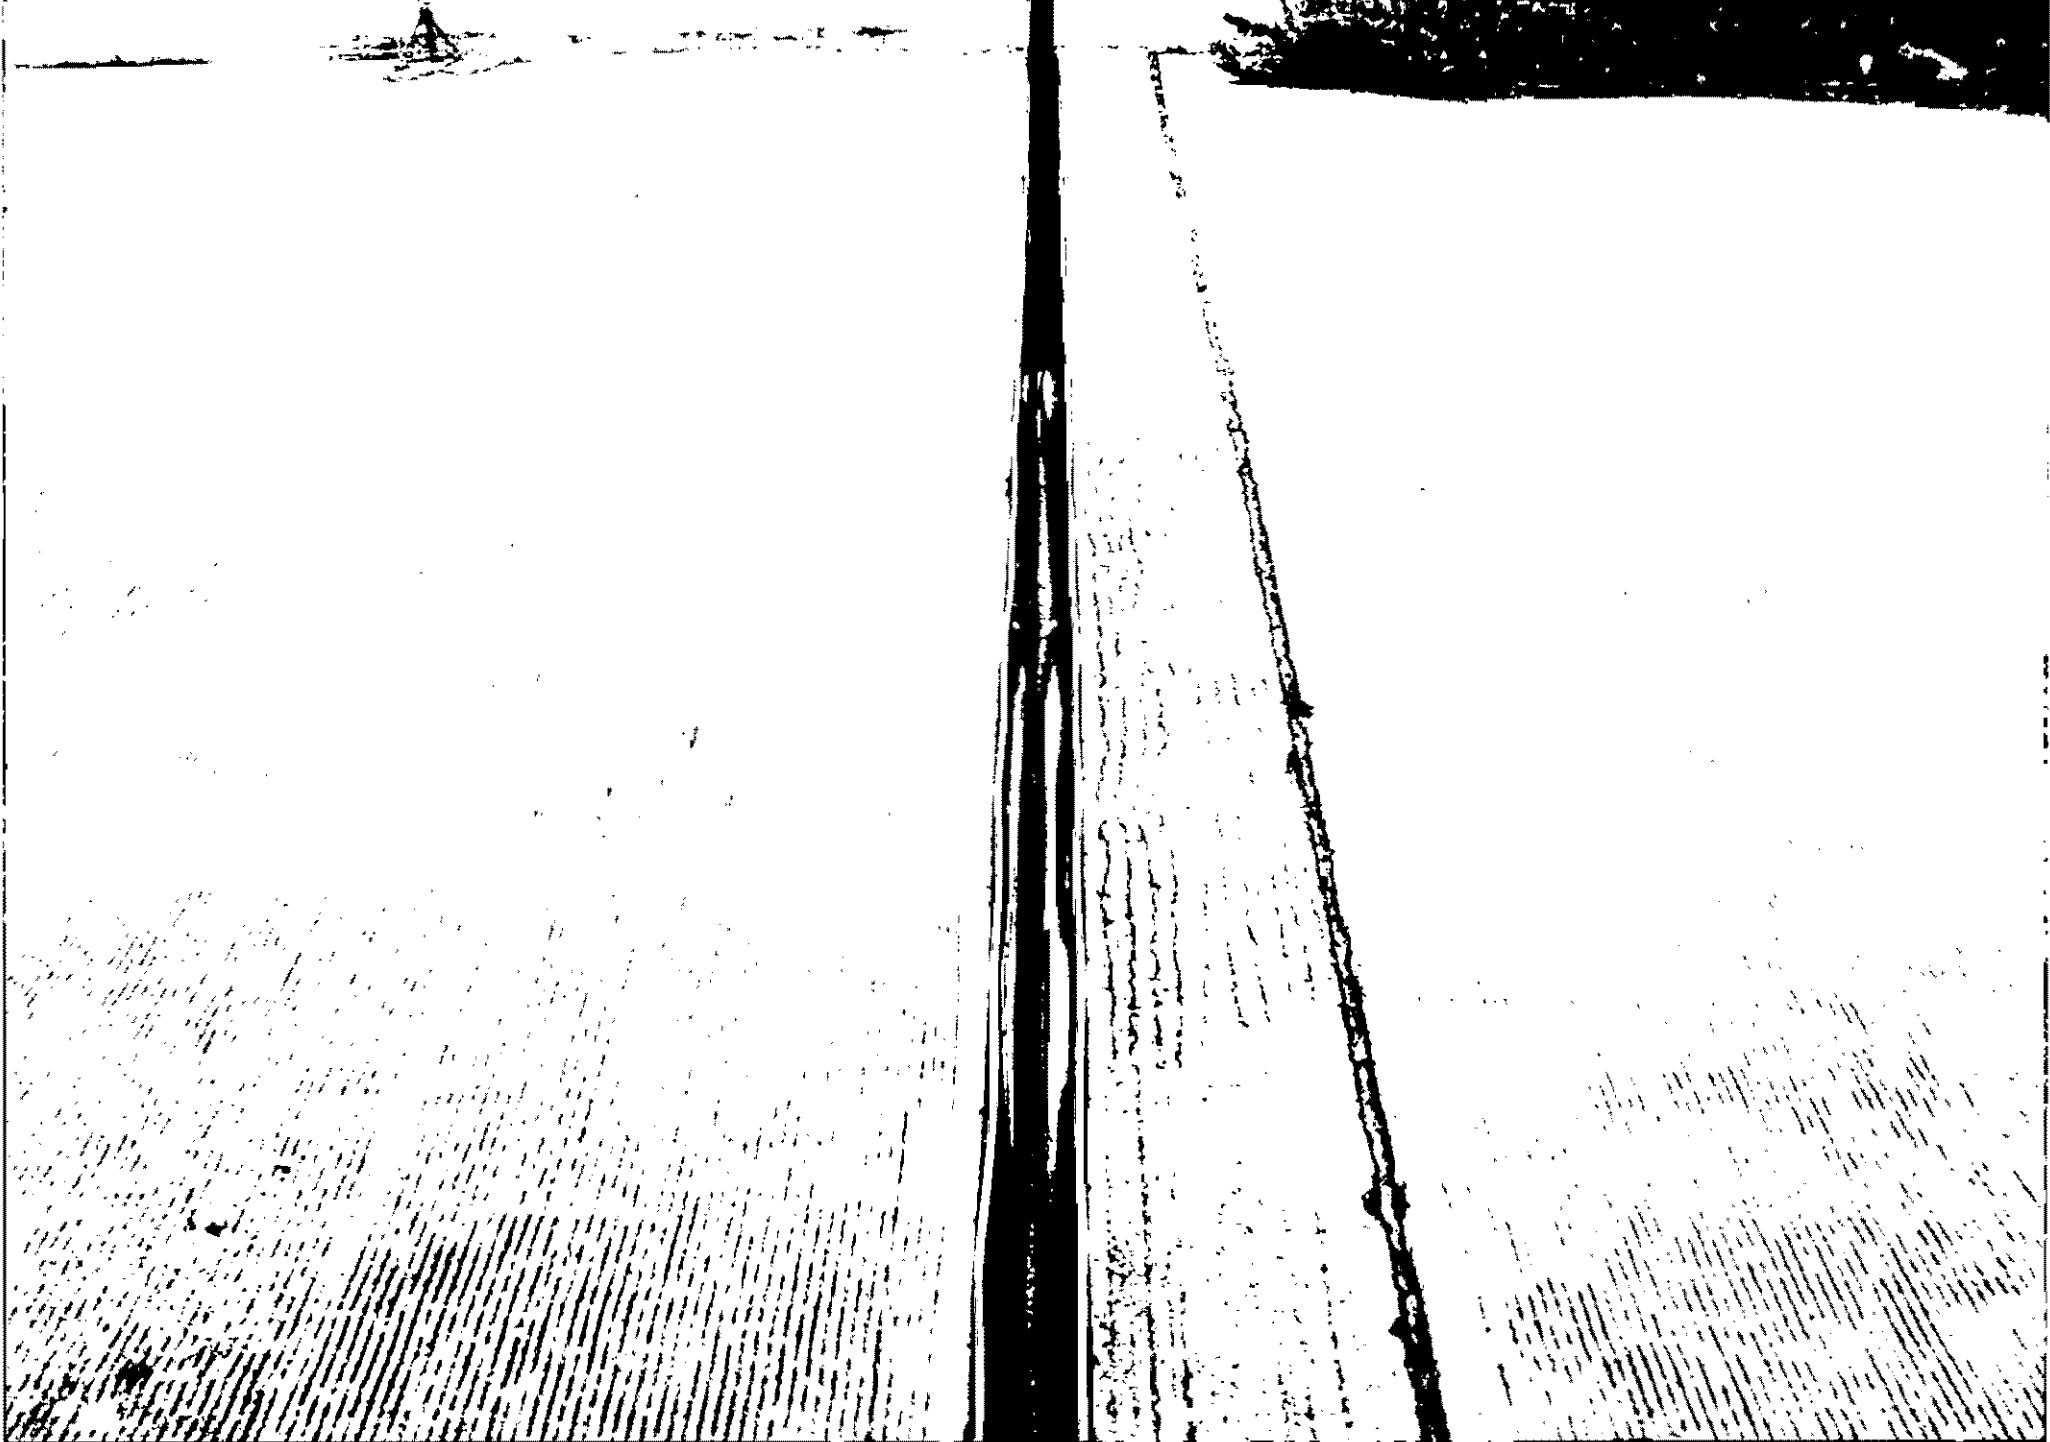
Expansion material torn, loose, cracked, split, and missing, (see photo).

Expansion material torn, loose, cracked, split and missing, typical.

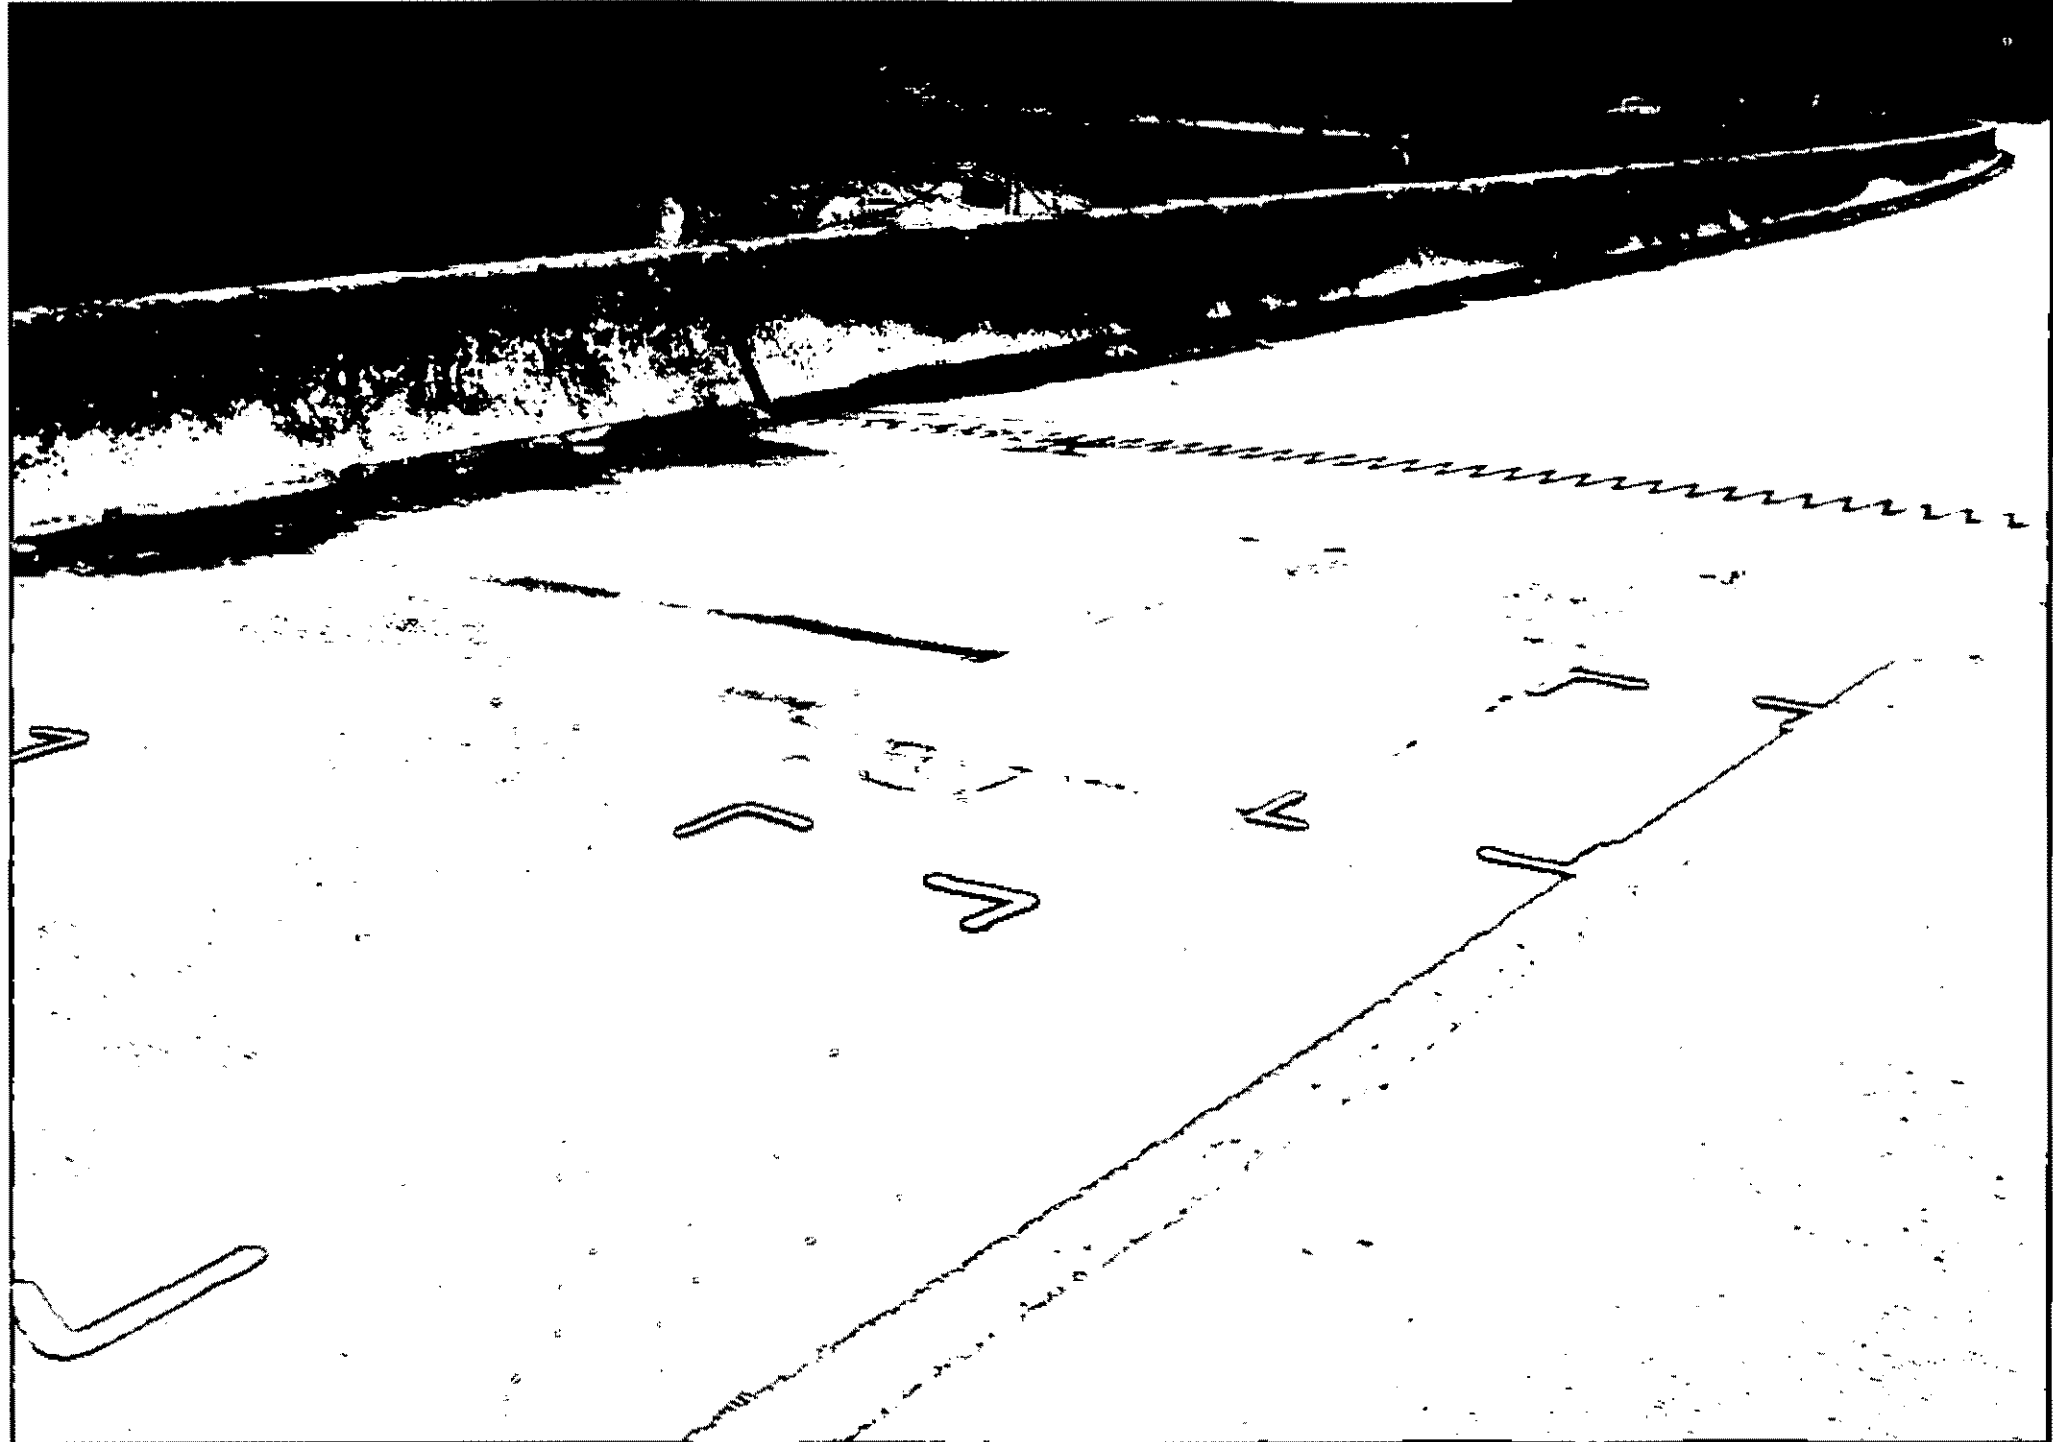
(6) Trans. hairline cracks w/eff. on underside of deck at soffit. Large spalls w/rust on deck, (see photo). Concrete spalling on underside of deck at finger joints. Trans. hairline cracks & hairline map cracking on top of deck. Large spall w/rebar exp. near mid-point of ramp. Deck drag preformed , Dec 2016, 6% spalls/delam.

Large spalls on deck that has been patched, typical.
