SCDOT BRIDGE INSPECTION FORM

(008) BRIDGE ID: 4010002600400
(005) ROUTE: RICHLAND I- 26
(006) CROSSING: C.N. AND L. RAILROAD

(009) LOCATION: 3MI NW OF COLA
(026) FUNCTIONAL CLASS: 11

Bridge Element Group Textual Data

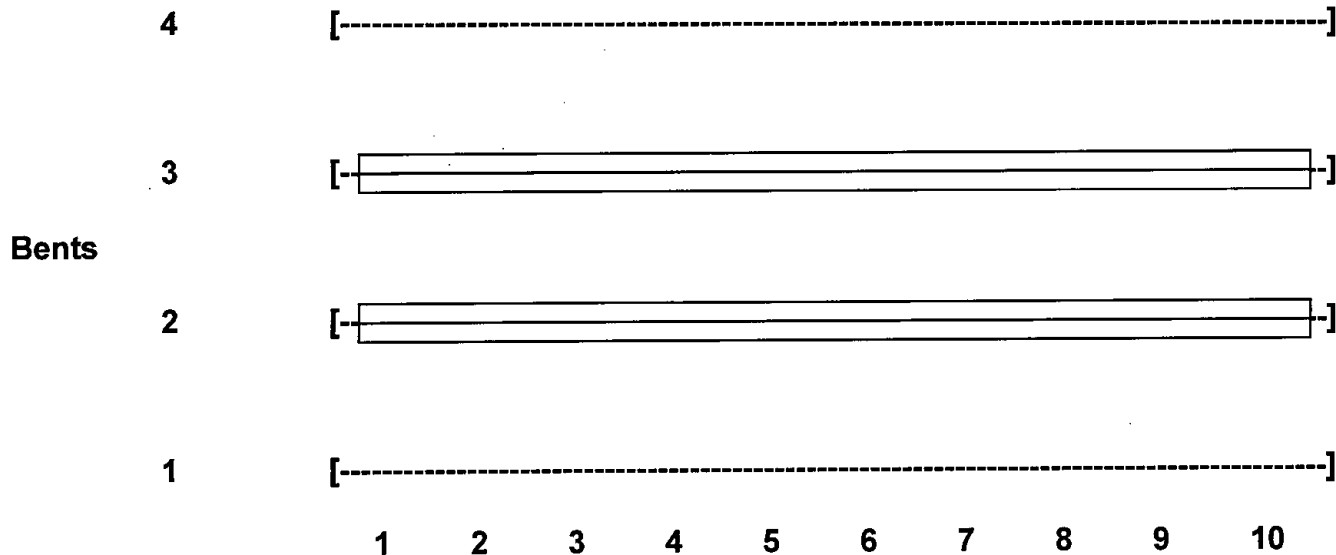
Sketch Sheet

(7) Hairline cracks in caps, (see sketch sheet).

Minor rust on bearings. Several elastomeric pads are starting to bulge out past saddles at bent 3. Several nuts in shim plates on the continuous saddles do not have full nut at bents 2 and 3. Several nuts on anchor bolts not tight, (see sketch sheet).

(4) Flexure cracks approximately mid-span on all beams. Continuous saddles have been installed at bents 2 and 3 beams 1-10, (see sketch sheet). Saddle connections at bent 2, beams 4-6 are not pulled up tight.

[=====] = Continuous saddles.
Concrete beams only.

- 8' long. h/l crack between beams 1 & 3.
- 2' vert. h/l crack under beam 3.
- 2' vert. h/l crack under beam 6.
- 2' vert. h/l crack under beam 7.
- 2' long. h/l crack between beams 12 & 13.

- 2' vert. h/l crack between columns 1 & 2, East side.
- 3' vert. h/l crack above column 4, West side.

- 3' vert. h/l crack above column 1, East side.
- 3' diag. h/l crack above column 1, East side.
- 3' diag. h/l crack above column 4, West side.

- 3' long. h/l crack between beams 2 & 3.
- 3' long. h/l crack between beams 3 & 4.
- 2' long. h/l crack between beams 9 & 10.

- Bent 1 beam 3 span 3 has a loose anchor bolt nut, left side.
- Bent 3 beam 5 span 3 has a loose saddle bolt, right side.
- Bent 3 beam 12 span 2 has a loose anchor bolt nut, left side.
- Bent 3 beam 13 span 2 has a loose anchor bolt nut, right side.
- Bent 3 beam 19 span 2 has a loose anchor bolt nut, right side.
- Bent 3 beam 20 span 2 has a loose anchor bolt nut, right side.
