I-26 Bridge Assessments

Bridge Assessment Report for Holy Trinity Church Road (S-36-39) over I-26

Prepared for:
The South Carolina Department of Transportation

November 11, 2016

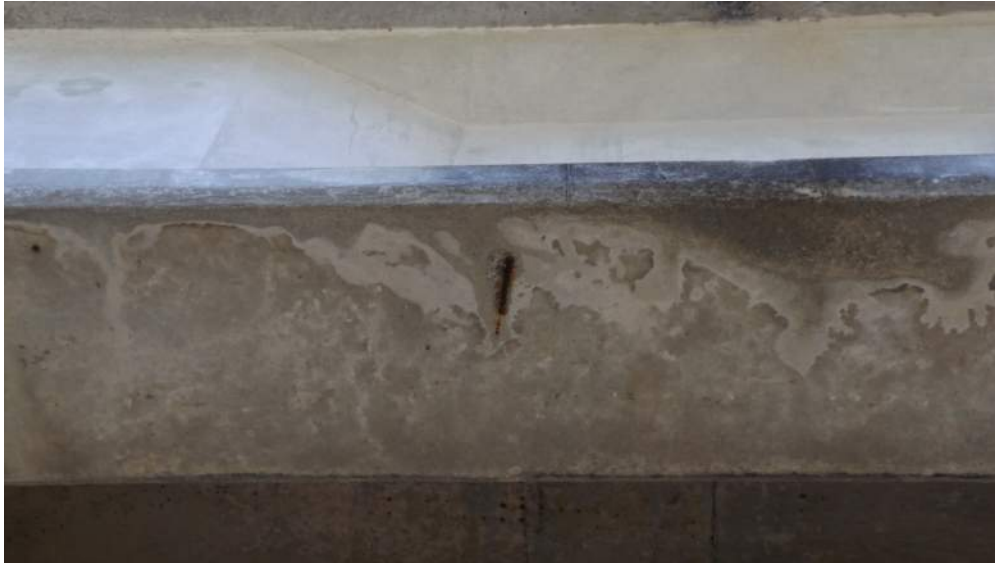
The existing prestressed concrete beams were assessed from accessible areas on the ground for deterioration and cracks. There is a small spall on the bottom of one of the concrete beams where reinforcing steel is exposed and corroded (see Figure 4). The most recent Bridge Inspection Report does document some light collision damage that has been repaired.

Figure 4 – Exposed Rebar in Beam

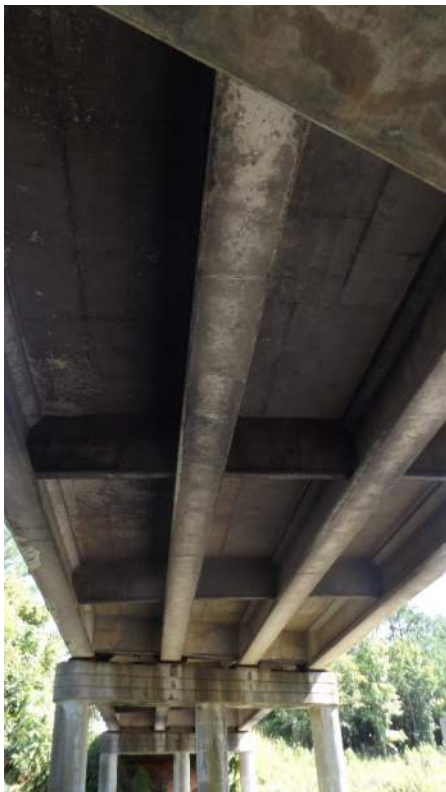
Figure 5 – Superstructure (from underneath) and Collision Damage to Bottom of Beam

The most recent Bridge Inspection Report documents numerous hairline cracks and spalls in various members of the bridge. The report also mentions light collision damage to multiple girders that has been repaired.

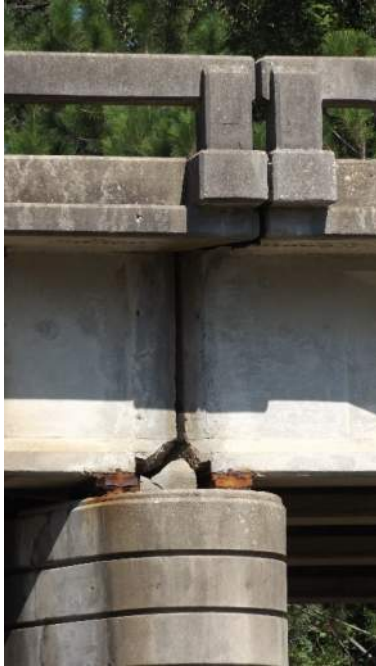
The intermediate and end diaphragms (semi-integral end bents) were visually assessed from accessible areas. A piece of the end diaphragm has cracked off at one of the bearing locations (see Figure 6). No other deterioration was observed.

Figure 6 – Portion of End Diaphragm cracked off

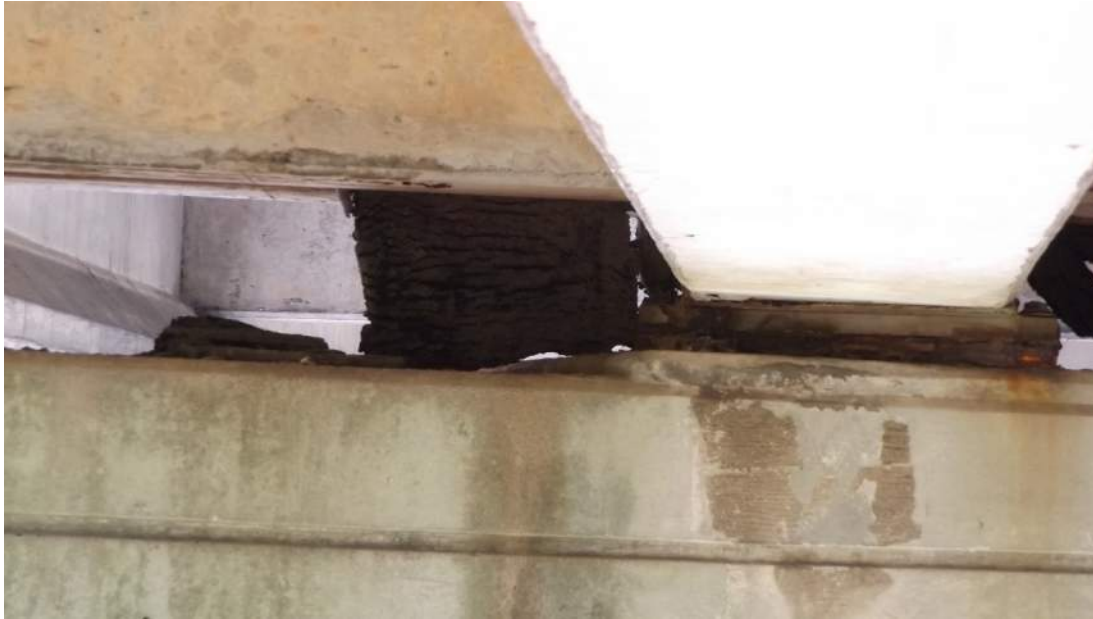
A portion of the end bent bearings were visible due to the semi-integral end bent and very little deterioration was observed. The exterior bearings showed more deterioration than the interior bearings at the end bents. The interior bent bearings were not accessible from short distance, but were viewed from the ground and appeared to be in a medium state of deterioration with moderate to severe corrosion.

Figure 7 - Bearing Corrosion and Expansion Joint material falling through joint opening

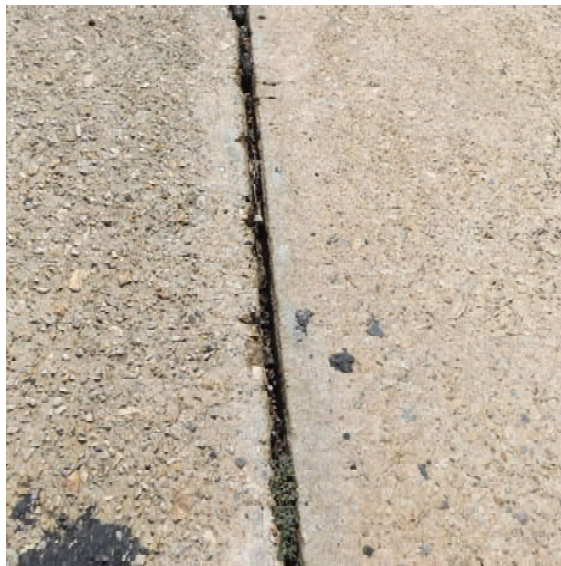
There are three deck expansion joints located within the bridge. They are located at Interior Bent 2, Interior Bent 3, and Interior Bent 4. All three expansion joints were observed from the shoulders due to the roadway not being closed. The joint filler is falling through the opening at several locations (see Figure 7). Where the joint filler hasn't fallen through, the material is in an advanced state of deterioration (see Figure 8).

Figure 8 - Expansion Joint

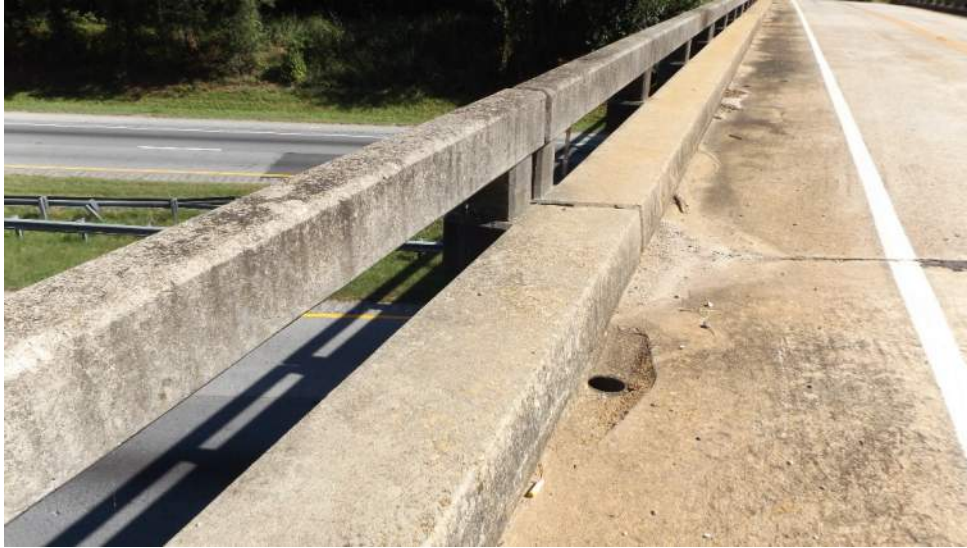
Figure 9 – Bridge Railing

The bridge railing (Figure 9) is a concrete railing on a concrete curb and showed minimal signs of deterioration.

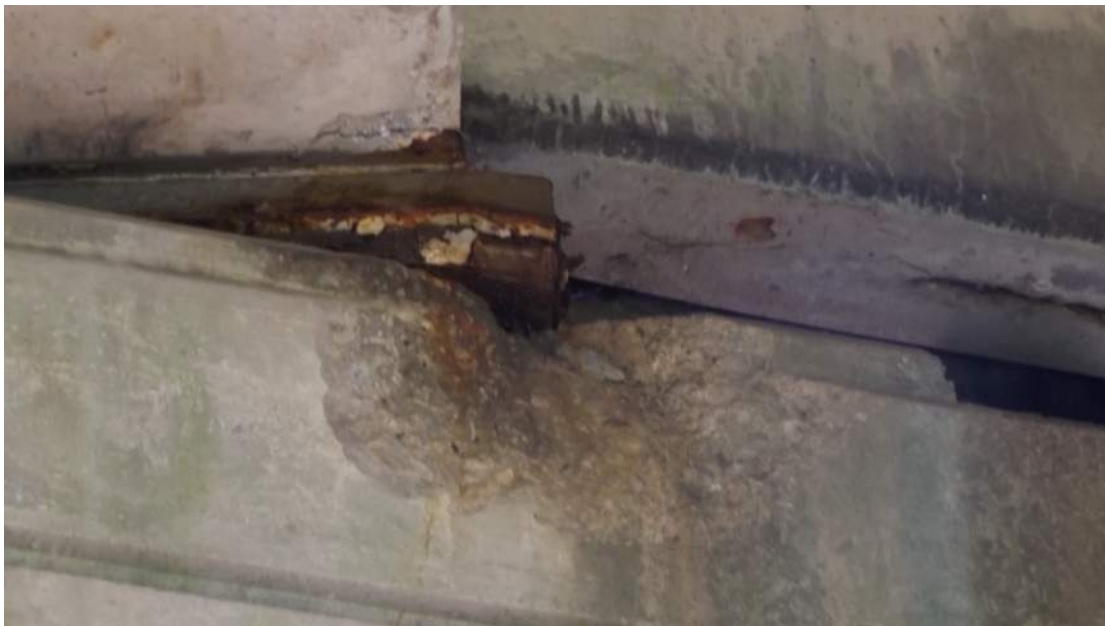
The interior bents show minimal signs of deterioration with the exception of a large spall on the top of one of the concrete caps where the concrete has spalled off and exposed the bottom of the bearing (see Figure 10). The columns also show minimal signs of deterioration with the exception of a large spall where the reinforcing steel is exposed and corroded with vertical cracks (See Figure 11). The most recent Bridge Inspection Report documents some spalling on all columns and the bottom of all interior bent caps along with a diagonal crack on one interior bent.

Figure 10 - Spall on Top of Pier Cap

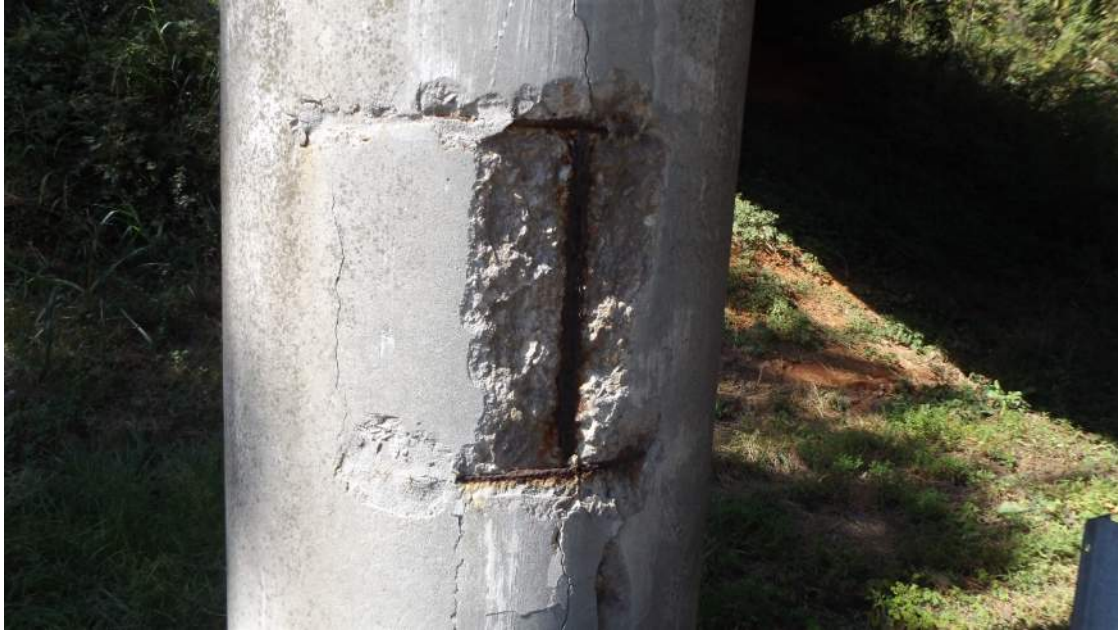
Figure 11 - Spall on Column

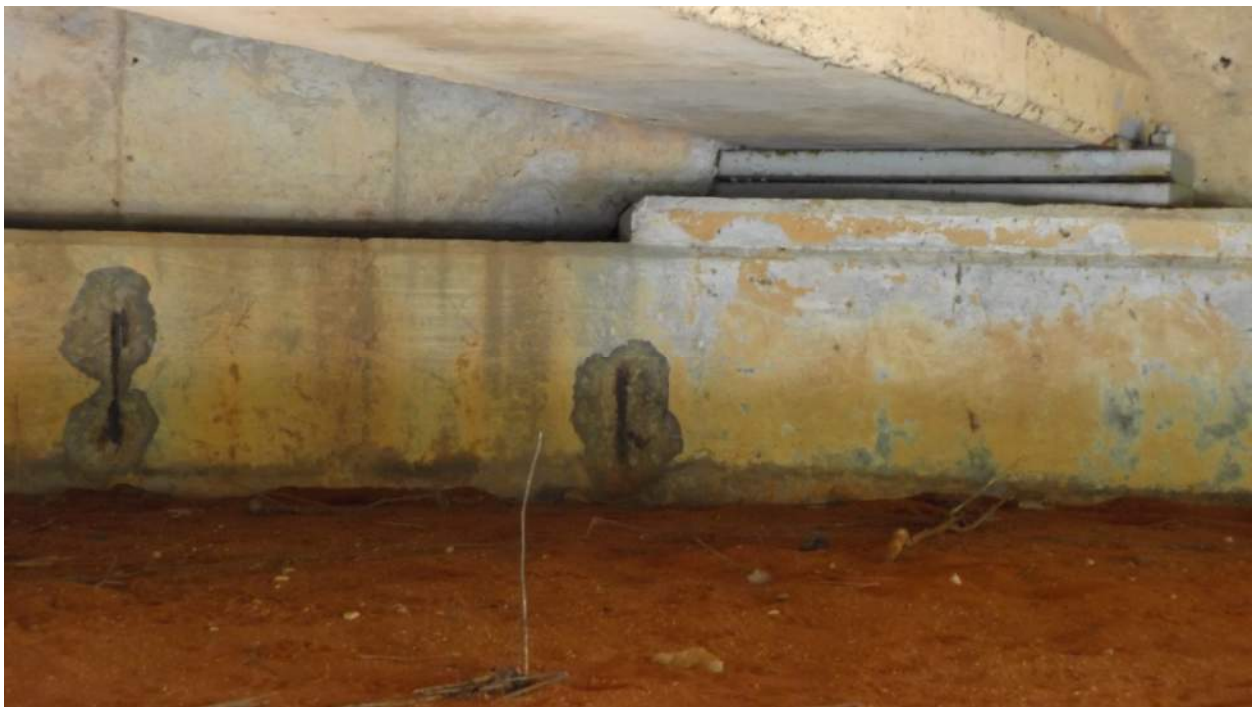
The end bent caps and wing walls show minimal signs of deterioration with the exception of a few small spalls on the face of the end bent cap where reinforcing steel is exposed (see Figure 12).

Figure 12 - End Bent Spalling

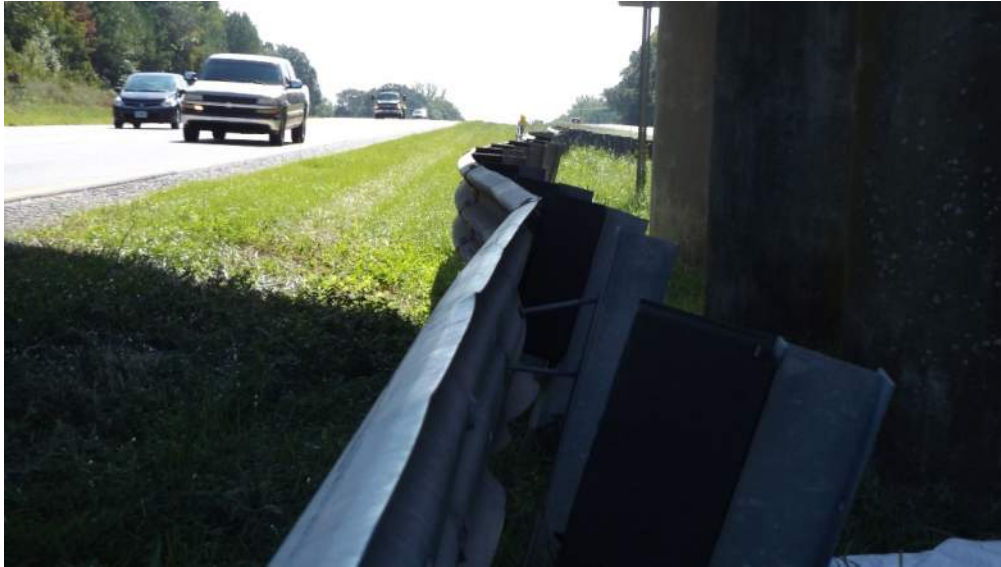
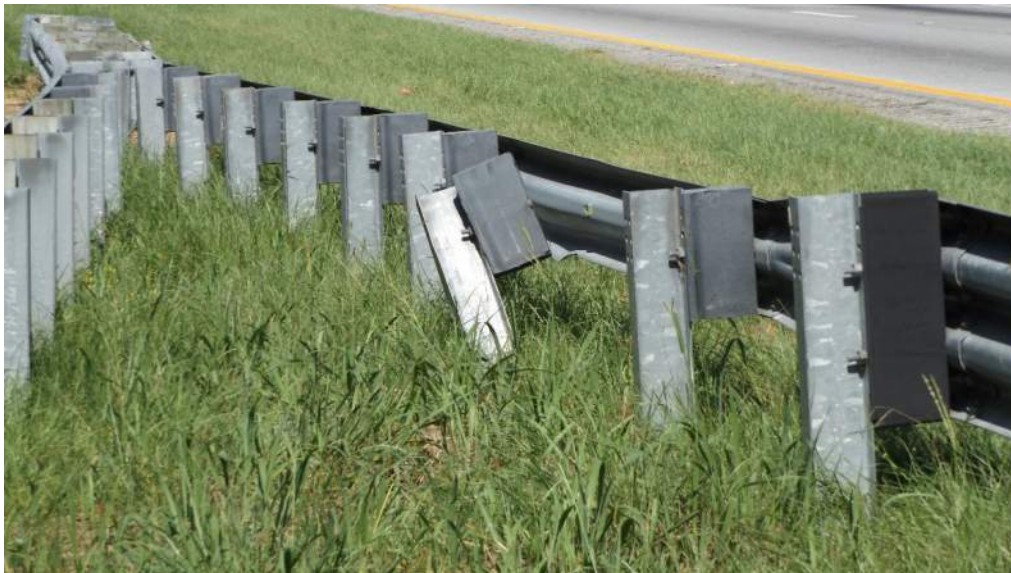
The guardrail in the median of I-26 at this bridge location is damaged in a few locations (see Figures 13 and 14).

Figure 13 – Guardrail Damage

Figure 14 – Guardrail Damage

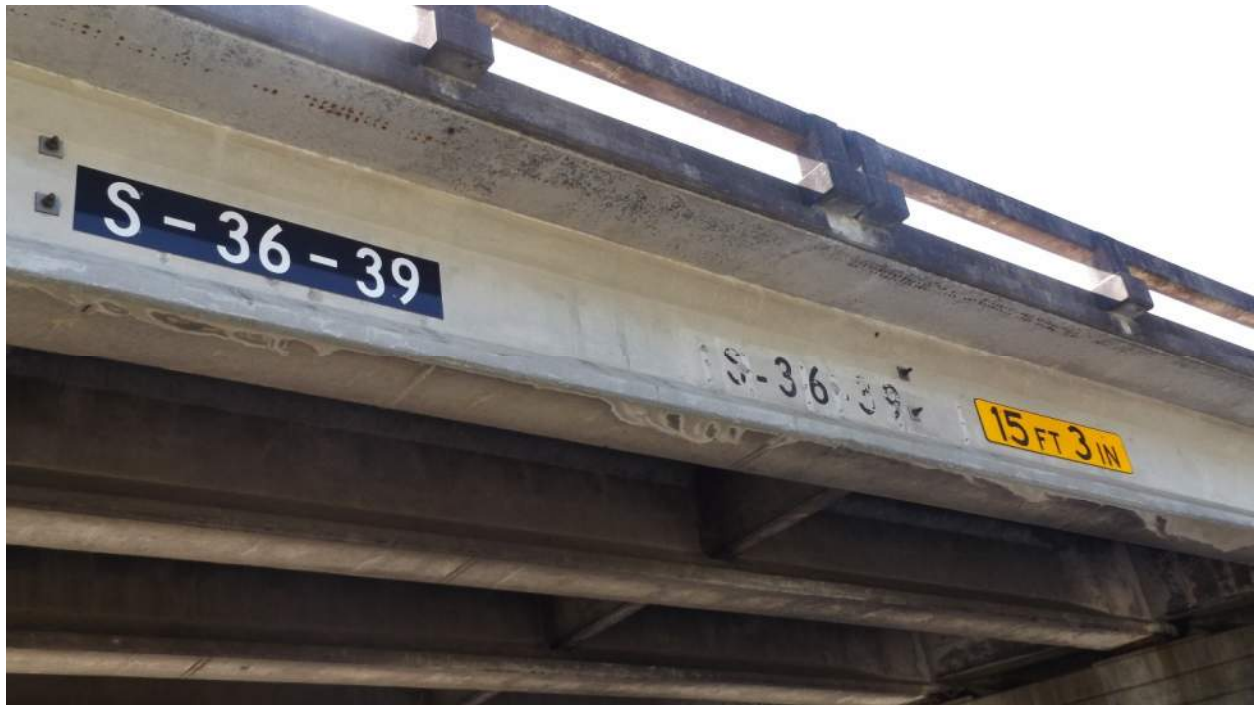
The posted vertical clearances under the existing bridge are 15'-3" (I-26 EB) and 15'-6" (I-26 WB). Neither of these meet the 16'-0" minimum specified for freeway under existing overpassing bridges in the SCDOT Highway Design Manual. The most recent Bridge Inspection Report documents collision damage to the beams that has been repaired.

Figure 15 - Vertical Clearance
