I-26 Bridge Assessments

Newberry County, South Carolina

Bridge Assessment Report for SC202 over I-26

November 11, 2016

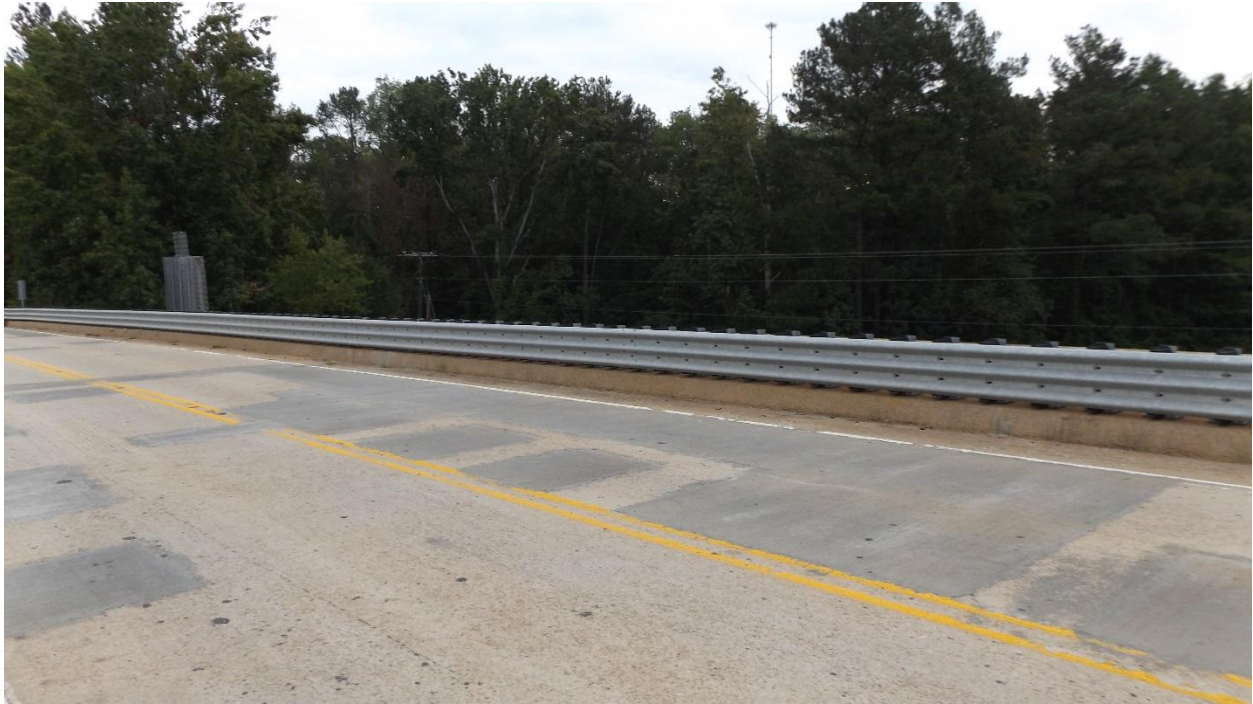
Figure 4 - Deck

The existing reinforced concrete deck was observed from the shoulder since the roadway wasn't closed. Overall, the bridge deck shows little deterioration. However, there are large areas that have been repaired, so there is potential deterioration that is not visible due to the repairs. The most recent Bridge Inspection Report documents that the deck was patched in 2011. The concrete end walls showed very little deterioration.

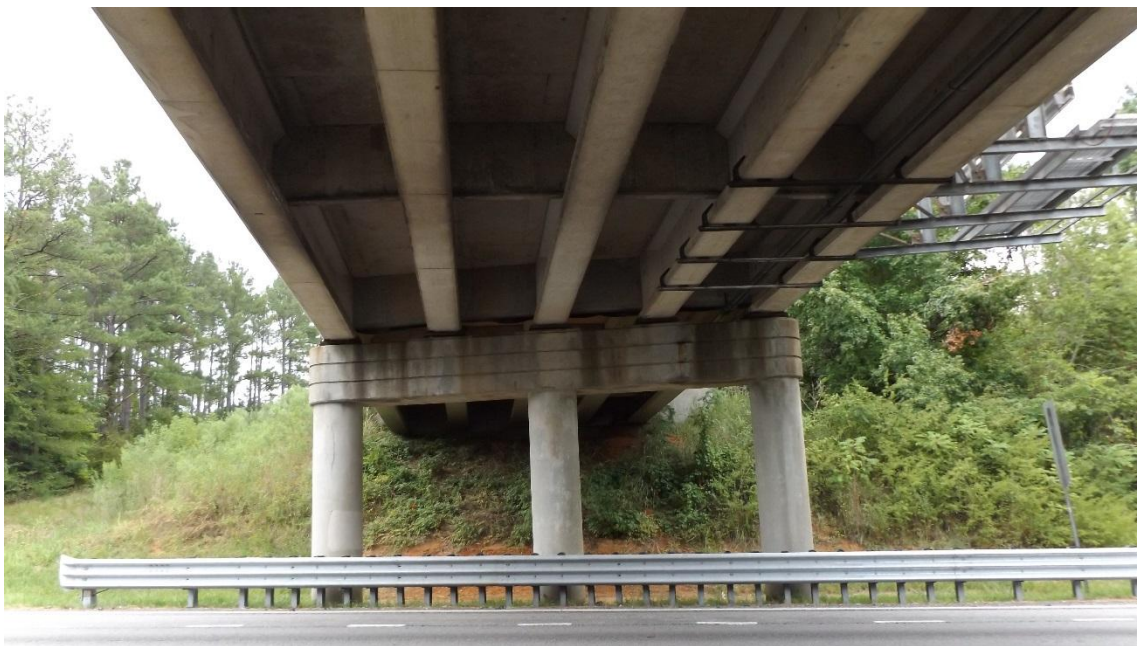
Figure 5 – Superstructure (from underneath)

The existing prestressed concrete beams were assessed from accessible areas on the ground for deterioration and cracks. No deterioration or cracks were observed from the ground. The most recent Bridge Inspection Report does document some cracking and delamination in the ends of the beams, including some diagonal cracking and spalling.

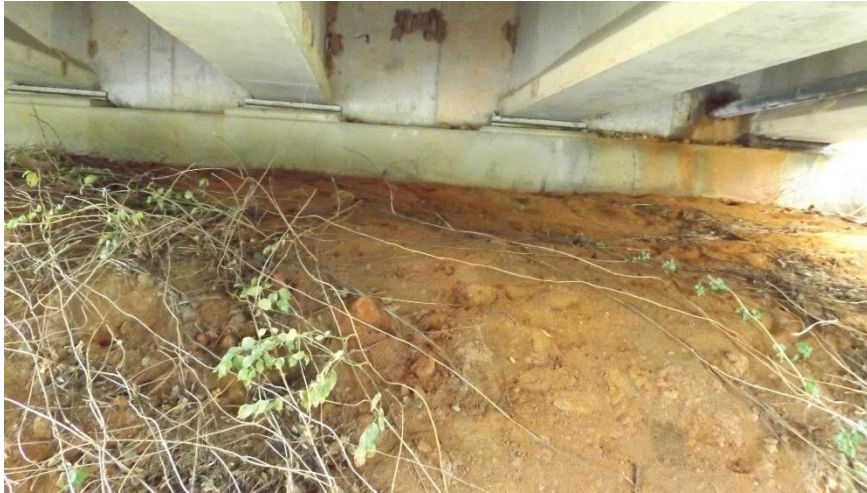
Figure 6 – End Bent Bearings

A small portion of the end bent bearings were visible due to the semi-integral end bent and very little deterioration was observed. The exterior bearings showed more deterioration than the interior bearings at the end bents. The interior bent bearings were not accessible from short distance, but were viewed from the ground and appeared to be in a medium state of deterioration with moderate corrosion.

- Raise bridge permanently or undercut I-26 WB lanes to achieve required vertical clearance
- Bearing replacement
- Joint replacement
- Crack repair – interior bent
- Spall repair – column
- General crack, spall, etc. repairs throughout bridge
- Wing wall repair
- Utility repair
- Potential addition of closed drainage system
- Potential seismic modifications

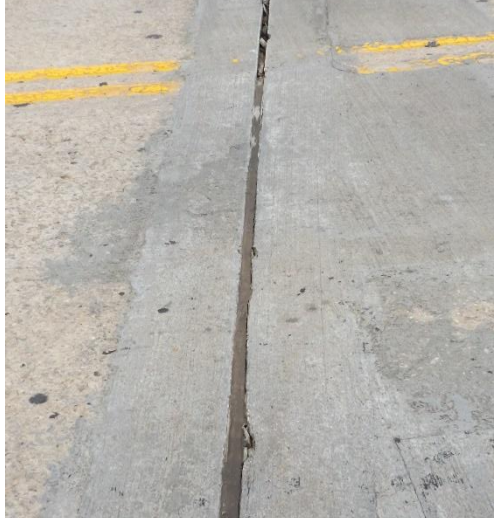
Figure 8- Expansion Joint

There are three deck expansion joints located within the bridge. They are located at Interior Bent 2, Interior Bent 3, and Interior Bent 4. All three expansion joints were observed from the shoulders due to the roadway not being closed. The joint filler is starting to fall through the opening at several locations. Where the joint filler hasn't fallen through, the material is in a moderate state of deterioration.

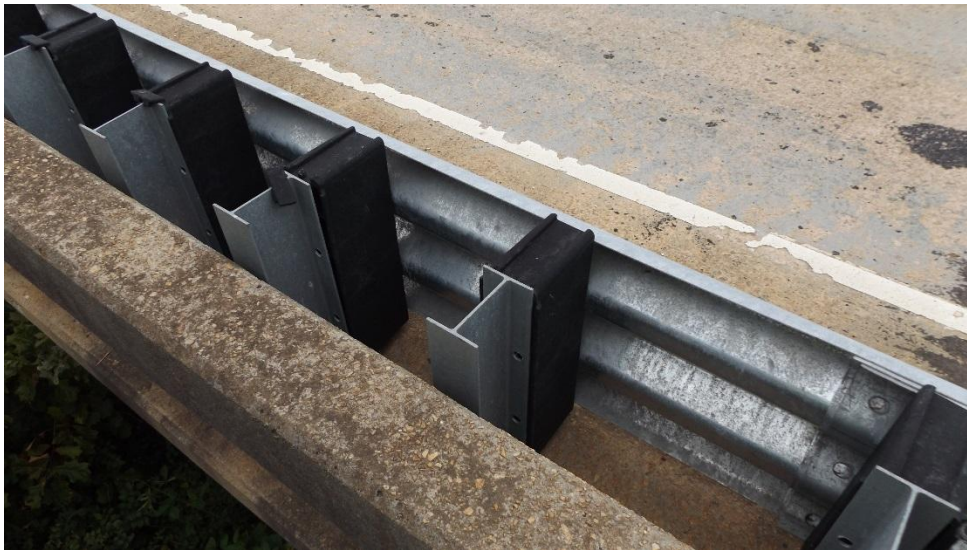
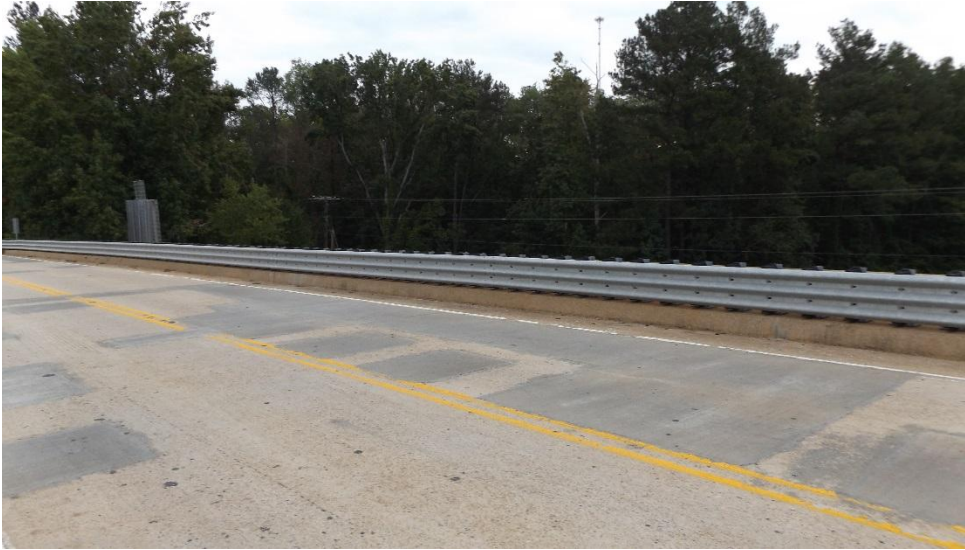
The bridge railing (Figures 9 and 10) is a concrete railing on a concrete curb with guardrail attached to it and showed minimal signs of deterioration.

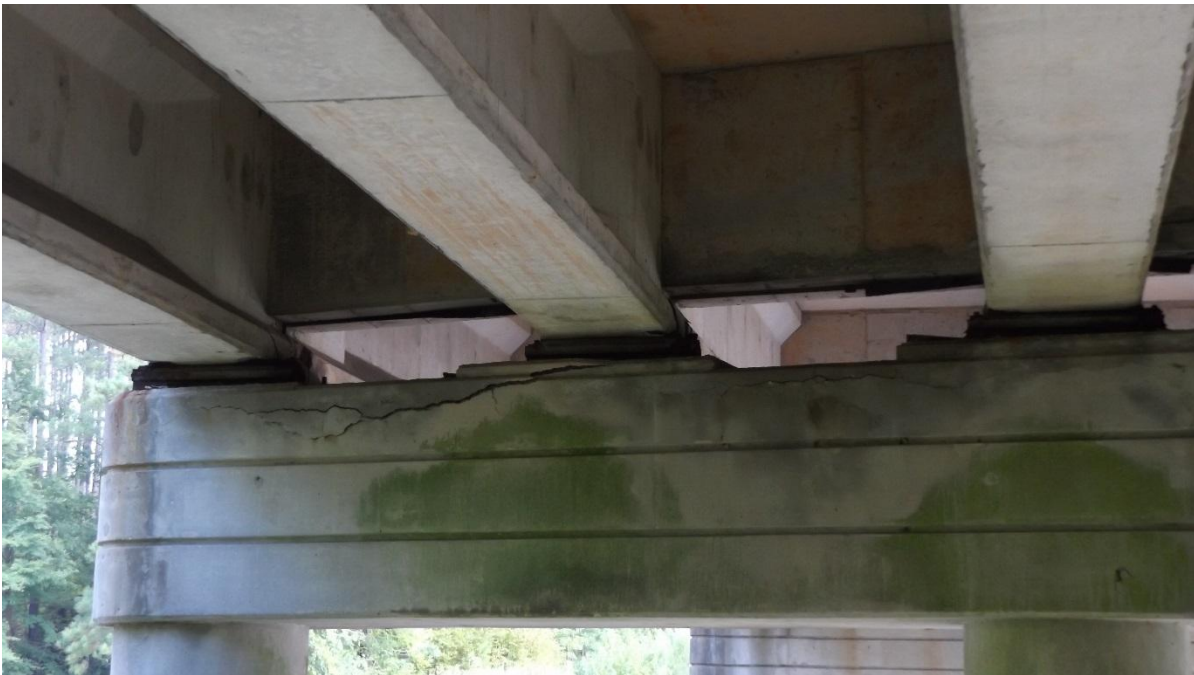
The interior bents are showing signs of deterioration in a few locations. There is a horizontal crack in one of the caps (see Figure 11) and a spall in one of the columns (see Figure 12). The most recent Bridge Inspection Report documents these two items and some additional cracking in the columns.

Figure 11 – Horizontal Crack in Bent Cap

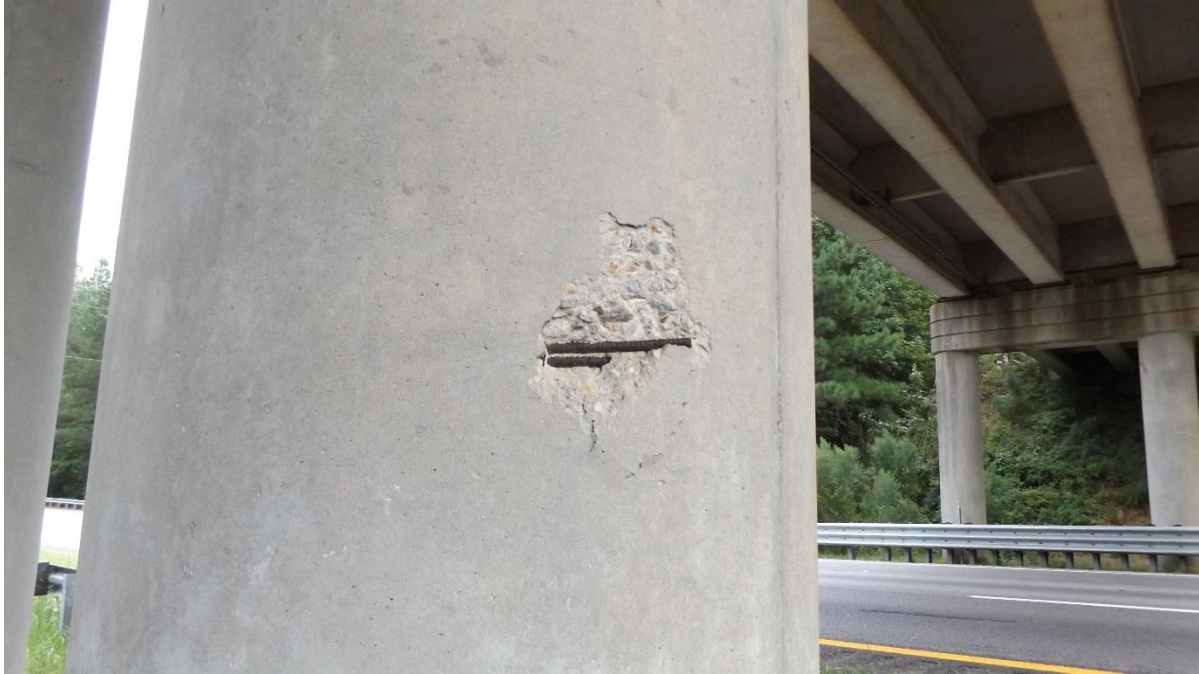
Figure 12 – Spall in Column

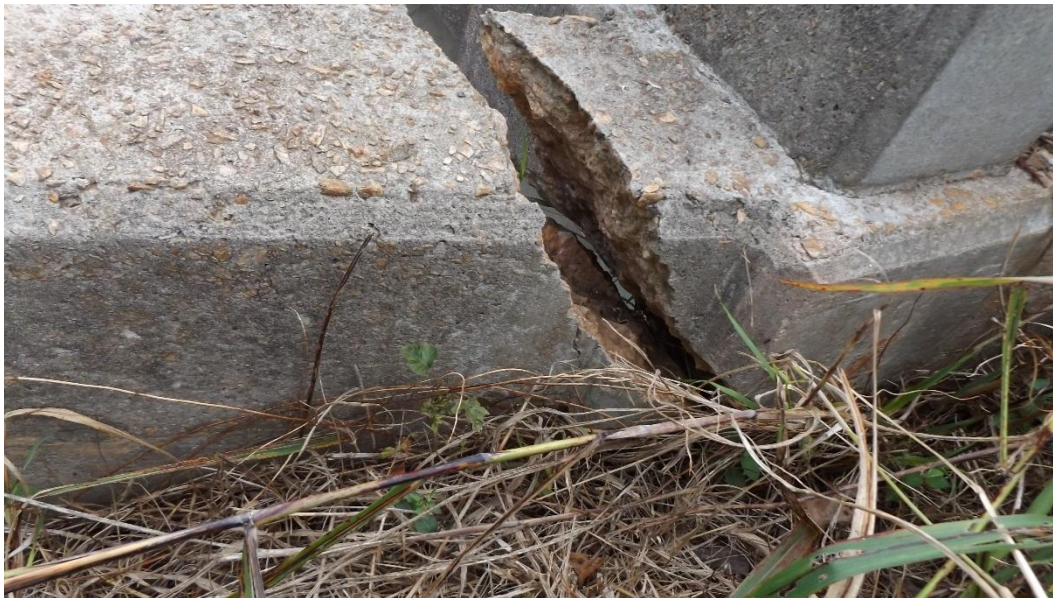
The end bent caps show minimal signs of deterioration. Some of the end bent wing walls have wide, full-width cracks (see Figure 13).

Figure 13 – Crack in Wing Wall

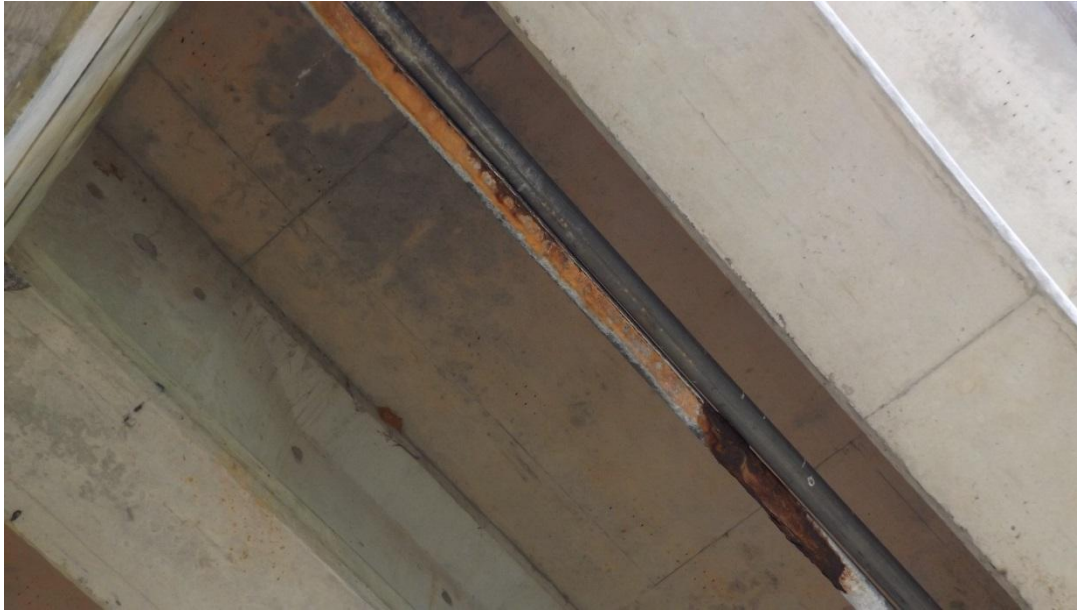
The conduit running between beams for the length of the bridge shows signs of deterioration. Additionally, wires from the conduit are hanging loose and an object the wires are connected to is laying on the ground (see Figures 14 thru 16).

Figure 14 – Conduit Corrosion

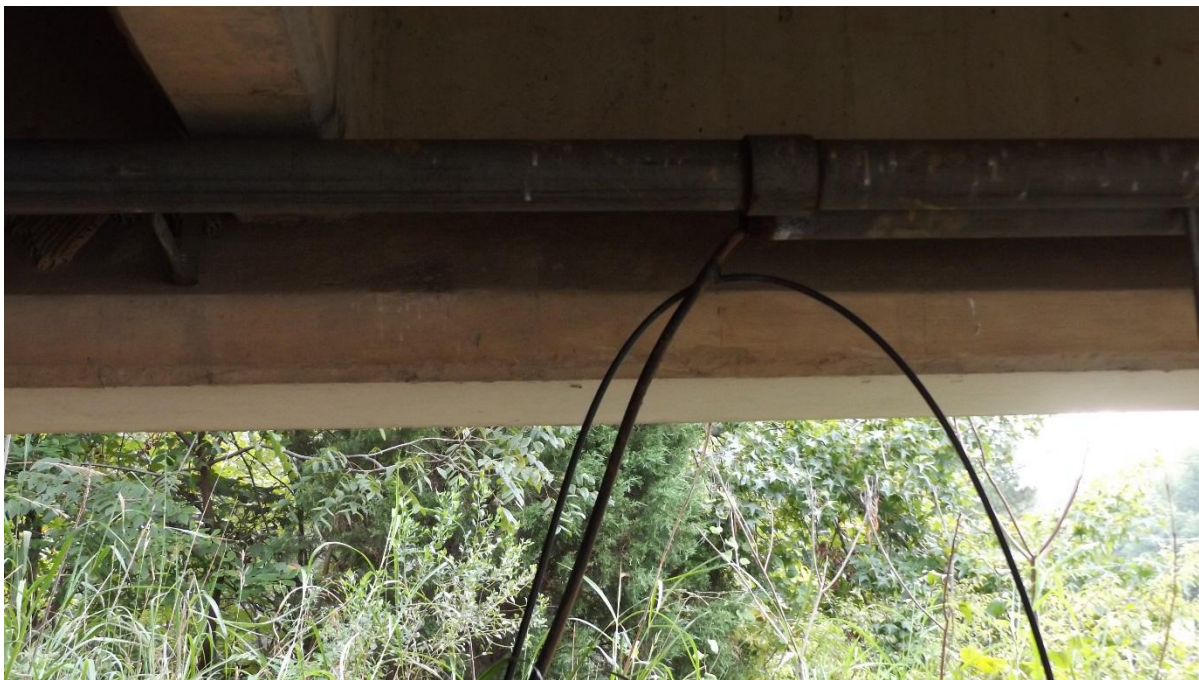
Figure 15 – Hanging Wires

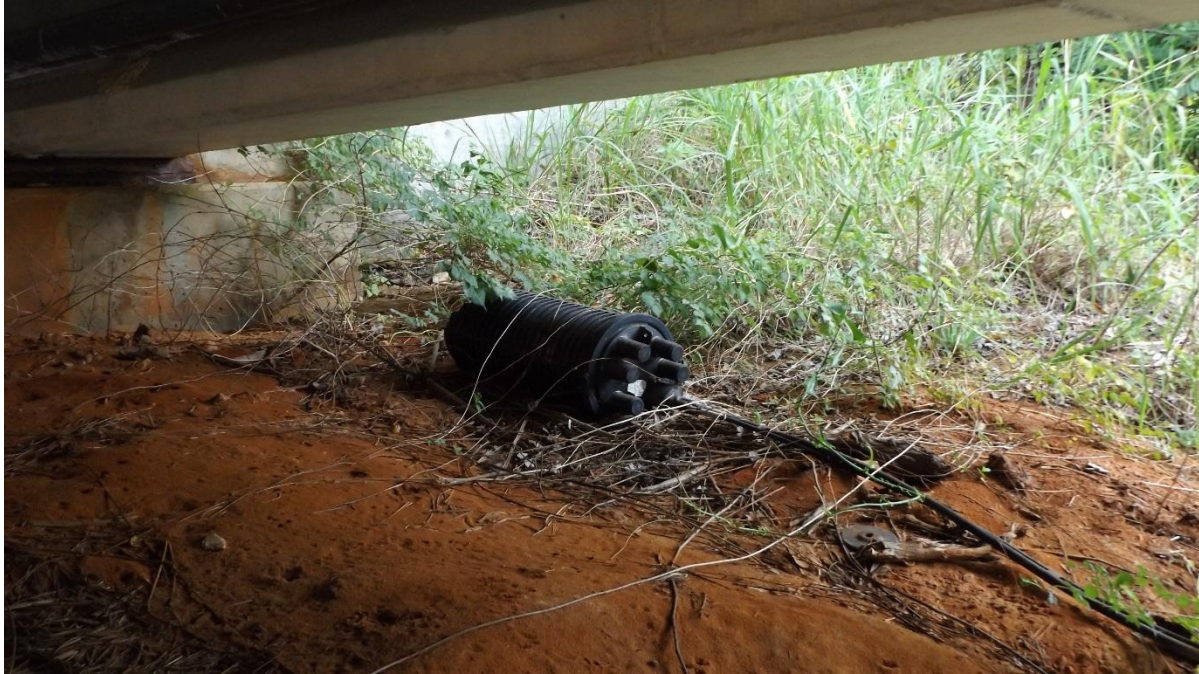
Figure 16 – Utility Object on Ground

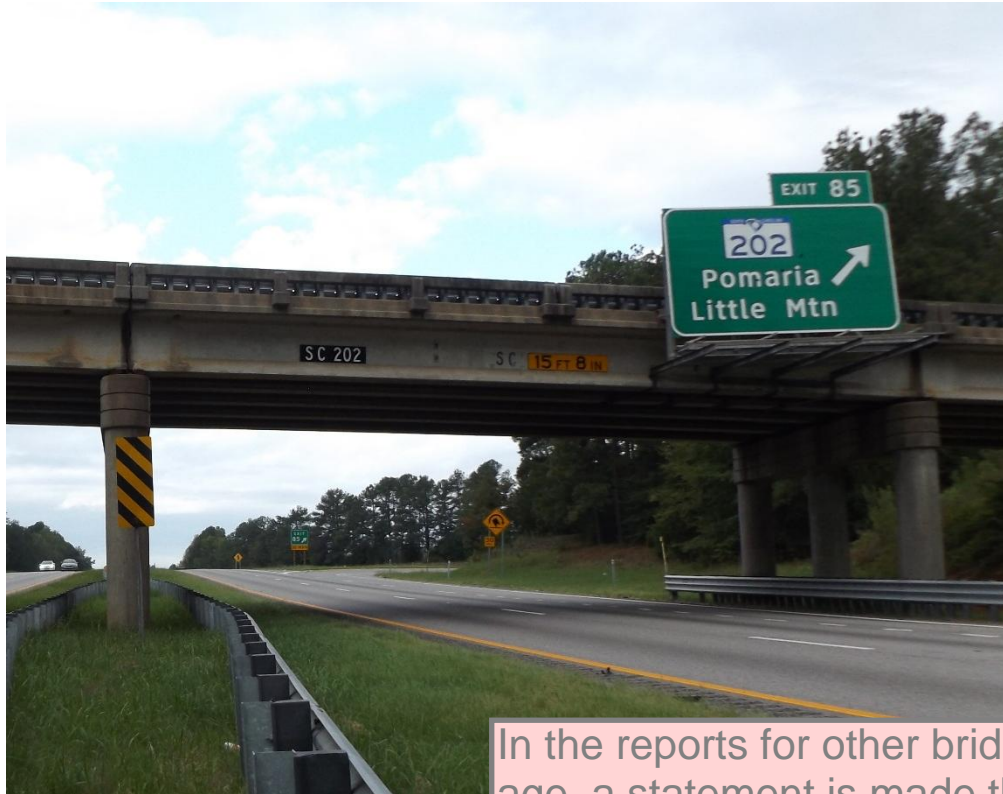
Figure 17 - Vertical Clearance

The posted minimum vertical clearance under the existing bridge is 15'-8" (I-26 WB) which does not meet the 16'-0" minimum specified for freeway under existing overpassing bridges in the SCDOT Highway Design Manual. The posted vertical clearance under the existing bridge on I-26 EB is 16'-10".
