## ***I-26 Bridge Assessments***

# **Bridge Assessment Report for Mt. Vernon Church Road (S-40-234) over I-26**

**Prepared for:**  
**The South Carolina Department of Transportation**

**November 11, 2016**

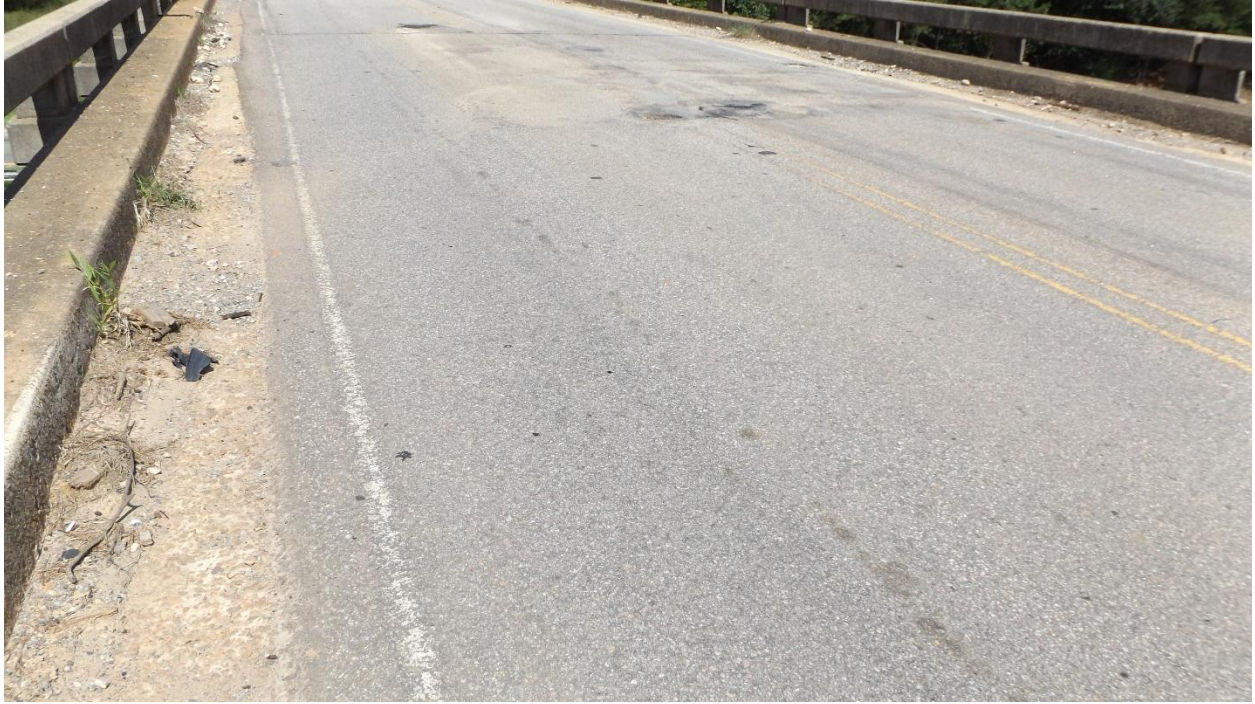
*Figure 4 – General View of Deck*

The existing reinforced concrete deck was observed from the shoulder since the roadway wasn't closed (see Figure 4). There are several areas on the deck where concrete has spalled off and the reinforcing steel is exposed and corroded (see Figure 5). Additionally, there are patched areas of the bridge deck that potentially conceal corroded rebar. The most recent Bridge Inspection Report documents that 56% of the deck is delaminated and has minor spalls. The concrete end walls showed very little deterioration.

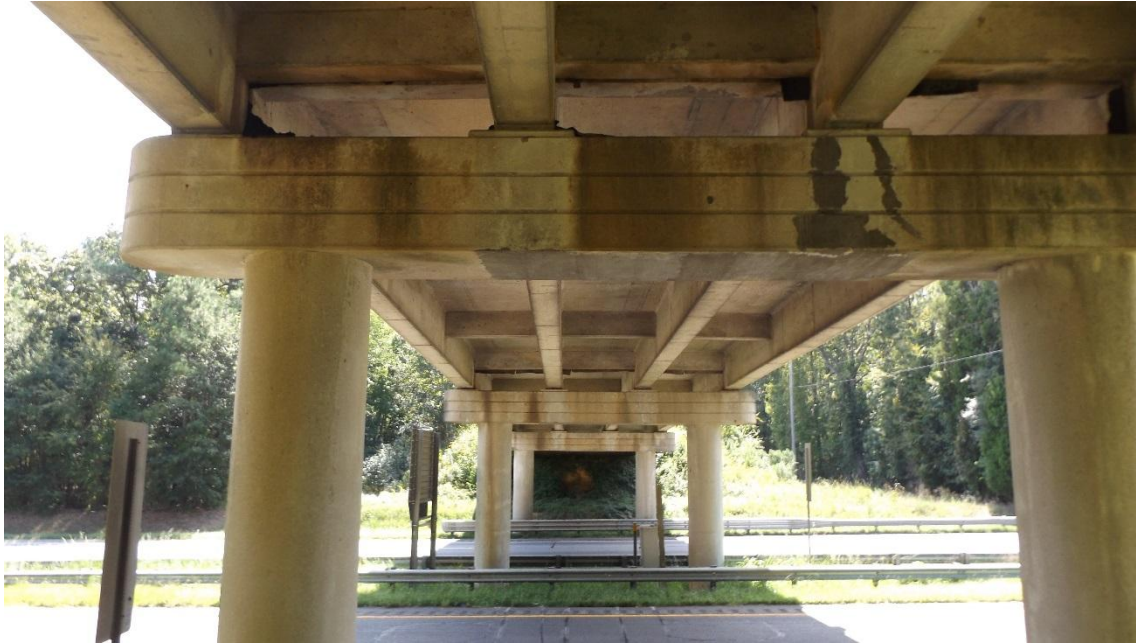
Figure 6 – Superstructure (from underneath)

The existing reinforced concrete beams were assessed from accessible areas on the ground for deterioration and cracks. No deterioration or cracks were observed from the ground. The most recent Bridge Inspection Report documents some flexural cracking at mid-span of most beams, additional cracking, some diagonal, near the bearings, and collision damage in one of the beams.

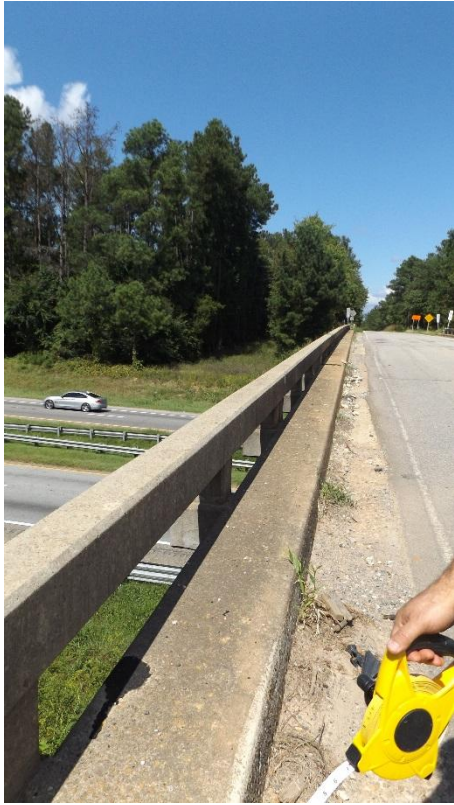
*Figure 7 – Bridge Railing*

The bridge railing (Figure 7) is a concrete railing on a concrete curb and showed minimal signs of deterioration.

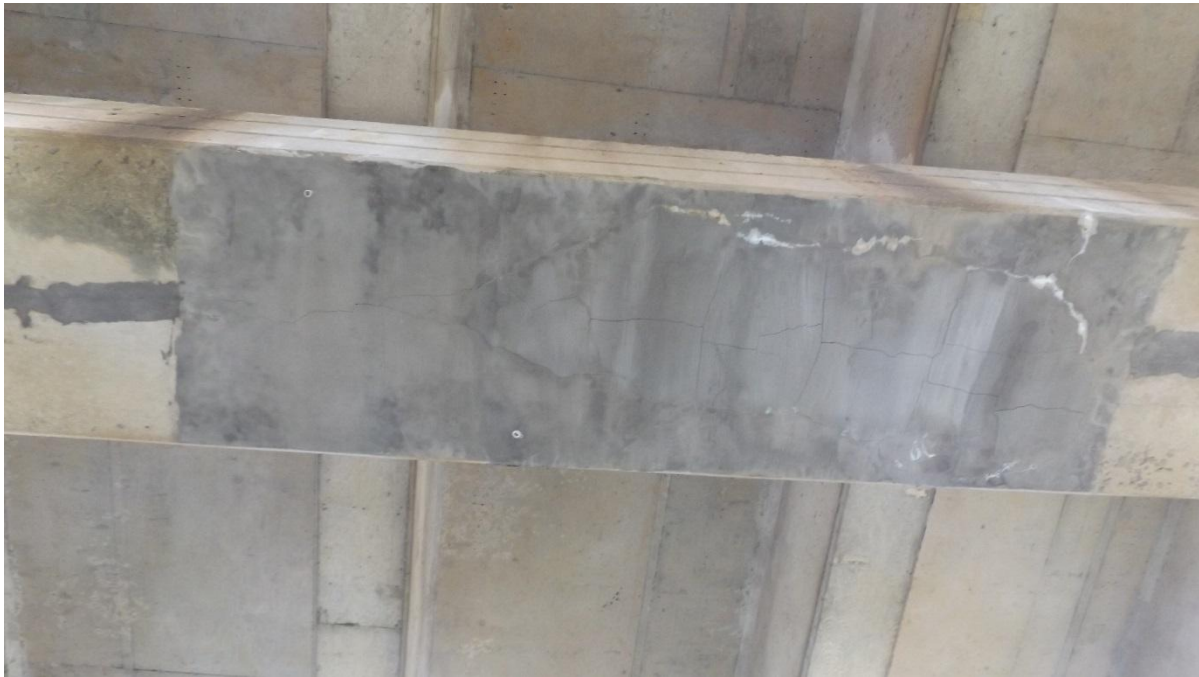
*Figure 8 – Repaired Area in Cap*

The interior bents are showing minor signs of deterioration. A repaired area has some web cracking (see Figure 8). The most recent Bridge Inspection Report documents additional cracking and repairs in the caps and columns.

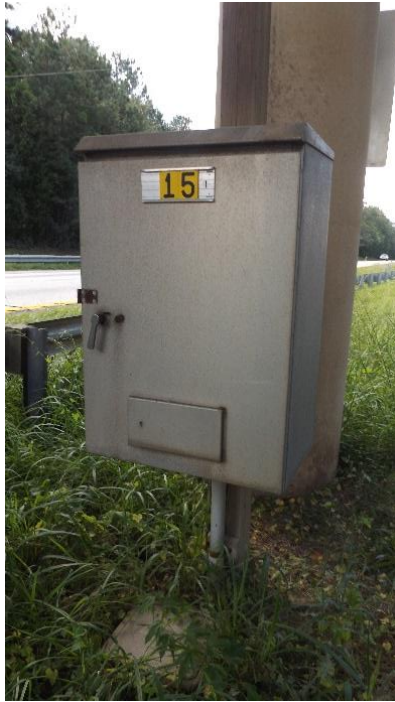
*Figure 9 – Electrical Box near Interior Bent 3*

No utilities were observed on/attached to the bridge, but there is what appears to be an electrical box and a "Weigh Station" sign in close proximity to Interior Bent 3 (median bent) (see Figure 9).

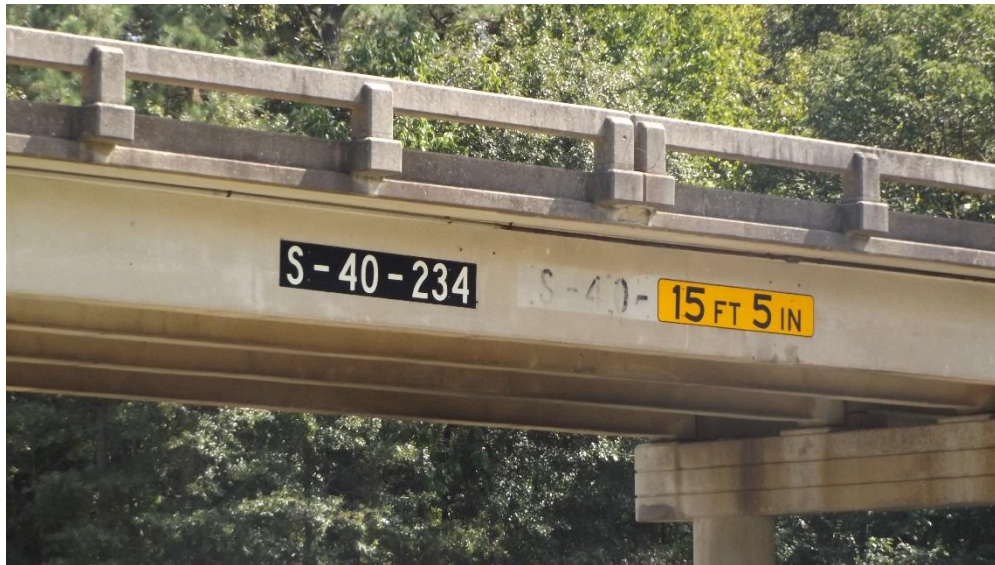
Figure 10 - Vertical Clearance (I-26 EB)

The posted minimum vertical clearance under the existing bridge is 15'-5" (I-26 EB) which does not meet the 16'-0" minimum specified for freeway under existing overpassing bridges in the SCDOT Highway Design Manual. The posted vertical clearance under the existing bridge on I-26 WB is 16'-0".
