I-26 Bridge Assessments

Bridge Assessment Report for Peak Street (S-32-49) over I-26

Prepared for:
The South Carolina Department of Transportation

November 11, 2016

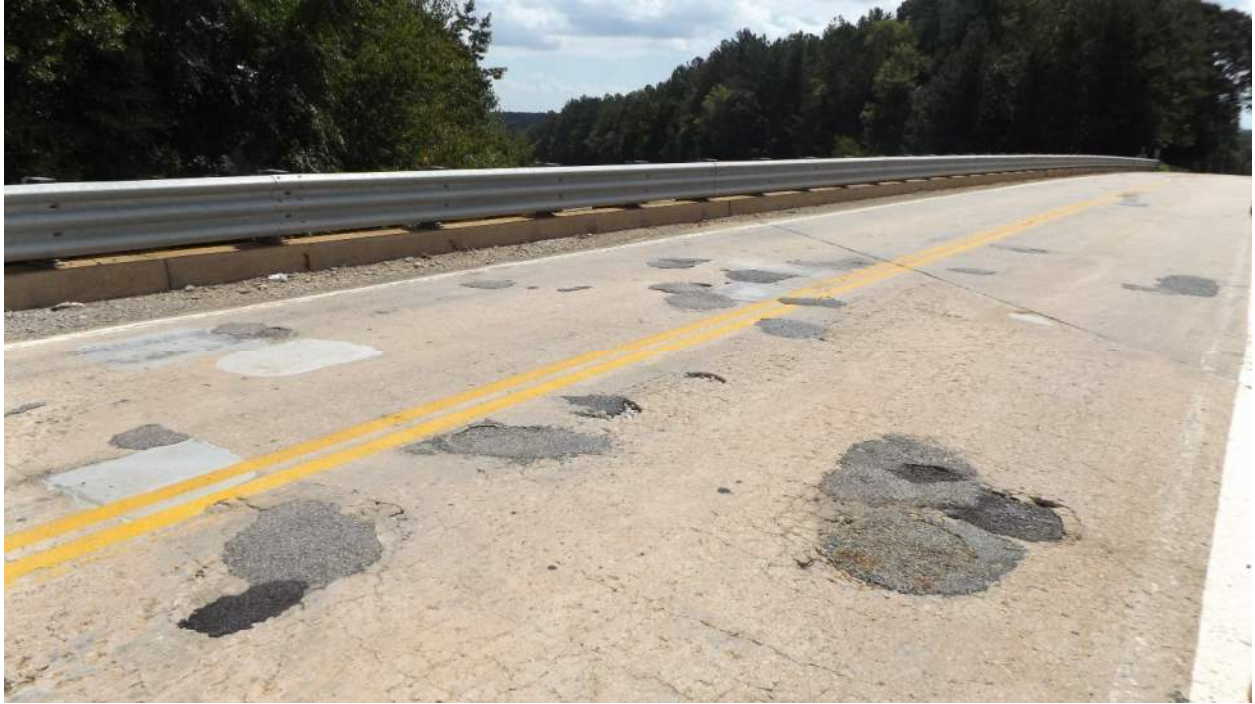
Figure 4 – General View of Deck

The existing reinforced concrete deck was observed from the shoulder since the roadway wasn't closed (see Figure 4). There are several areas on the deck where concrete has spalled off and the reinforcing steel is exposed and corroded (see Figure 5). Additionally, there are patched areas of the bridge deck that potentially conceal corroded rebar. The most recent Bridge Inspection Report documents that 80% of the deck is delaminated and the deck has significant cracking, spalls, and scaling, some of which has been repaired. The concrete end walls showed very little deterioration.

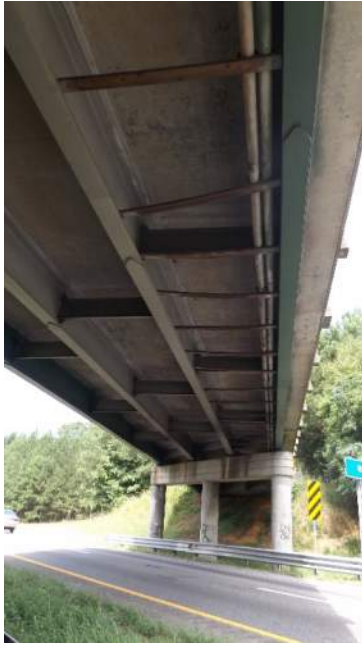
The existing steel beams were assessed from accessible areas on the ground for deterioration. Minor deterioration was observed from the ground. The most recent Bridge Inspection Report documents that the steel beams were re-painted but metal loss and minor corrosion still exists.

Figure 6 – Superstructure (from underneath)

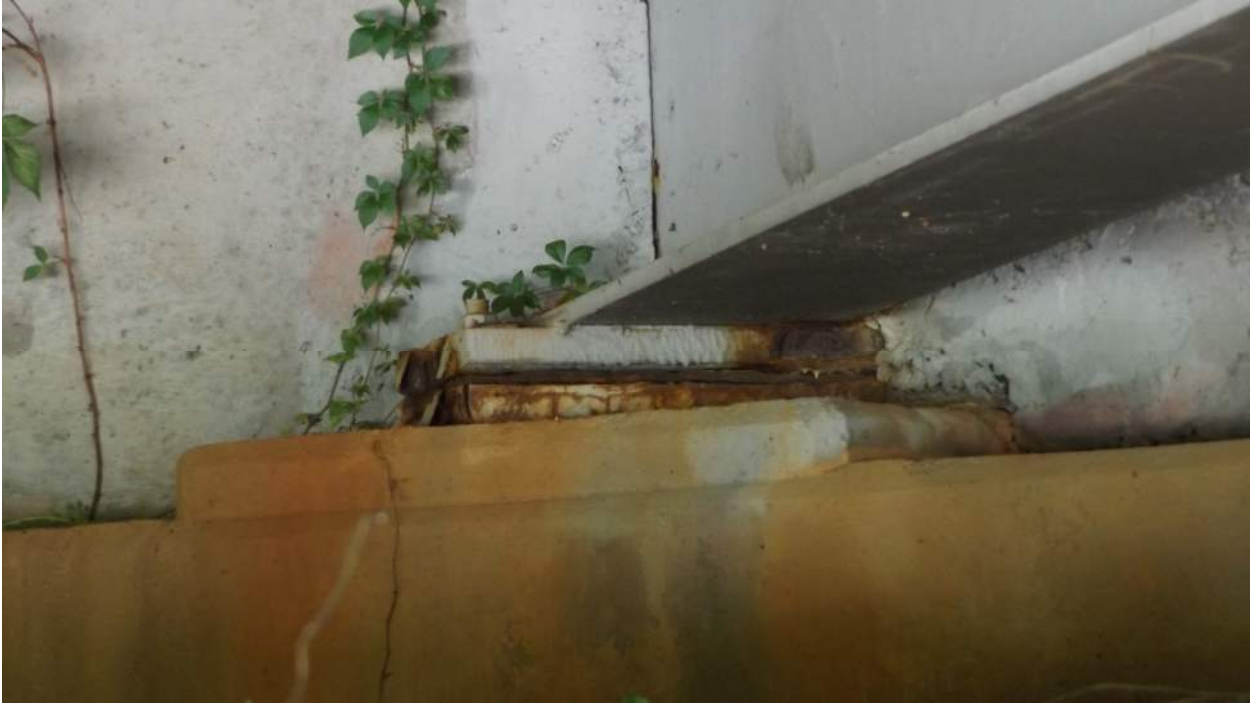
A portion of the end bent bearings were visible due to the semi-integral end bent and moderate/severe corrosion was observed (see Figure 7). The exterior bearings showed more deterioration than the interior bearings at the end bents. The interior bent bearings were not accessible from short distance, but were viewed from the ground and appeared to be in a moderate/severe state of deterioration with heavy corrosion (see Figure 8). The most recent Bridge Inspection Report documents moderate/heavy rust on bearings and some missing anchor bolt nuts.

Figure 7 – End Bent Bearing

The two options to consider for this bridge are replacement and rehabilitation. Rehabilitation for this existing Peak St. bridge would consist of deck replacement, bearing replacement, joint replacement, crack/spall repairs, utility repairs, a potential closed drainage system, and either permanently raising the bridge (and likely a portion of the roadway approaches) or undercutting I-26 to achieve the required vertical clearance. The estimated cost of rehabilitating this bridge is approximately \$1.06 million. The estimated cost of replacing this bridge is approximately \$3.7 million. Both estimated costs (rehabilitation and replacement) include design and construction costs for the bridge and roadway approaches.

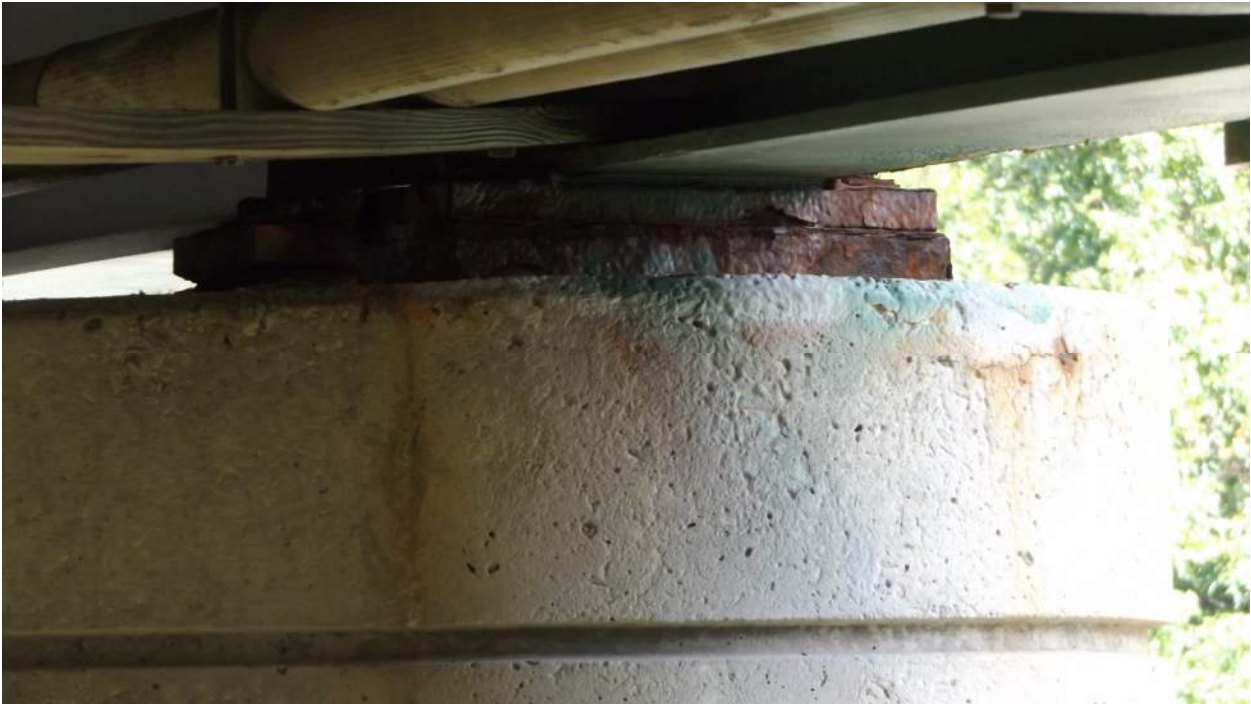
Figure 8 – Interior Bent Bearing

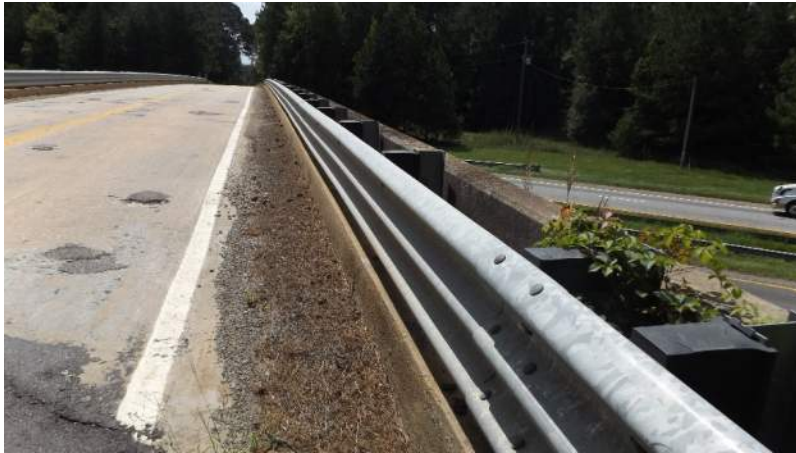
The bridge railing (Figure 9) is a concrete railing on a concrete curb with guardrail attached to it and showed minimal signs of deterioration.

Figure 9 – Bridge Railing

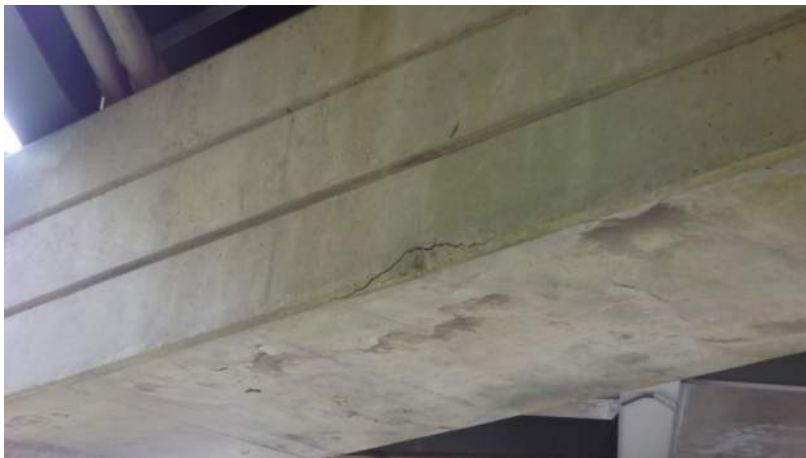
The interior bents are showing minor signs of deterioration. Figure 10 shows a crack in one of the interior bent caps. The most recent Bridge Inspection Report documents hairline cracks and minor spalls in caps and hairline cracks and minor spalls in columns, some of which have been patched.

Figure 10 – Crack in Interior Bent Cap

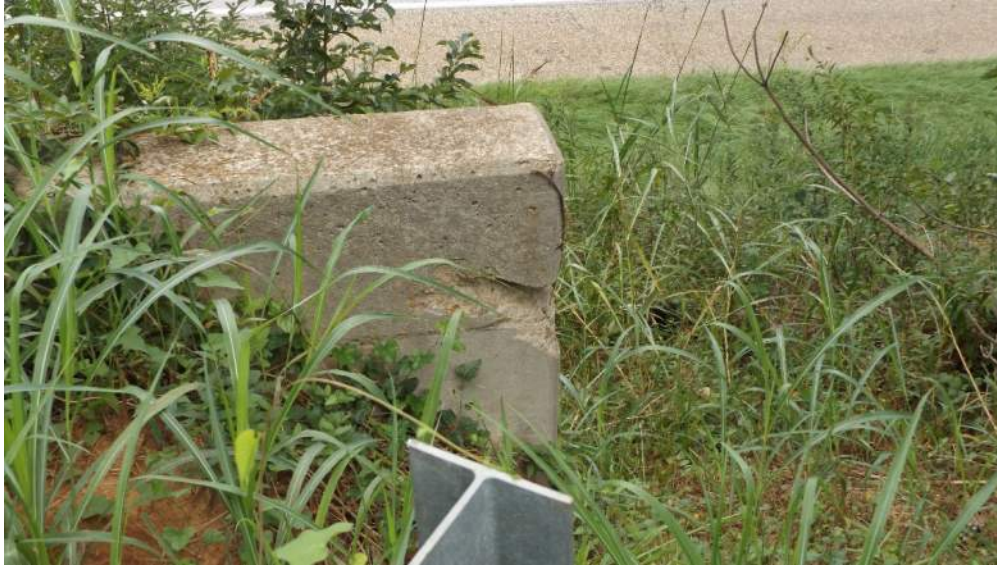
The end bent caps show minimal signs of deterioration. One of the wing walls had a large chunk missing (see Figure 11). The most recent Bridge Inspection Report documents minor spalls with rebar exposed at End Bent 1.

Figure 11 – End Bent Wing Wall

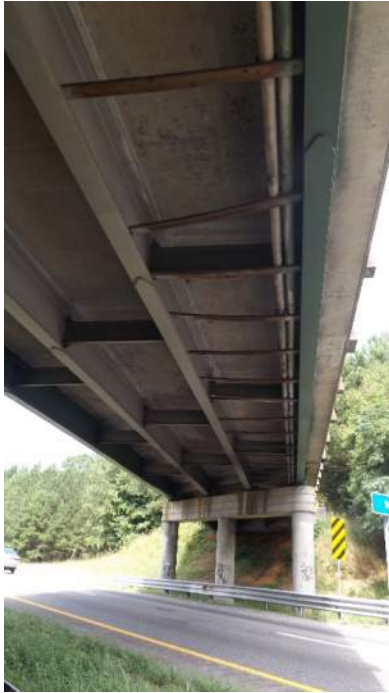
Two conduits are located in an exterior bay and run the entire length of the bridge (see Figure 12). At the end of the conduit, the wires go underground near the end bent (see Figure 13). The wooden slats that help support the conduits were all in place, but there is probably a more stable support system that could be used (see Figures 14 and 15).

Figure 12 – Conduit under Bridge

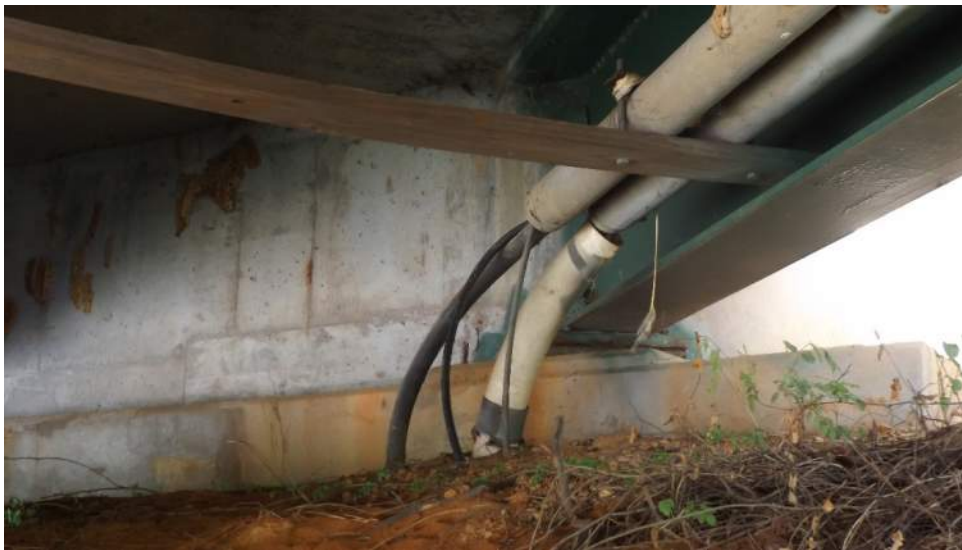
Figure 13 – Utilities going underground near End Bent

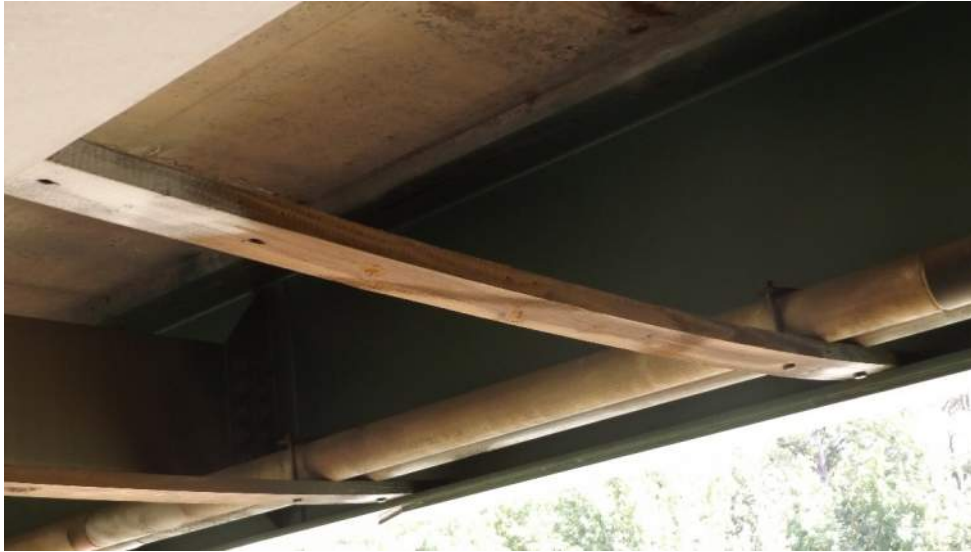
Figure 14 – Wooden Slats supporting Conduit

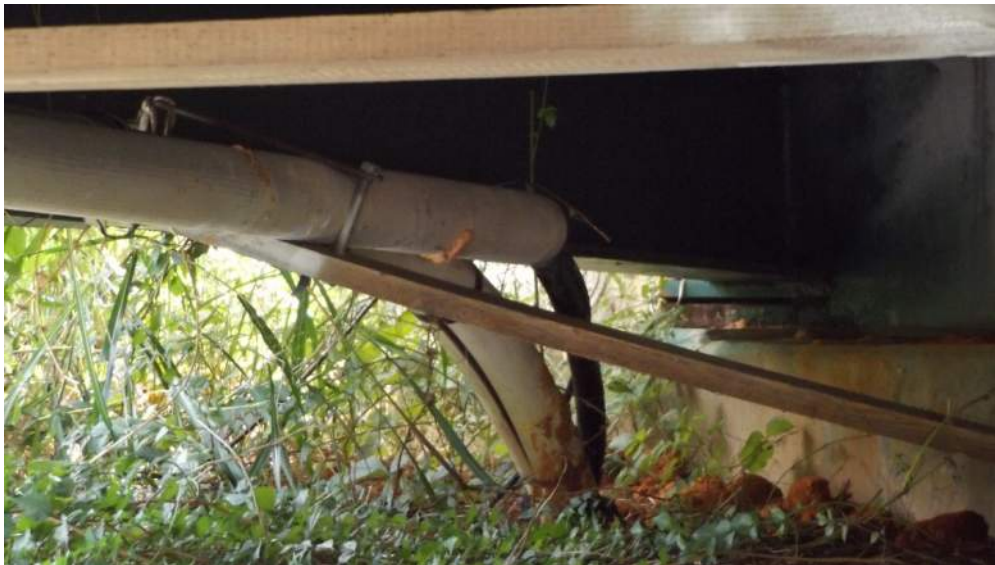
Figure 15 – Wooden Slat has fallen off the Beam

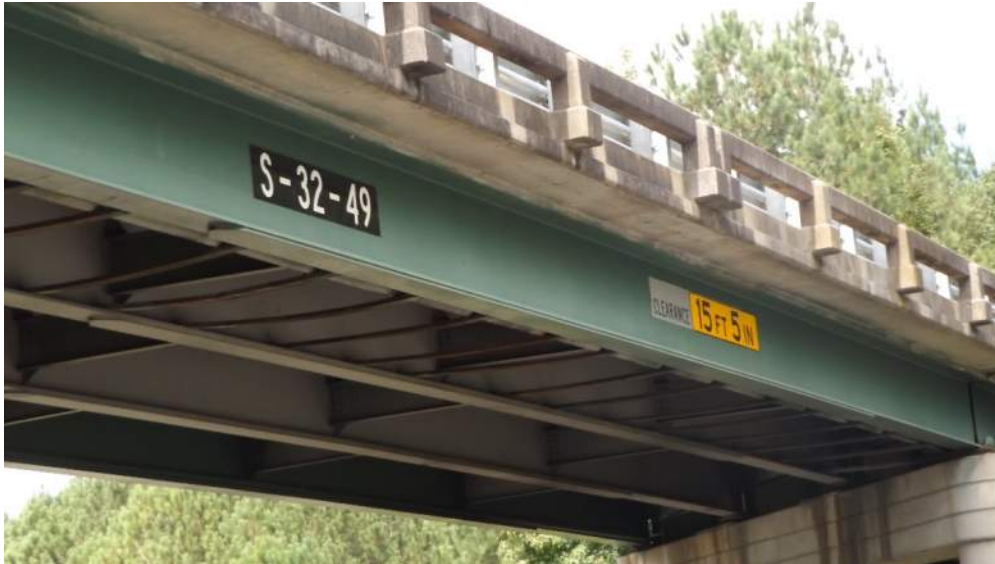
The posted minimum vertical clearances under the existing bridge are 15'-5" (I-26 WB) and 15'-10" (I-26 EB), neither of which meets the 16'-0" minimum specified for freeway under existing overpassing bridges in the SCDOT Highway Design Manual.

Figure 16 - Vertical Clearance (I-26 WB)
