S-36-39 (Holy Trinity Church Road) Bridge Over I-26
Newberry County, South Carolina

Asbestos and Lead-Based Paint
Survey Report

ARM Project #16-326-16

May 25, 2017

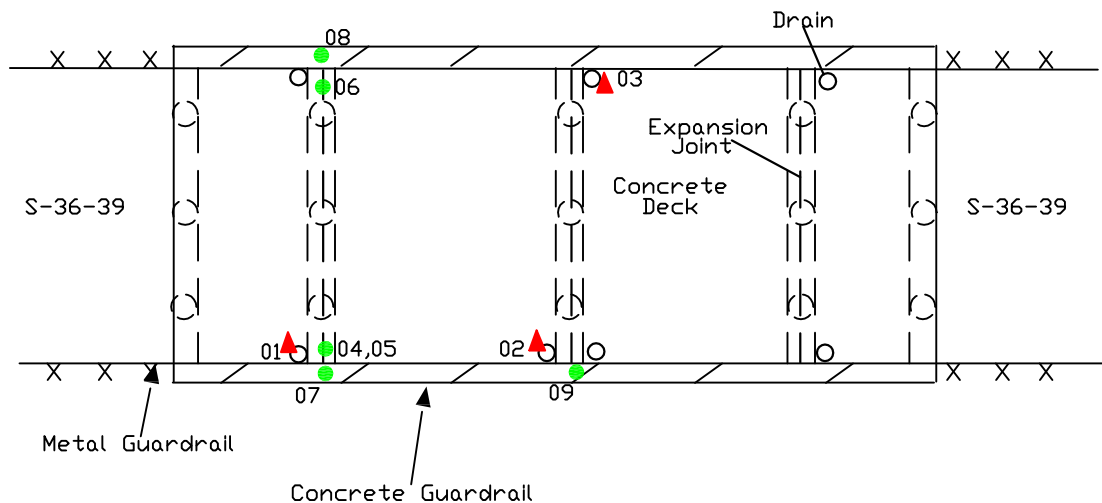
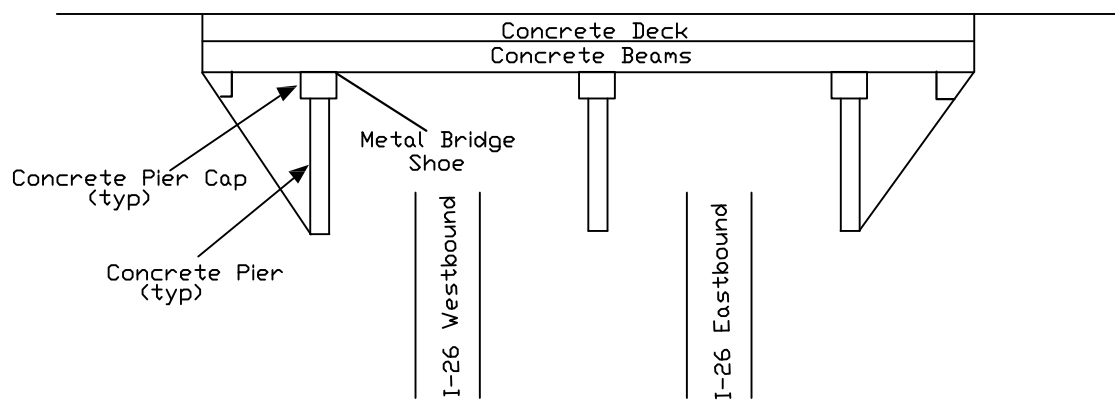
Sample Number	Suspect Material	Material Location	Present Condition	Analytical Results*	Estimated Material Quantity
01, 02, 03	Transite Drain	Drain pipes through bridge deck	Good / NF	70% Chrysotile Asbestos 3% Crocidolite Asbestos	8 LF
04, 05, 06	Expansion Joint Material	Between bridge deck sections	Good / NF	No Asbestos Detected	150 LF
07, 08, 09	Buffer Material	Between bridge deck and concrete rail sections	Good / NF	No Asbestos Detected	325 SF

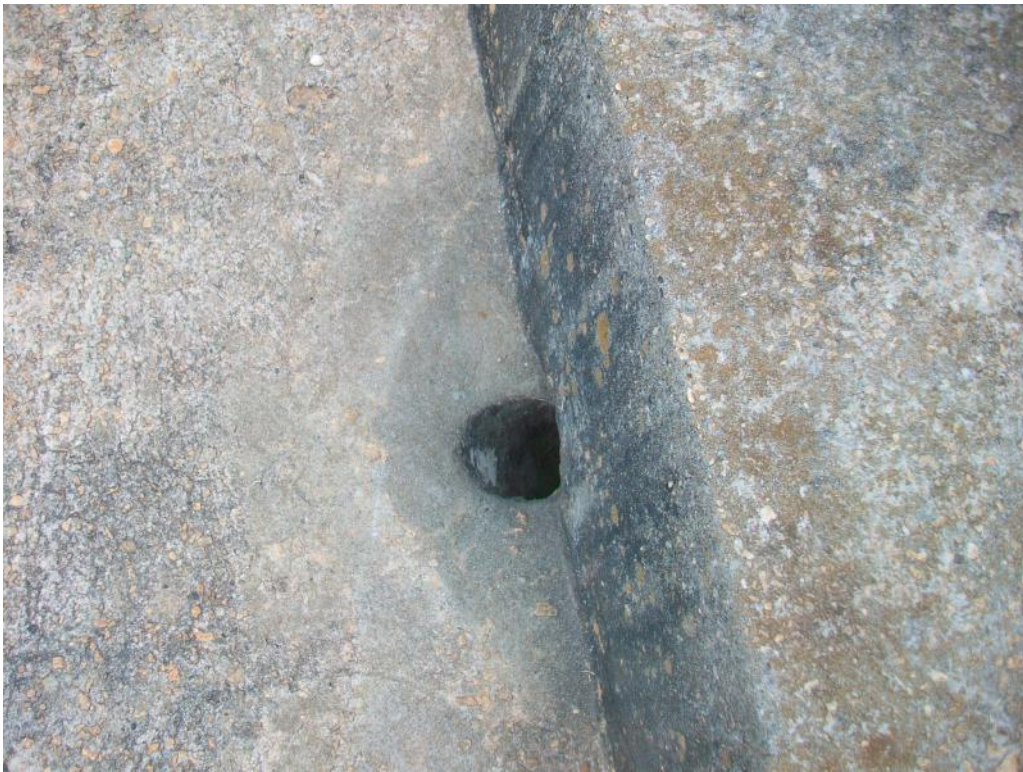
The sample results indicated that the bridge drain pipe material contains asbestos. The laboratory results are included in Appendix C of this report.

An asbestos inspection was performed for a structure, the S-36-39 Bridge located over I-26, in Newberry County, South Carolina. **The results of the asbestos survey indicate that the transite bridge drains are an asbestos containing material (ACM).** In its present condition, and without significant disturbance, there is a low potential for significant concentrations of asbestos fibers to be released from this material. However, it is recommended that this material be removed prior to any renovation, demolition, or other process that might disturb the material, or render it friable. SCDHEC regulations will not allow for a Category II ACM such as this to be left in place during demolition activities. Based on the potential for the ACM to be rendered friable during the removal process, it is recommended that the removal of this material be conducted by a licensed abatement contractor. No other asbestos containing materials were identified on the bridge structure.

Photograph 3 – Typical view of asbestos containing transite drain pipe located on the bridge structure.

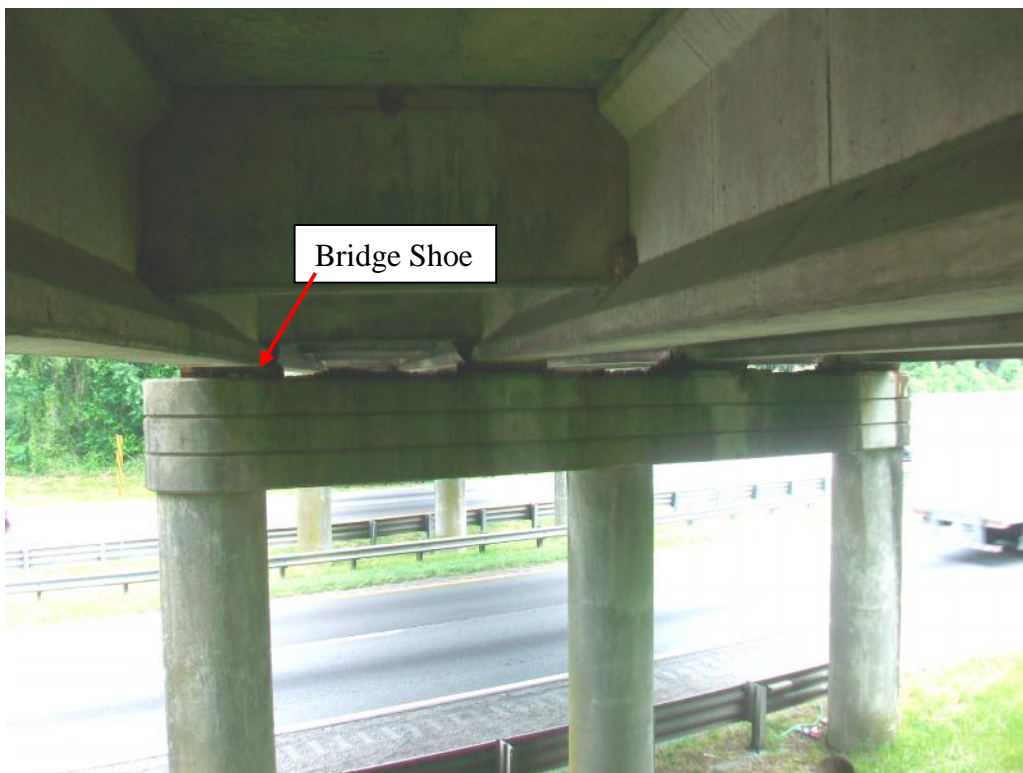
The results of these analyses indicate that the metal components of the bridge structure, except for the galvanized metal approach guard rails, tested positive for lead-based paint. The XRF data results are presented in Appendix D. Photographs of the site are located in Appendix F.

A lead-based paint survey was performed for the S-36-39 Bridge over I-26 in Newberry County, South Carolina. **The results of the XRF analyses indicate that all of the metal components of the bridge structure, except for the galvanized metal guard rails are coated with lead based paint. These materials include the anchor bolt plates and bolts and the bridge shoes.** If these bridge components are disturbed during renovation or demolition, contractors and workers should be informed as to the presence of lead-based paint and appropriate work practices and personal protective equipment should be used to prevent exposure to lead dust/fumes or spreading lead contamination from the work site. The building components containing lead based paint should be disposed of in accordance with federal and state regulations. All waste debris coated with lead-based paint equal to or greater than 0.7mg/cm² must be disposed of in an approved Class Two (C&D) or Class Three (MSWLF) landfill or approved metal recycler. The OSHA lead standard for construction work (29CFR 1926.62) would apply to all demolition or renovation activities that disturb any of the materials containing lead.

Photograph 4 – View of the underside of the bridge. All metal bridge components, except for the galvanized metal guardrails are coated with lead based paint.
