**Asbestos & Lead-Based Paint
Assessment
I-77 North Bound over US 21
Structure No. 401007712200
Blythewood, South Carolina
S&ME Project No. 23610178A**

Reference: **Asbestos & Lead-Based Paint Assessment**
I-77 North Bound over US 21
Structure No. 40100771220
Blythewood, South Carolina
S&ME Project No. 23610178A

An asbestos assessment and lead-based paint assessment was conducted on December 1, 2023, of the I-77 North Bound Bridge over US Highway 21 (Structure No. 401007712200) in Blythewood, South Carolina. The purpose of the assessment was to identify asbestos-containing materials (ACMs) and lead-based paint coatings associated with the structure prior to repair activities.

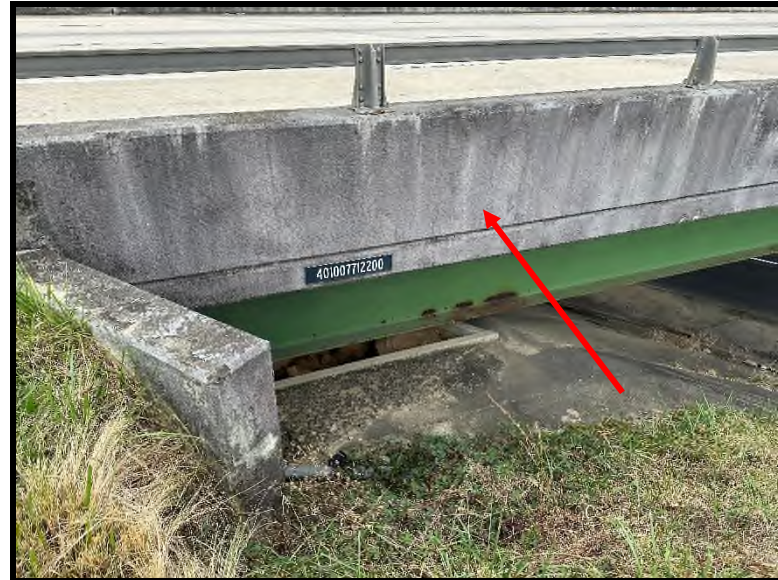
2 Structure number. **The concrete surfacing texture tested positive for asbestos (2% Chrysotile).**

S&ME recommends proper removal and disposal of the ACM by a licensed asbestos abatement contractor prior to activities that may disturb an ACM. State and Federal regulations should be carefully considered in order to verify compliance before any actions are initiated that may disturb an ACM. If additional suspect ACMs not included in this report are discovered and will be disturbed by renovation or demolition activities, bulk samples must be collected by a licensed asbestos inspector and analyzed for asbestos content, prior to disturbance of the suspect material(s).

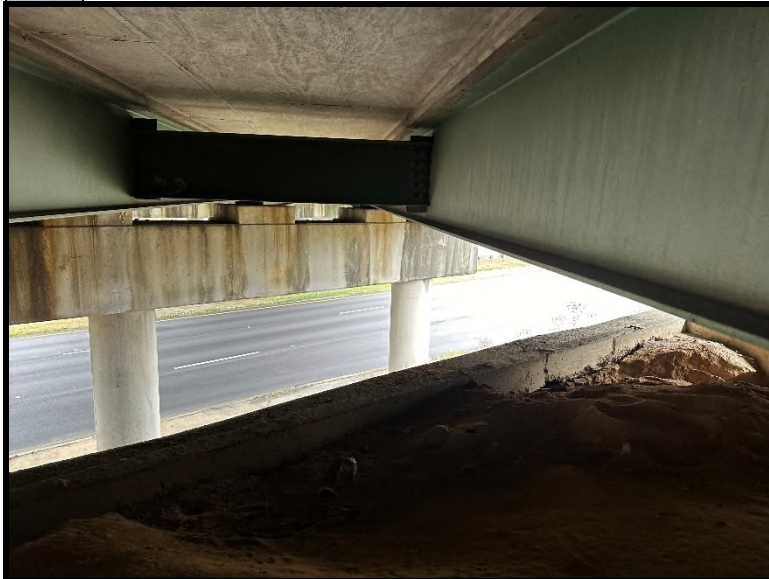
The lead-based paint assessment of the subject bridge **did identify** the presence of lead-based paint on the green structural steel (6.6-7.6 mg/cm²).

3 View beneath the bridge. **The green structural steel tested positive for lead-based paint (6.6-7.6 mg/cm²).**

Destructive actions to paint containing detectable levels of lead (*e.g.* paint preparation, component removal, demolition, sanding, grinding, burning, etc.) may require the contractor to comply with the standards of the OSHA regulations 29 CFR 1926.62 (Lead in Construction), including but not limited to training, initial exposure

SCDHEC Regulation 61-107.19 permits demolition materials painted with lead-based paint ($\geq 0.7 \text{ mg/cm}^2$) to be disposed in a permitted Class Two (C&D) or Class Three Subtitle D, Municipal Solid Waste (MSW) landfill.
